DIGITAL PHOTOGRAPHIC LOG

1. **Facility Name:** Sun Fiberglass Products, Inc.
2. **County / AIRS ID No:** Hernando County / 0530363.
3. **Inspection Type:** INS2 and Full Compliance Evaluation (FCE).
4. **Inspection Date:** 02/23/2012.
5. **Date Photographic Log was completed:** 02/28/2012.
6. **Camera Used:** Olympus Camedia Digital Camera, 5.0 Megapixel, C-50 ZOOM, S/N 115248297.
7. **Recording Media:** FUJIFILM xD-Picture Card, 128 MB, S/N DPC-128, R31695 5RZ7, 0244 MAD.
8. **All Digital Photos Were Copied To:** Hard Disk of Computer DEP 143271; some photos copied to this Digital Photographic Log.
9. **Original Copy Is Stored In/On:** Hard disk of computer DEP 143271.
10. **Were the photos altered?:** NO YES explain yes:
11. **Photographer:** Amaury Betancourt
12. **Signature of Photographer:** _____

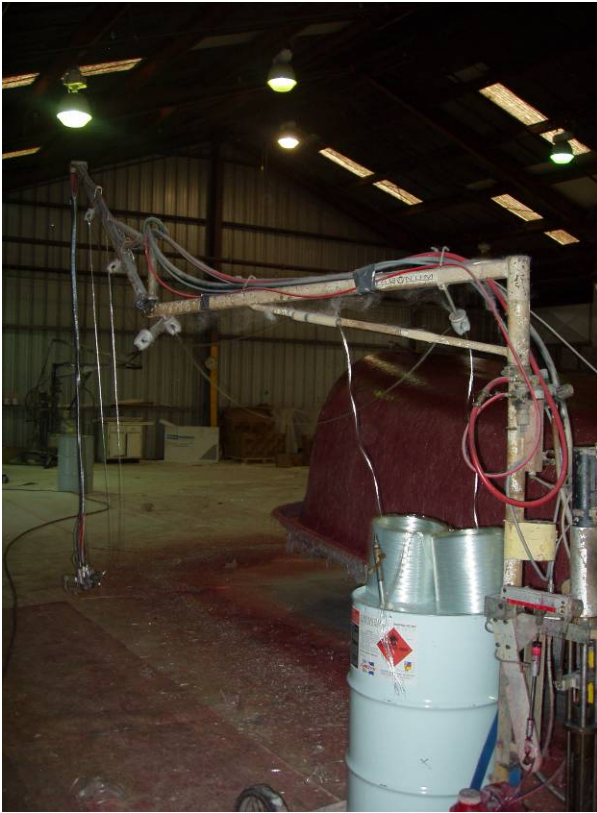
Photo ID No: Photo_0530363_02_23_2012-2

Application tool (chop gun) used to spray a mixture of resin, fiberglass, and catalyst onto a pool mold that has already received gelcoat. The white barrel contains resin and the fiberglass rolls are sitting on top of the barrel. The catalyst is a red material in a jug next to the resin. Resin, chopped fiberglass, and catalyst have already been partially applied to the unfinished pool visible just behind the chop gun in the photograph. Operators use hand rollers to remove air bubbles and to apply the materials to the mold. The camera is facing approx. NE.

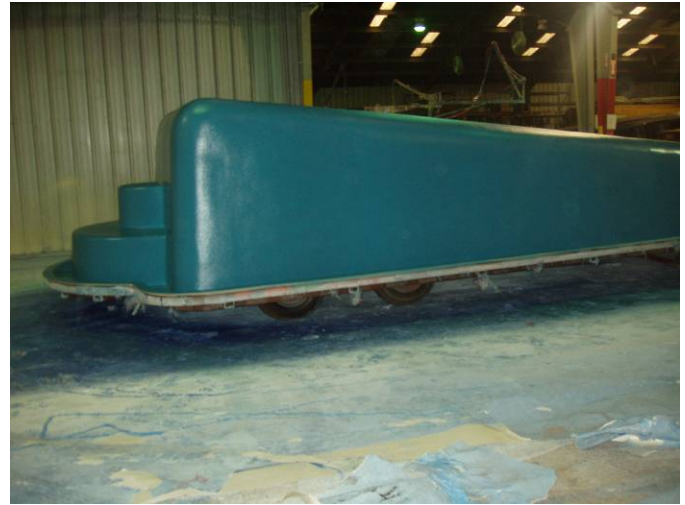
Photo ID No: Photo_0530363_02_23_2012-4

Pool mold that has received gelcoat and is waiting to receive resin, chopped fiberglass, and catalyst. The camera is facing approx. ESE.

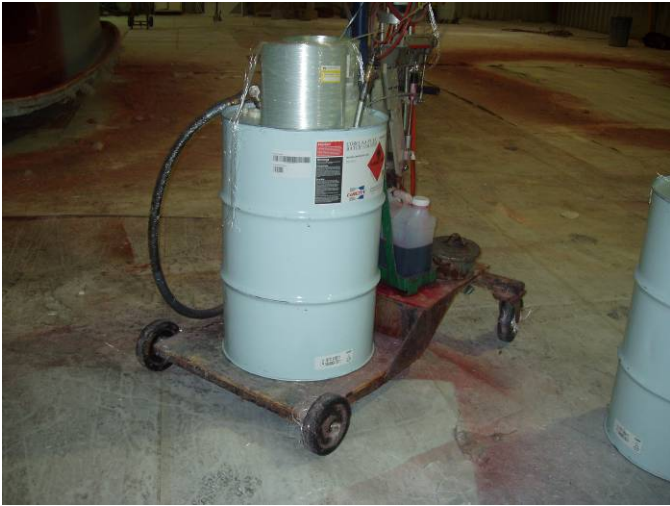
Photo ID No: Photo_0530363_02_23_2012-5
Time – Approx. 11:00 AM
Cart carrying raw materials for chop gun, including resin, which is in the white barrel, fiberglass rolls, which are sitting on top of the resin, and catalyst, which is the red material inside the jug next to the resin. The camera is facing approx. N.

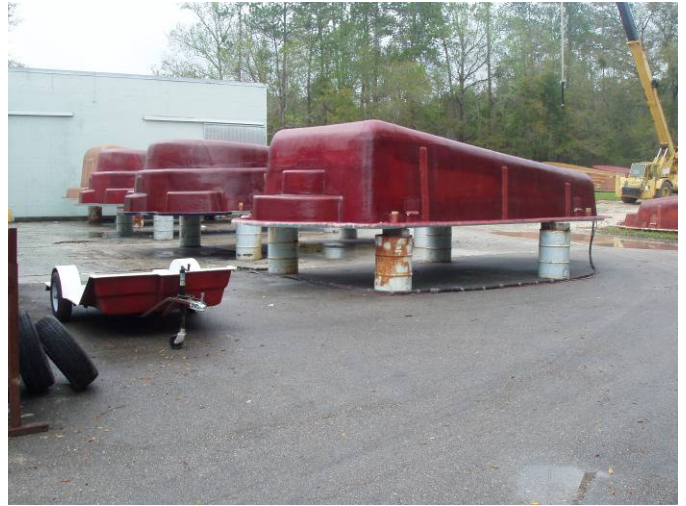
Photo ID No: Photo_0530363_02_23_2012-7
Time – Approx. 11:00 AM
Location at the facility where the perimeter of each pool is trimmed using hand tools equipped with vacuum devices to capture dust. A crane visible in the background of the photo is used to lift each finished pool out of its mold. The camera is facing approx. NW.

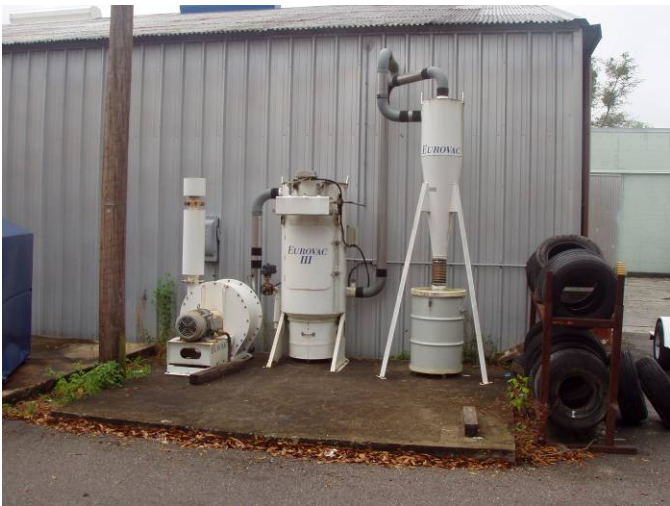
Photo ID No: Photo_0530363_02_23_2012-6
Time – Approx. 11:00 AM
The Eurovac III system uses filters to capture and collect dust from tools and operations within the building. The camera is facing approx. WSW.

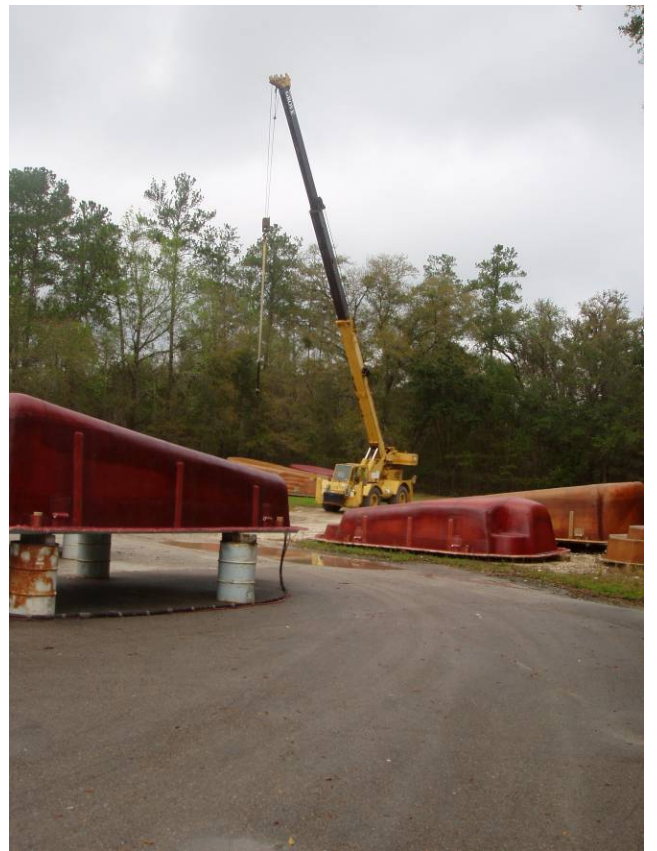
Photo ID No: Photo_0530363_02_23_2012-8
Time – Approx. 11:00 AM
Crane used to lift each finished pool out of its mold. The camera is facing approx. NNW.

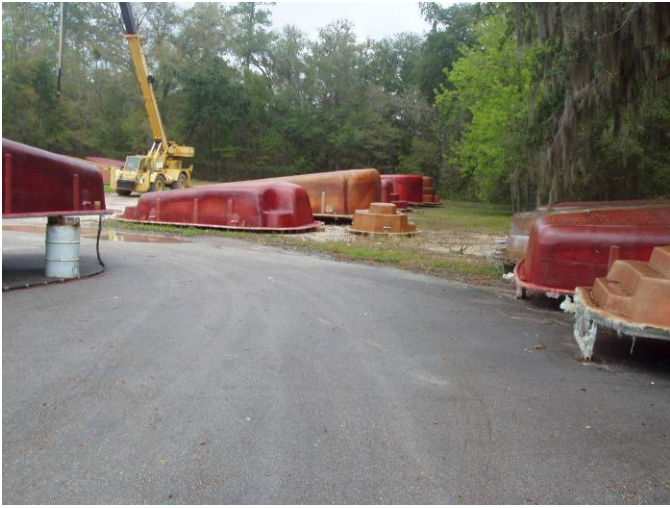
Photo ID No: Photo_0530363_02_23_2012-9
Time – Approx. 11:00 AM
Finished pools await shipment outside of the facility's building. The camera is facing approx. N.

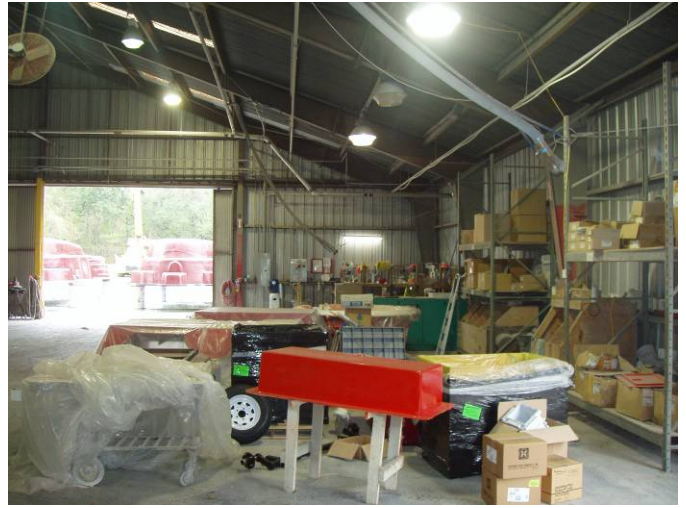
Photo ID No: Photo_0530363_02_23_2012-11
Time – Approx. 11:15 AM
Another view of the mold repair area in the building. The camera is facing approx. N.

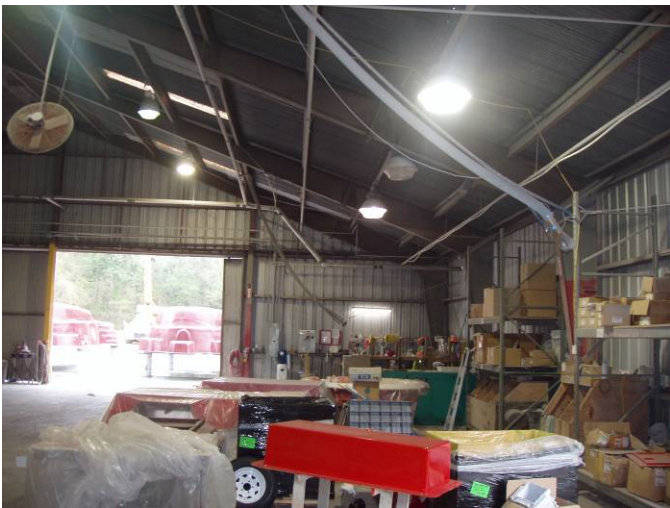
Photo ID No: Photo_0530363_02_23_2012-10
Time – Approx. 11:15 AM
Pool molds are repaired and maintained on this side, the East side, of the building. Vacuum connections for the Eurovac III system, which uses filters to capture and collect dust from tools and operations within the building, are visible in this photograph. One of these vacuum connections is visible in the foreground of this photograph, which is the grey cable diagonally. The camera is facing approx. N.

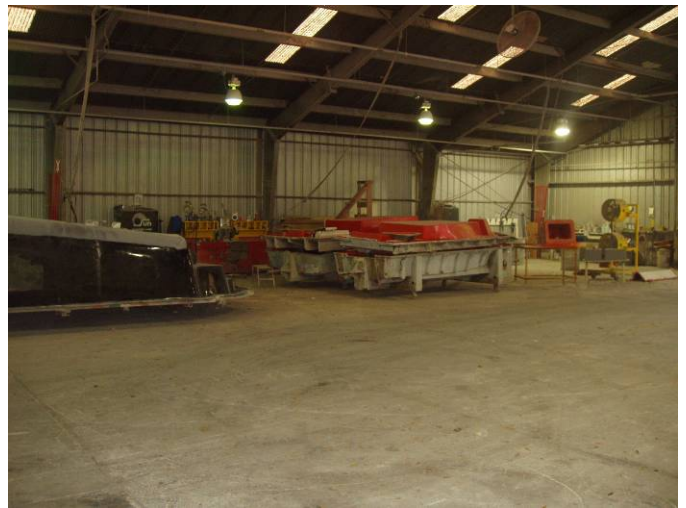
Photo ID No: Photo_0530363_02_23_2012-12
Time – Approx. 11:15 AM
A pool mold (large black object in this photograph) is visible. This area in the building is used to repair and maintain pool molds. The camera is facing approx. NW.

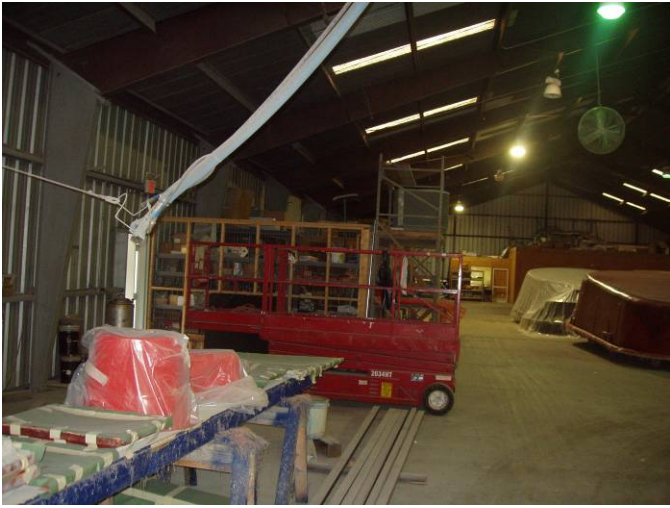
Photo ID No: Photo_0530363_02_23_2012-13
Time – Approx. 11:15 AM
Pool mold repair and maintenance area. The grey cable hanging diagonally in the foreground of the photograph is a vacuum connection for the Eurovac III system. The camera is facing approx. S.

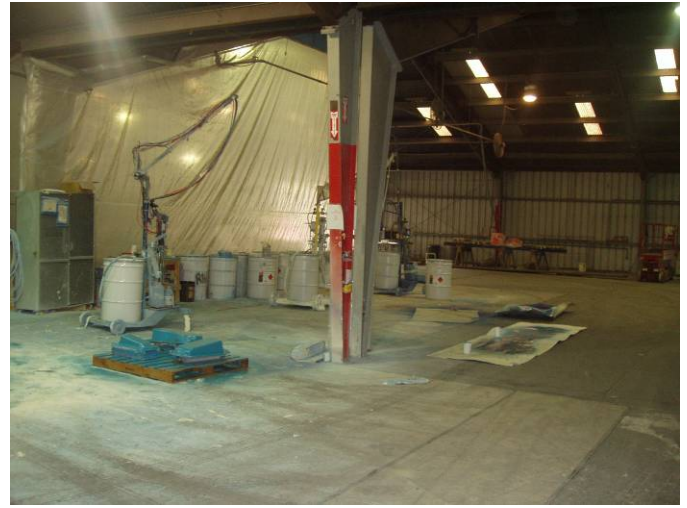
Photo ID No: Photo_0530363_02_23_2012-15
Time – Approx. 11:15 AM
Location for storing and using gelcoat in barrels. The camera is facing approx. NE.

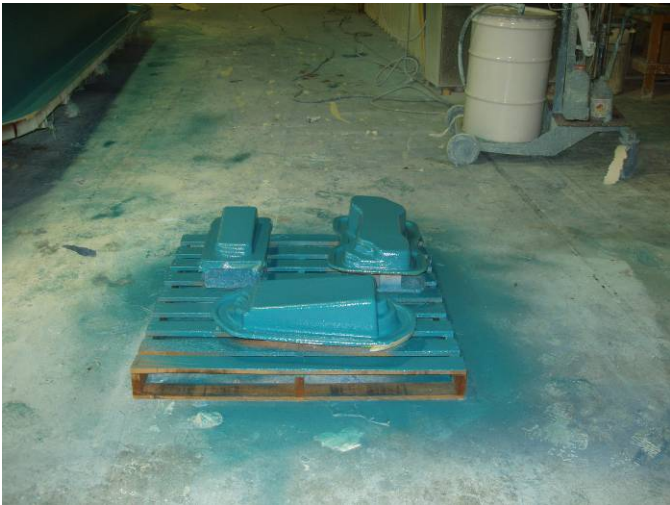
Photo ID No: Photo_0530363_02_23_2012-14
Time – Approx. 11:15 AM
These are small model pools, called “Barbie” pools, used to show models of the types of pools made by Sun Fiberglass Products, Inc. The dimensions of these small pools are approximately 1.5 feet long by 1 foot wide by 0.5 feet high. The camera is facing approx. N.

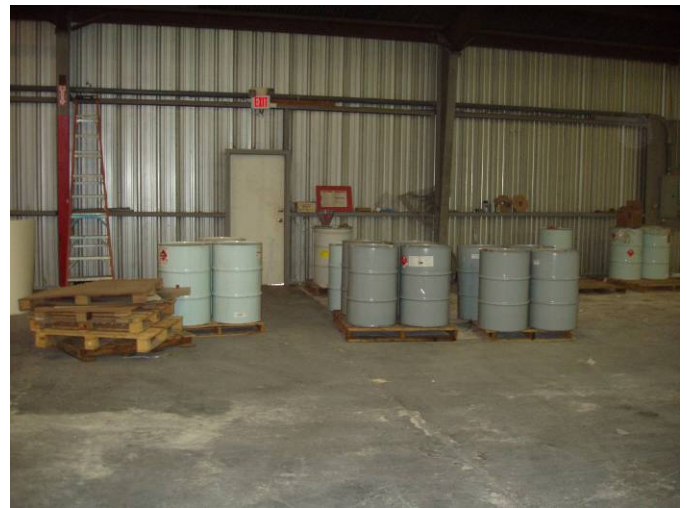
Photo ID No: Photo_0530363_02_23_2012-16
Time – Approx. 11:20 AM
Location inside building for storing resins in barrels. The camera is facing approx. WNW.

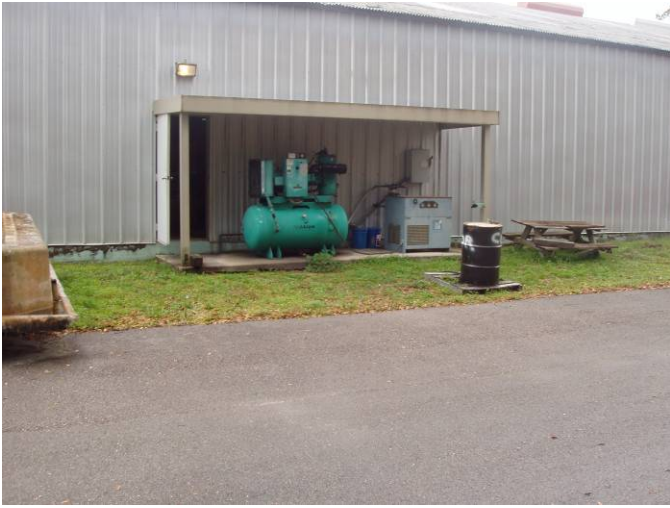
Photo ID No: Photo_0530363_02_23_2012-17
Time – Approx. 11:25 AM
The compressor system for running the tools used inside the building. The black barrel collects water from the compressor and when the barrel is filled, it is sent to be analyzed for oil and to be disposed of properly. The camera is facing approx. WNW.
