Florida Department of Environmental Protection Inspection Photo Log

Facility Name: MFM Industries	ID #: 0830017
Inspection Date: 11/9/09	Sky Conditions: partly cloudy
Persons Present: Wanda Parker-Garvin (FDEP, photographer), Michael S. Gascoigne (MFM Industries)	
Digital camera used. Photo files saved at: O:\COMPLIANCE-Central Files\Inspection Reports 2009-2010\Wanda's Inspections\Lake\MFM Industries\Photos

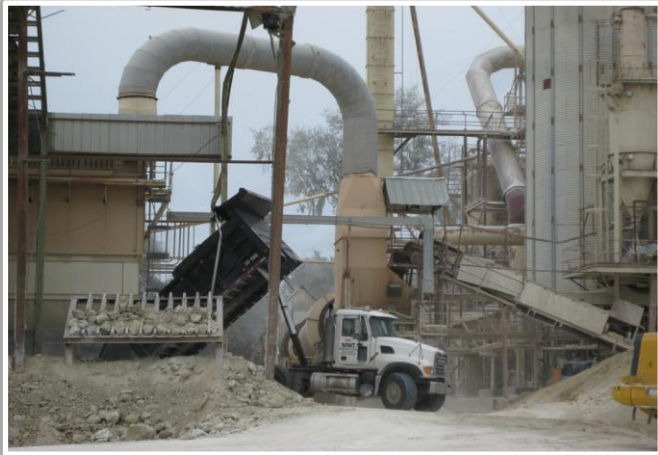
Photo 1: A dust cloud located in the middle of the facility which was observed upon entering the facility.

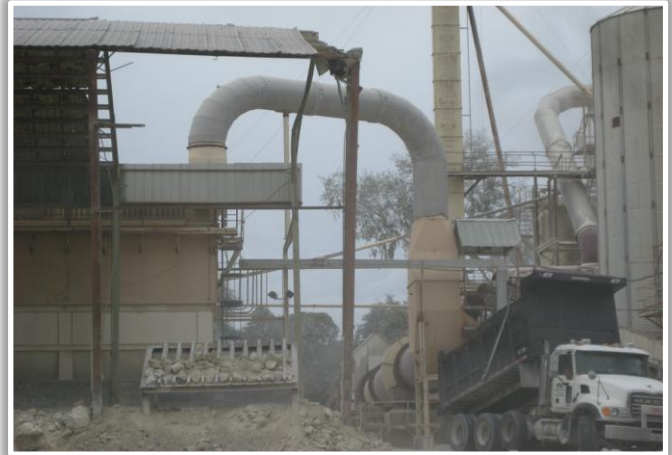
Photo 2: A dust cloud located in the middle of the facility which was observed upon entering the facility.

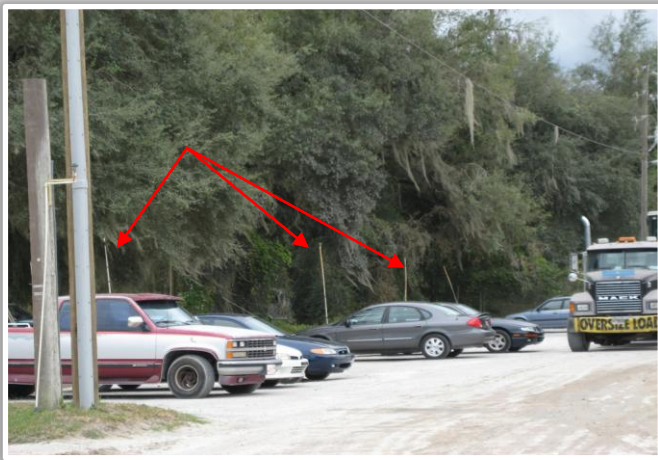
Photo 3: Approximately 10 ft vertical sprinklers in the background along the front end of parking area.

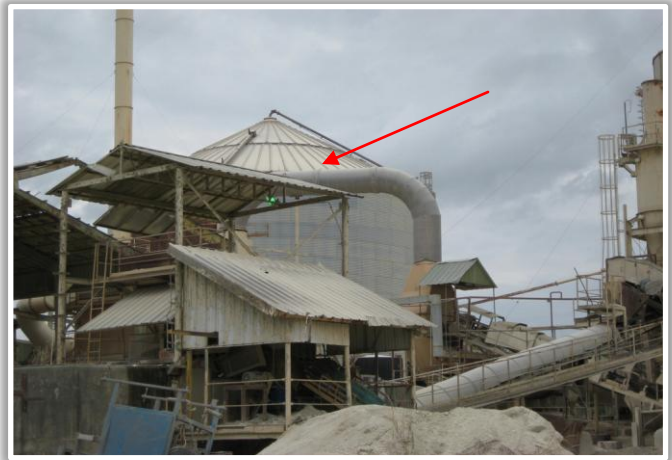
Photo 4: Tank #9 containing only dust from the collection system is located in the background.

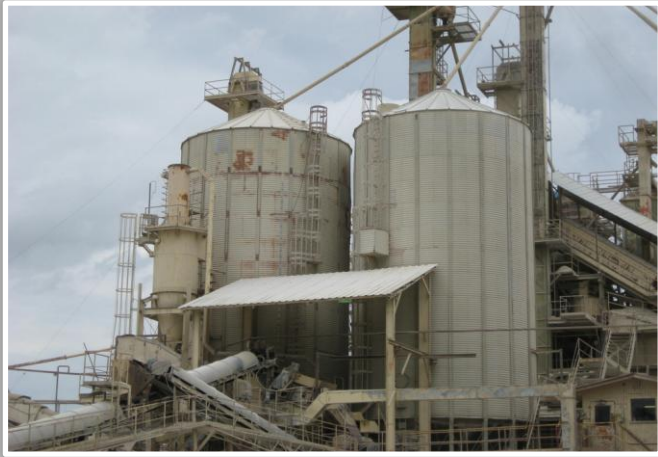
Photo 5: Tanks #7 and #8 containing product.

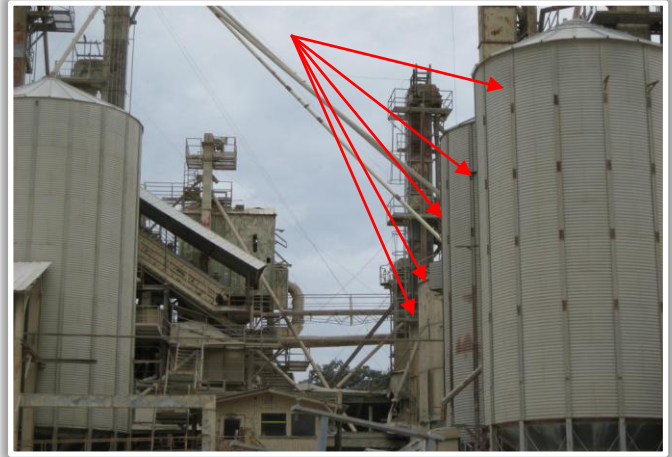
Photo 6: Tanks #1, #2, #3, #4 and #5 - four containing product and one containing bentonite.

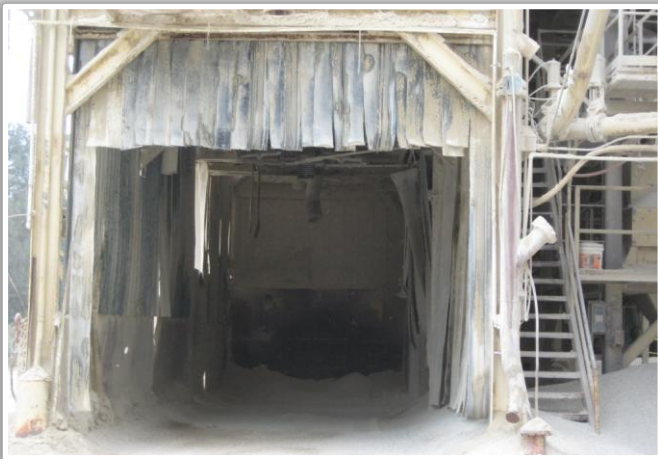
Photo 7: Front view of the load out area.

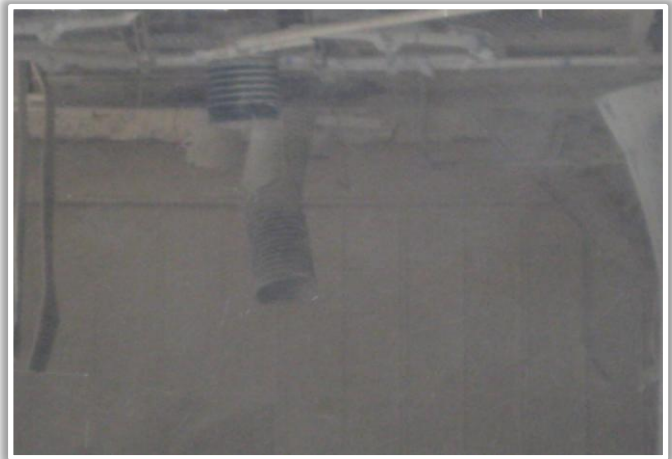
Photo 8: Close up view of the discharge shuttes inside the load out area.

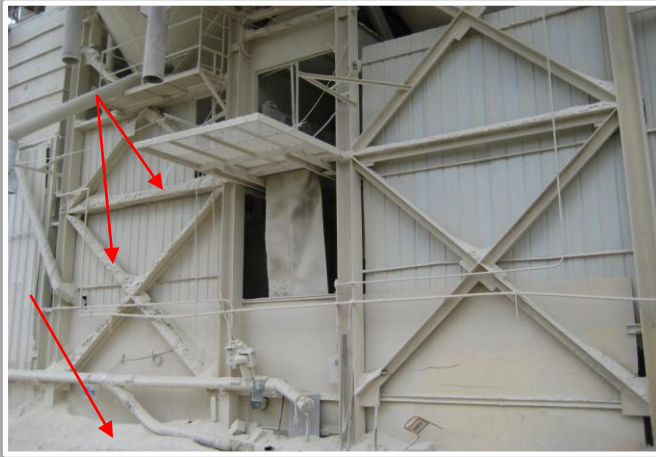
Photo 9: Side view of the load out area showing accumulation of unconfined particulate matter.

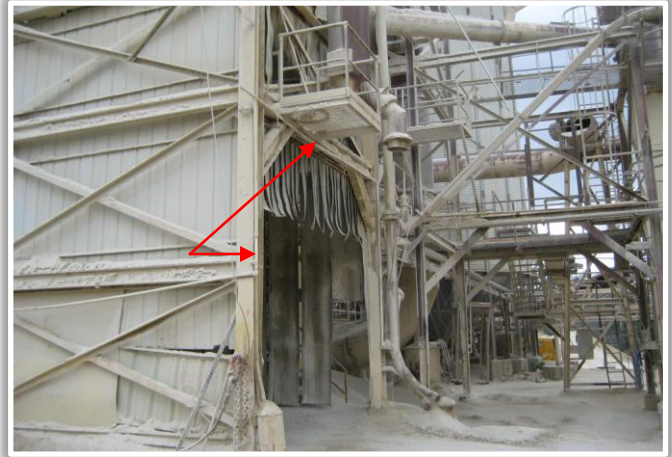
Photo 10: Side and frontal view of load out area showing inoperable sprinkler system.

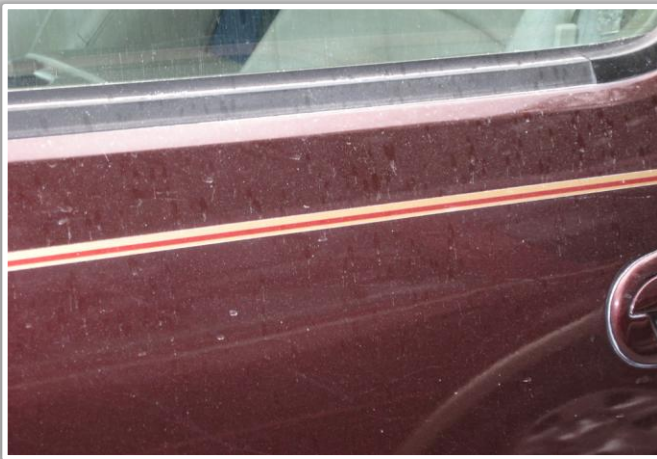
Photo 11: Accumulated clay-like material on the side of Mr. Roland's (complainant) vehicle.

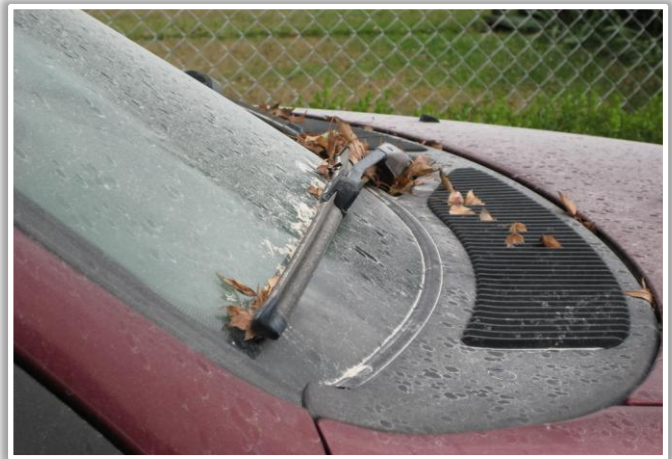
Photo 12: Accumulated clay-like material on the windshield/hood of Mr. Roland's vehicle.

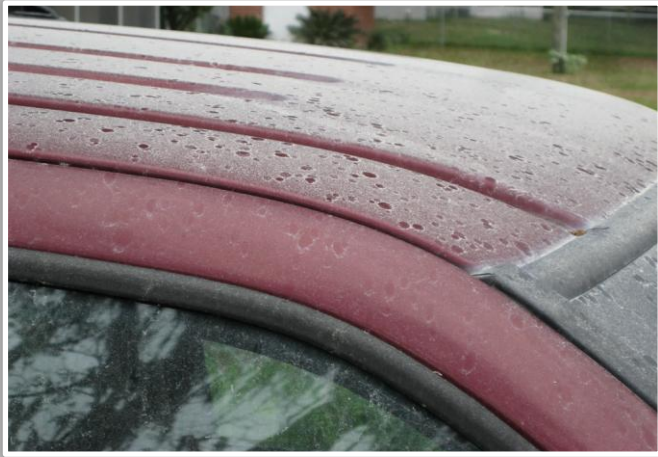
Photo 13: Accumulated clay-like substance on the top of Mr. Roland's vehicle.

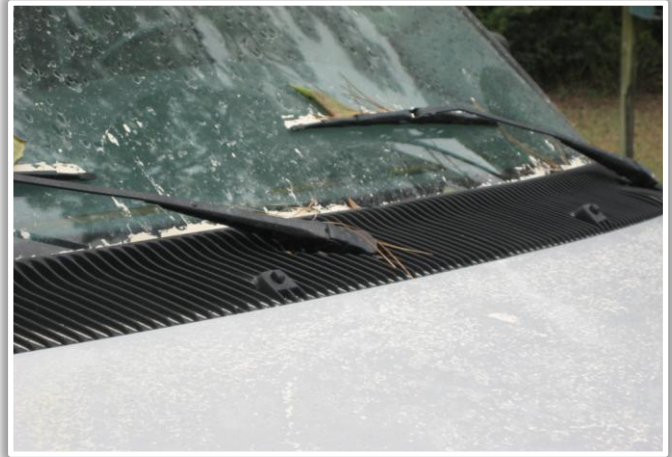
Photo 14: Accumulated clay-like substance on the windshield/hood of a neighbor's vehicle.

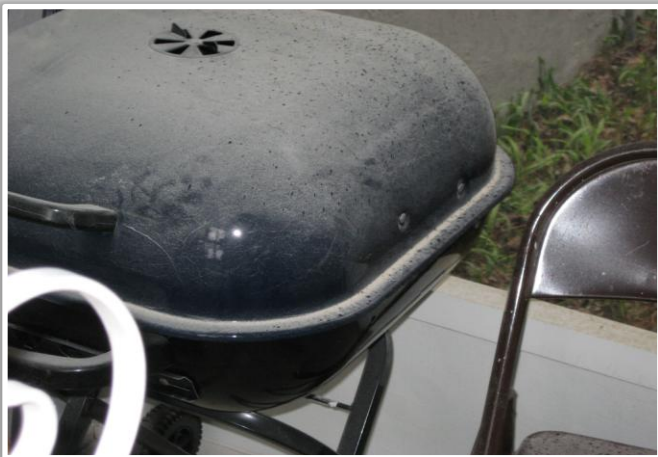
Photo 15: Accumulated clay-like substance covering the barbeque grill and chair on the enclosed porch David & Lilia Kiefer (Mr. Roland's tenants who live next door).

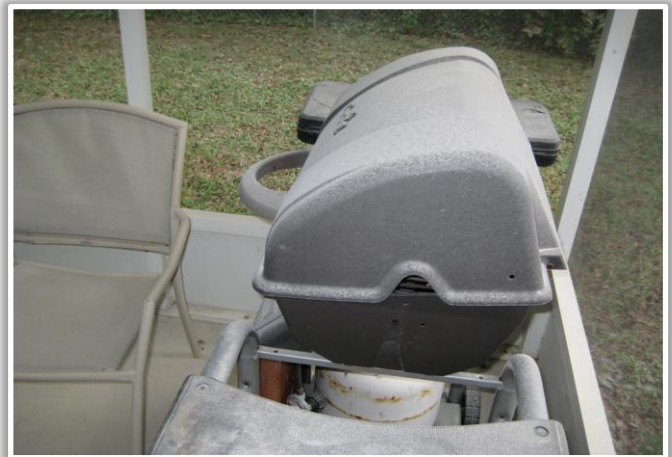
Photo 16: Accumulated clay-like substance covering the barbeque grill and chair on the enclosed porch of David & Lilia Kiefer.

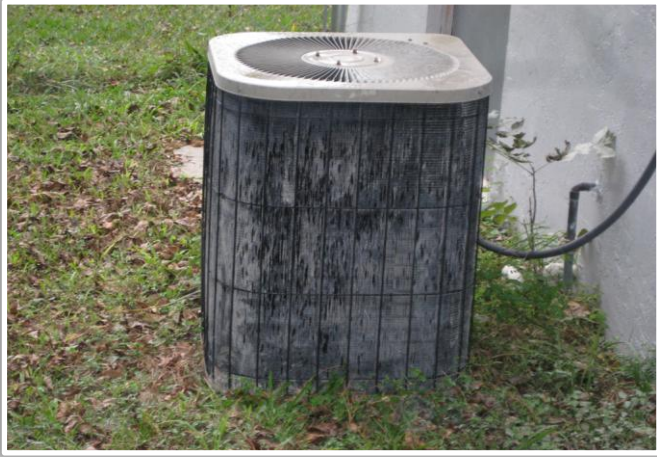
Photo 17: Accumulated clay-like substance covering the outside air conditioning unit of David & Lilia Kiefer.

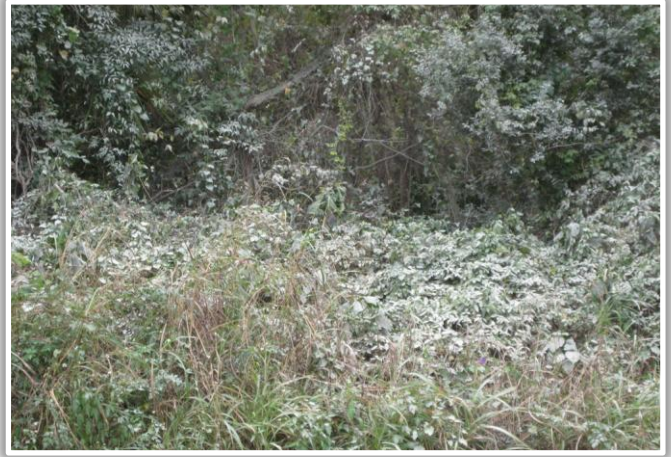
Photo 18: Accumulated clay-like substance covering the vegetation located directly across the road (CR 329) from MFM Industries.

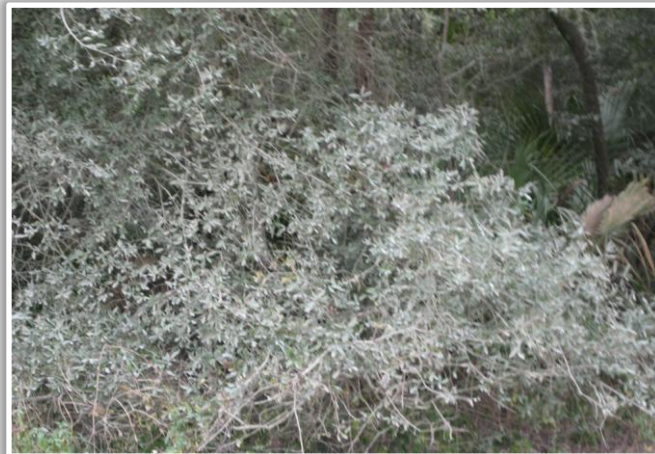
Photo 19: Accumulated clay-like substance covering the vegetation located directly across the road (CR 329) from MFM Industries.
