Florida Department of Environmental Protection Inspection Photo Log

Facility Name: Anderson Columbia Plant #8	ID #: 0830135
Inspection Date: 11/3/11	Sky Conditions: Clear
Persons Present: Wanda Parker-Garvin (FDEP, photographer), Stewart Carroll (Asphalt Operations Manager)	
Digital camera used. Photo files saved at: O:\COMPLIANCE-Central Files\Inspection Reports 2011-2012\Wanda's Inspections\Marion\Anderson Columbia 0830135

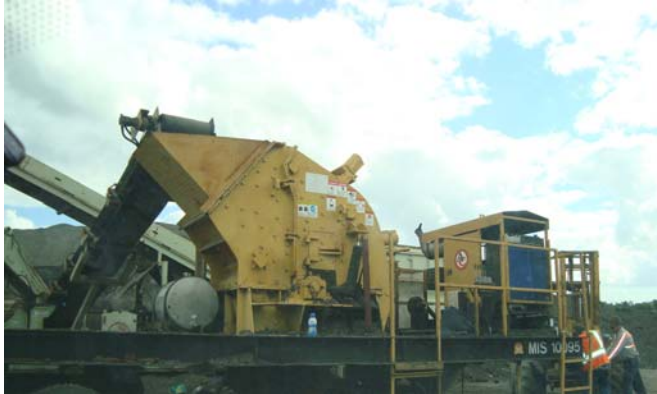
Crusher unit and engine located to the right.

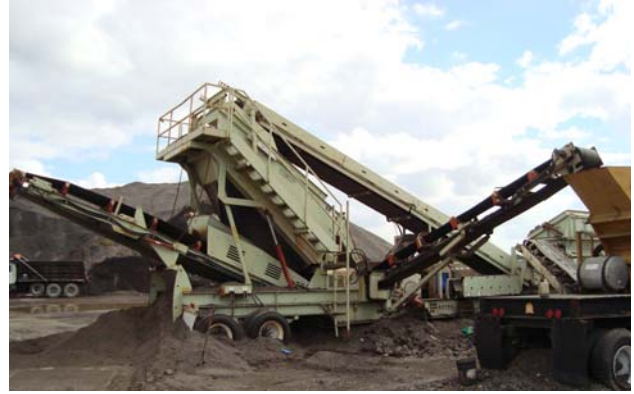
Screener and four (4) conveyor belts.

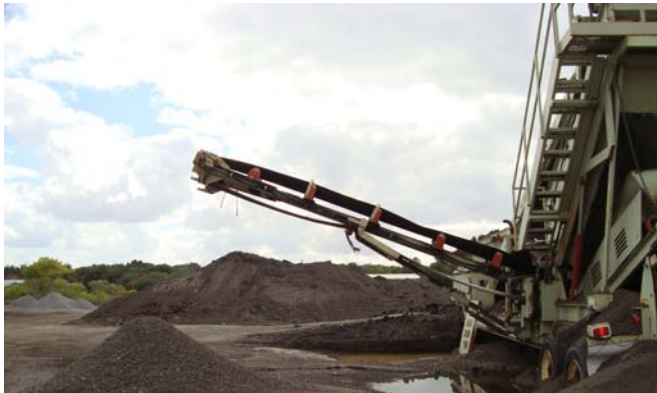
Side of unit with 5th conveyor belt.

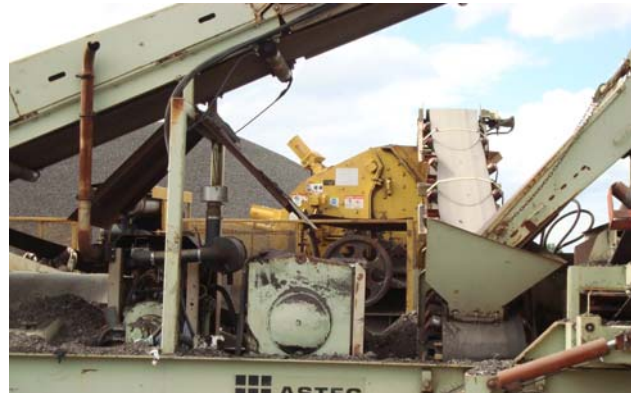
Engine for the screener.

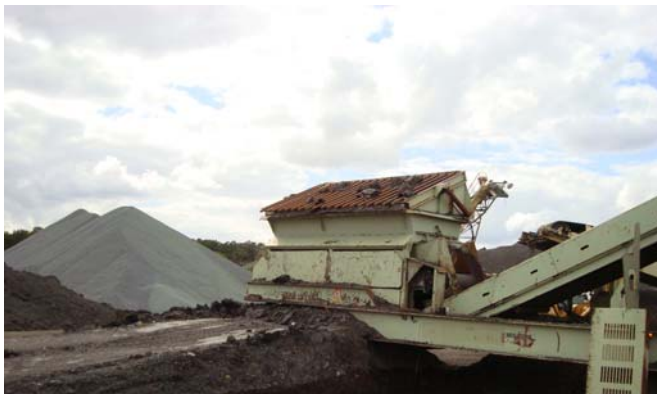
Loader for the crusher with initial screener.

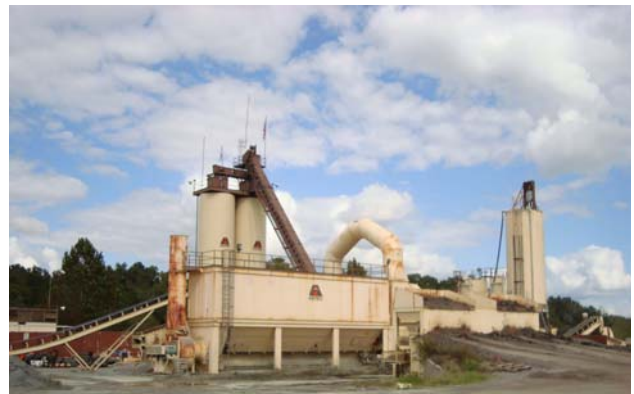
The asphalt plant.
