DIGITAL PHOTOGRAPHIC LOG

- 1. Facility Name: Standard Carbon
- 2. County / Facility ID No: Marion / 0830170
- 3. Inspection Type: INS24. Inspection Date: 07/12/11
- 5. Type of Camera Used: Canon Power Shot 5.0 mega pixels A530 (Air Section digital camera)
- 6. Digital Recording Media: Canon 16 MB MultiMediaCard
- 7. All Digital Photos Were Copied To: N/A
- 8. Original Copy Is Stored On: Nedin Bahtic's Computer\Documents and Settings\Bahtic_N\My Documents\My Pictures\Inspections\Marion\0830170 Standard Carbon (07-12-11)
- 9. Were the photos altered?: NO YES explain yes:
- 10. Photographer: Nedin Bahtic
- 11. Signature of Photographer:_____

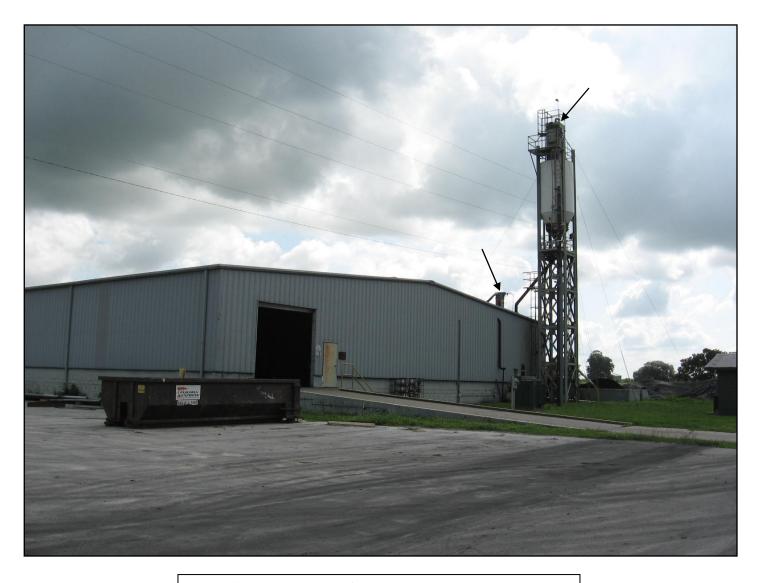
Photo ID No. / Date / Time: IMG_1328 / 07-12-11 / 1020 Mahle and Flex-Kleen baghouses

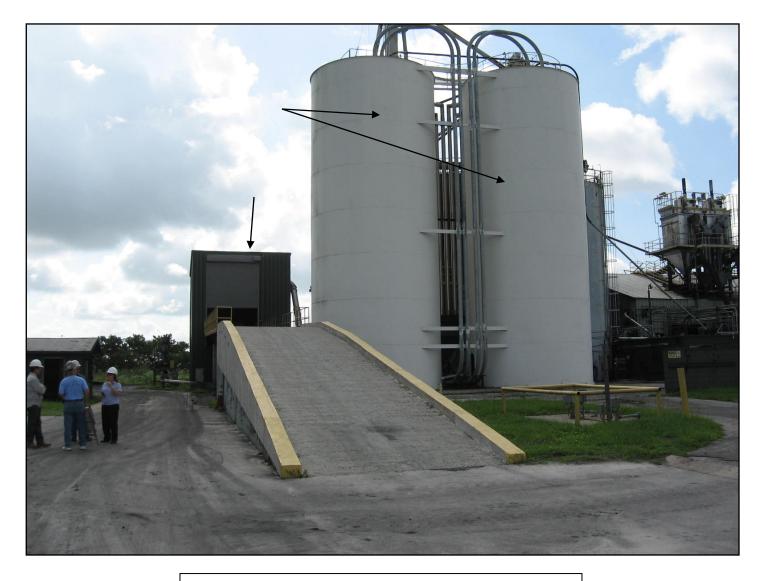
Photo ID No. / Date / Time: IMG_1329 / 07-12-11 / 1020 Truck unloading building; Silos 9 & 11

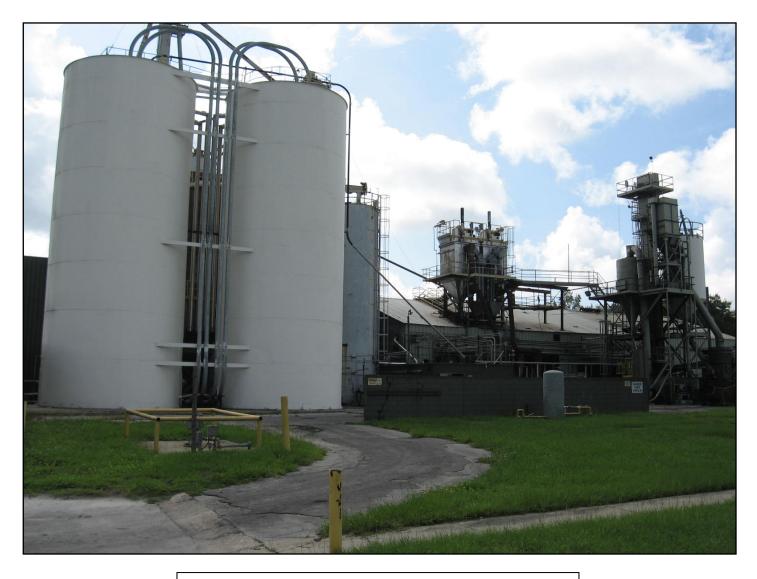
Photo ID No. / Date / Time: IMG_1330 / 07-12-11 / 1020 Standard Carbon facility – view from west

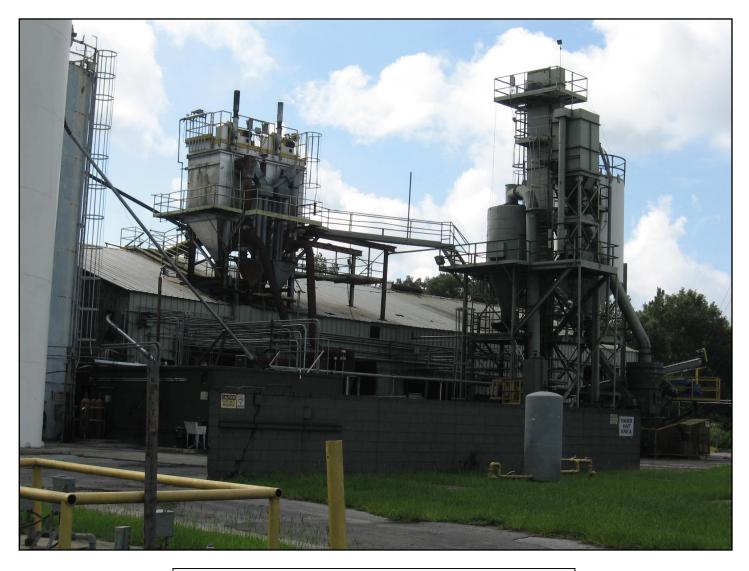
$Photo\ ID\ No.\ /\ Date\ /\ Time:\ IMG_1331\ /\ 07\text{-}12\text{-}11\ /\ 1020\\ \textbf{Standard\ Carbon\ facility-view\ from\ west}$

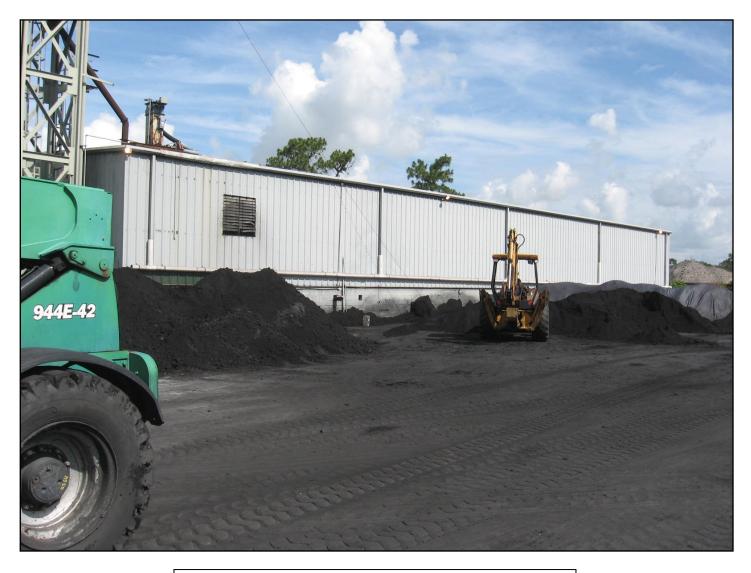
Photo ID No. / Date / Time: IMG_1332 / 07-12-11 / 1031 Wet fly ash receiving area

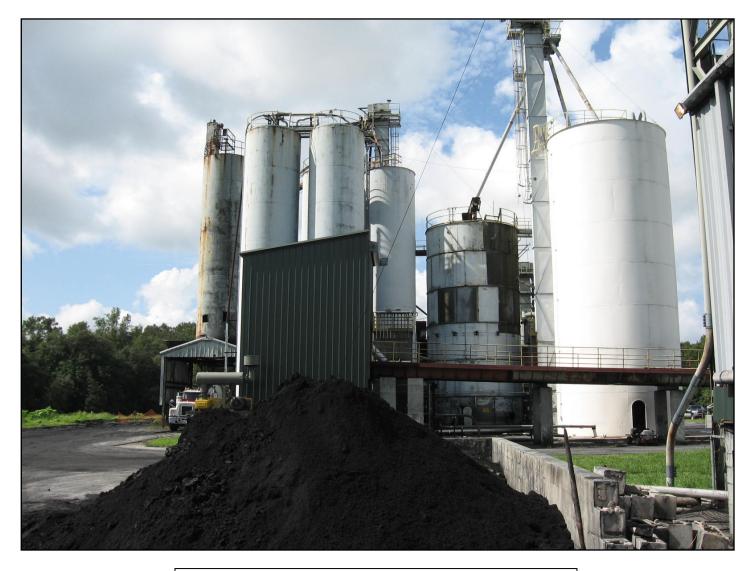
$Photo\ ID\ No.\ /\ Date\ /\ Time:\ IMG_1333\ /\ 07\text{-}12\text{-}11\ /\ 1034\\ \textbf{Standard\ Carbon\ facility-view\ from\ north}$

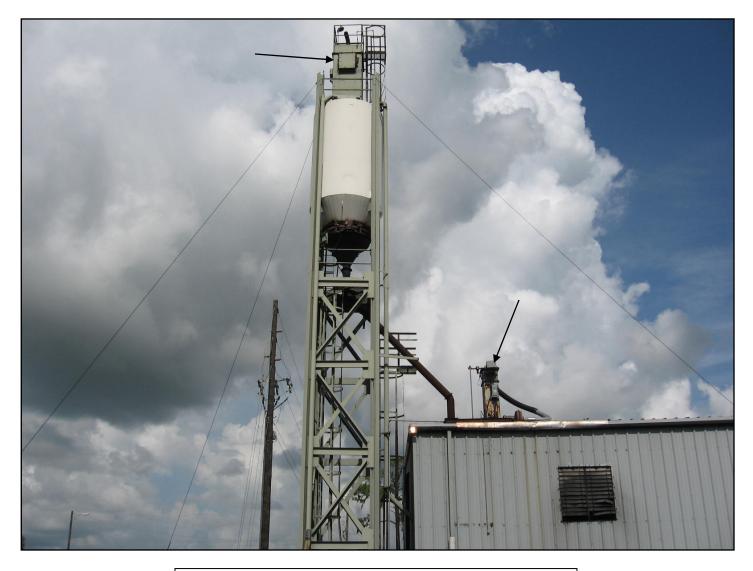
Photo ID No. / Date / Time: IMG_1334 / 07-12-11 / 1037 Flex-Kleen and Mahle baghouses

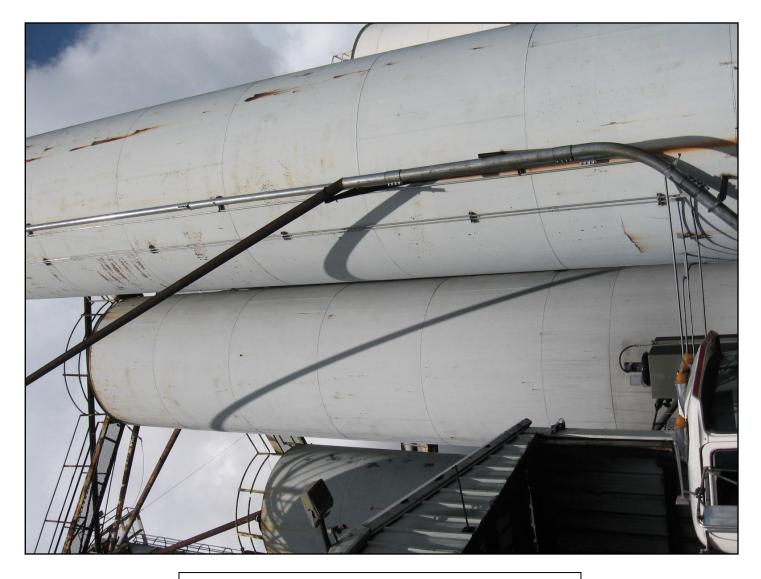
Photo ID No. / Date / Time: IMG_1335 / 07-12-11 / 1039 Carbon storage silos

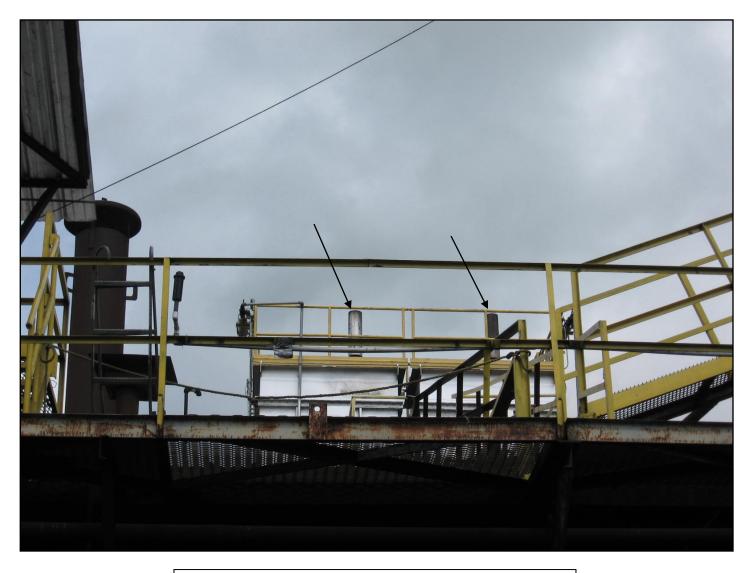
Photo ID No. / Date / Time: IMG_1337 / 07-12-11 / 1046 Exhausts from Kilns 2 & 1

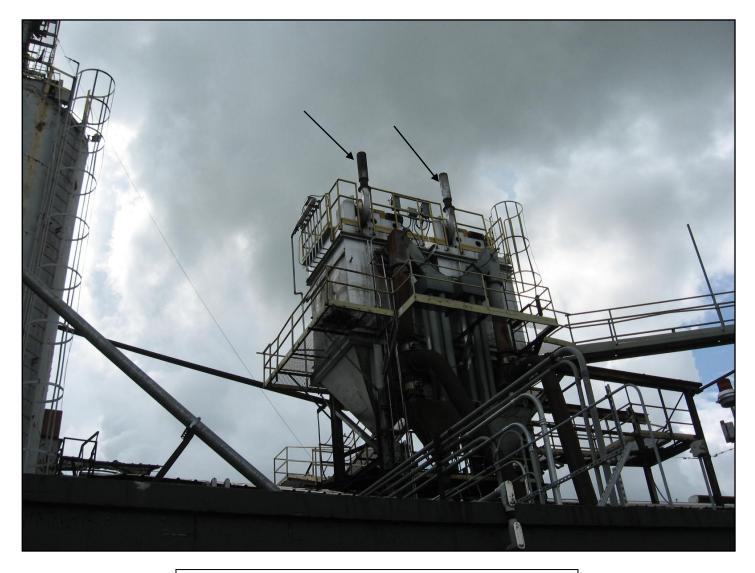
Photo ID No. / Date / Time: IMG_1338 / 07-12-11 / 1050 Exhausts from Kilns 1 & 2

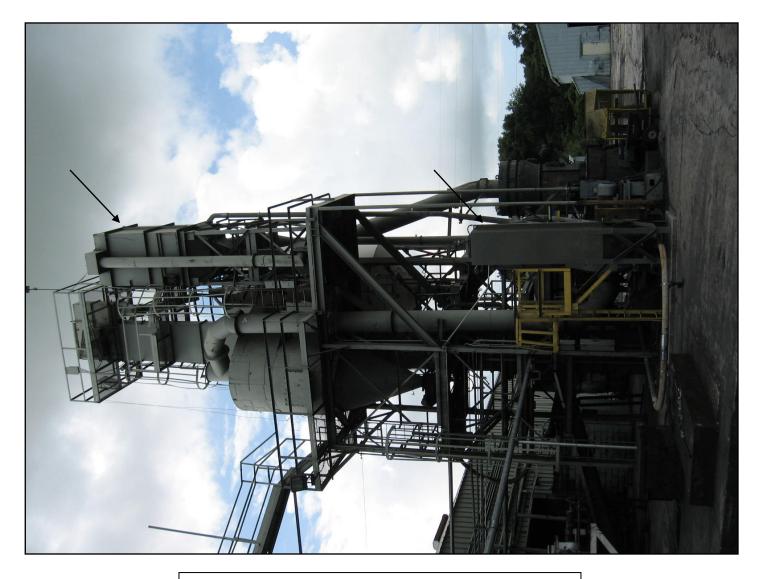
Photo ID No. / Date / Time: IMG_1339 / 07-12-11 / 1050 $\bf Mikro\ Pulsaire\ and\ PJ-3\ baghouses$

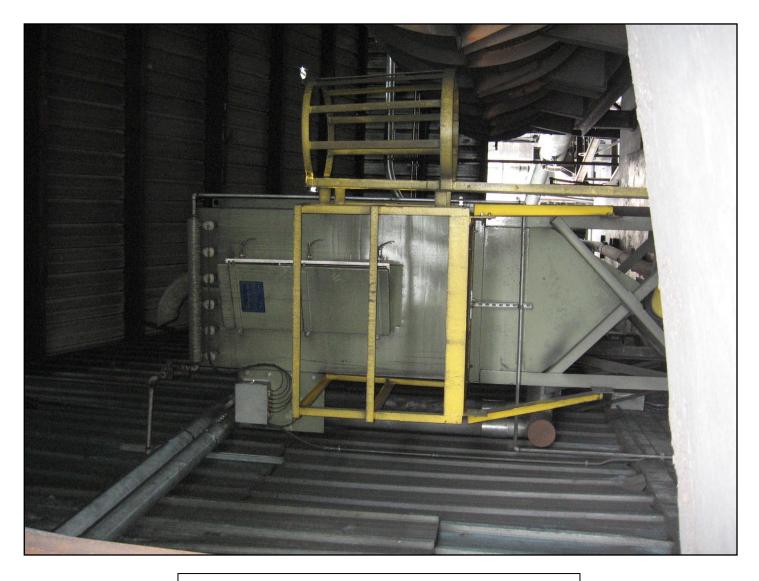
Photo ID No. / Date / Time: IMG_1341 / 07-12-11 / 1059 ${\bf PJ-2\ baghouse}$

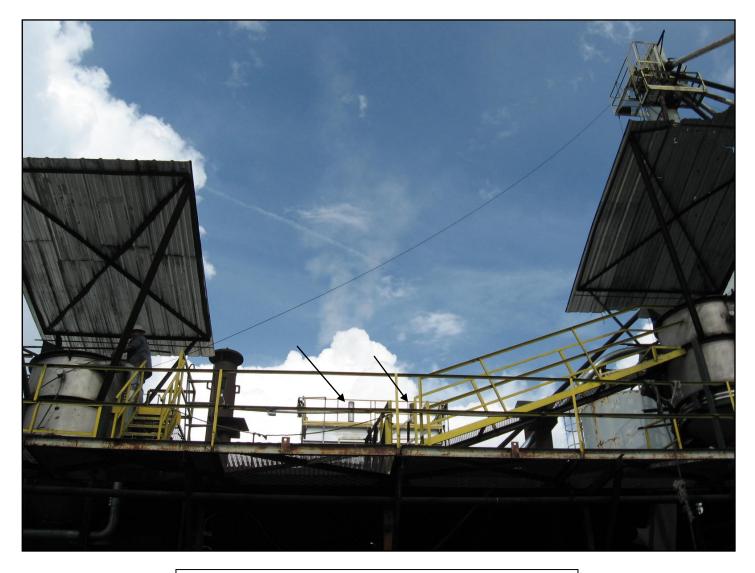
Photo ID No. / Date / Time: IMG_1342 / 07-12-11 / 1109 Exhausts from Kilns 2 & 1

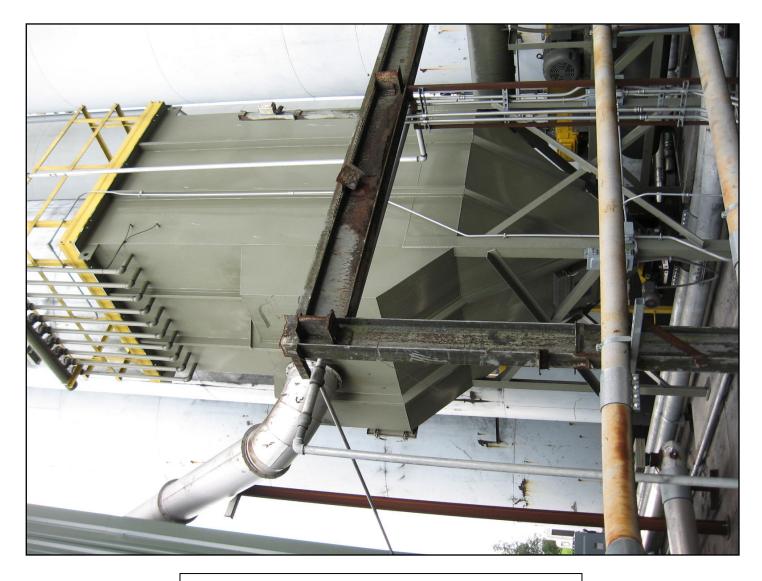
Photo ID No. / Date / Time: IMG_1344 / 07-12-11 / 1134 ${\bf PJ\text{--}T}$ baghouse

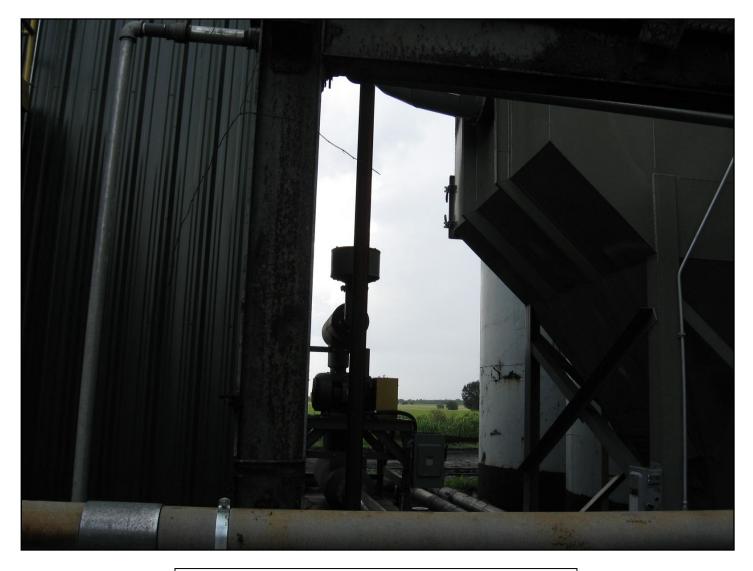
Photo ID No. / Date / Time: IMG_1345 / 07-12-11 / 1134 $\,$ Blower for PJ-T baghouse

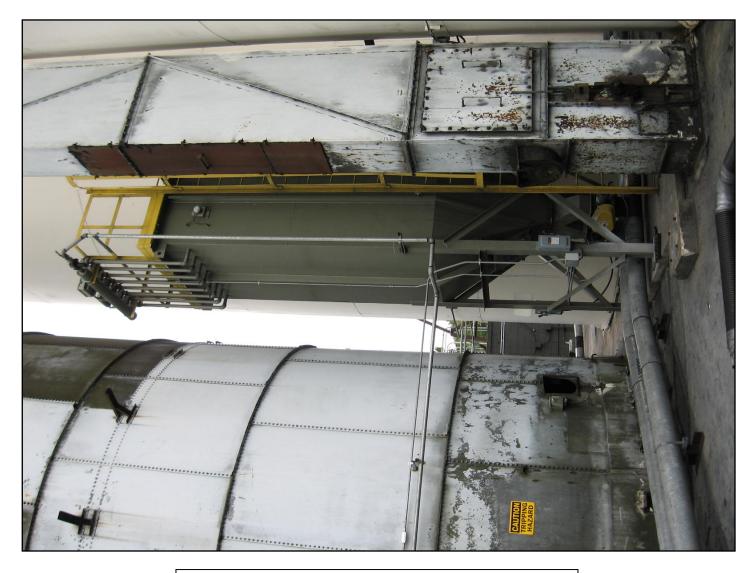
Photo ID No. / Date / Time: IMG_1346 / 07-12-11 / 1134 $\bf PJ-1$ baghouse
