Facility Name: Omni Waste of Osceola County, LLC	ID #: 0970079
Date: 1/13/08	Sky Conditions: broken
Persons Present: DEP: Allen Rainey (Photographer), Rodell Rice, Caroline Shine, Wanda Parker-Garvin, Golder Associates: Kevin Brown, Don Grigg, Omni: Mike Kaiser	
Digital camera used. Photo files saved at: C:\Documents and Settings\rainey_a\My Documents\My Pictures\Omni Landfill

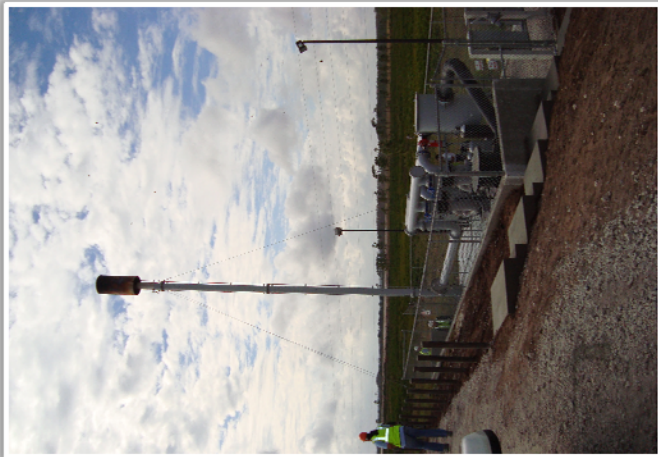
Photo 1: SSW view of landfill gas collection and control device.

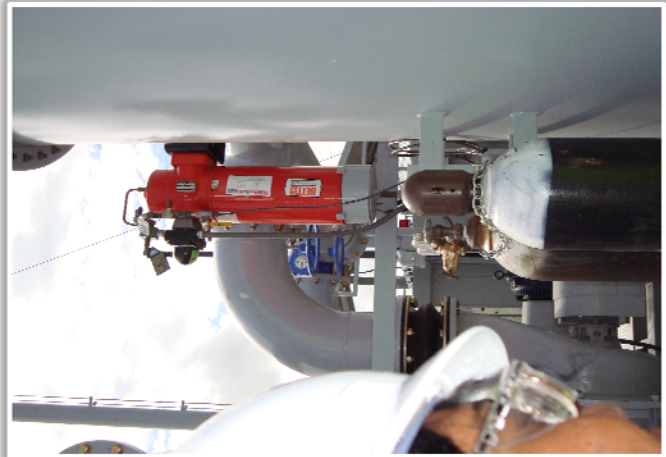
Photo 2: Red device automatically shuts off gas flow to flare when the flare flame goes out.

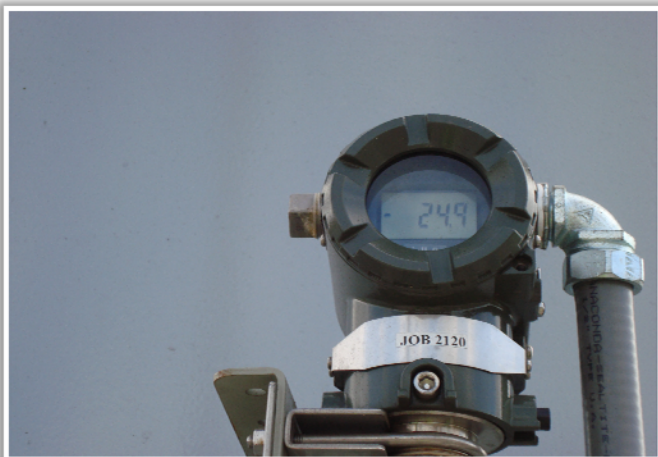
Photo 3: Digital gauge showing -24.9 vacuum near the blower within the collection system

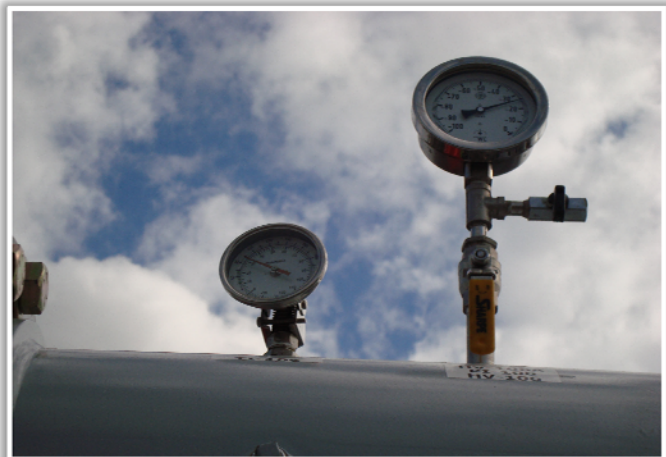
Photo 4: Needle gauges on inlet to blowers show temperature (left) and vacuum (right) within the collection system. Inlet pressure can be set so that collection system well adjustments and weather fronts have no pressure effects.

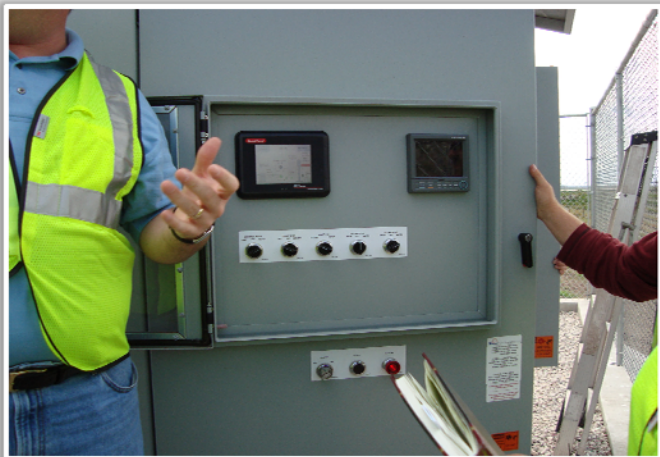
Photo 5: Open collection system control panel.

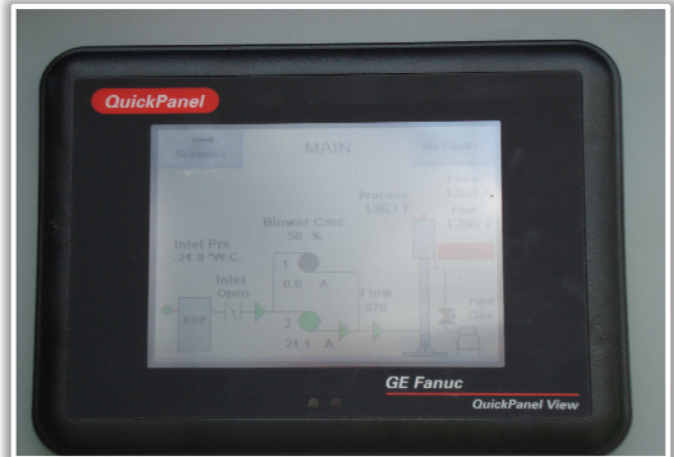
Photo 6: QuickPanel View depicted in photo 5 showing operation of blowers. Blowers operate one at a time. Blower #2 operating at time of inspection.

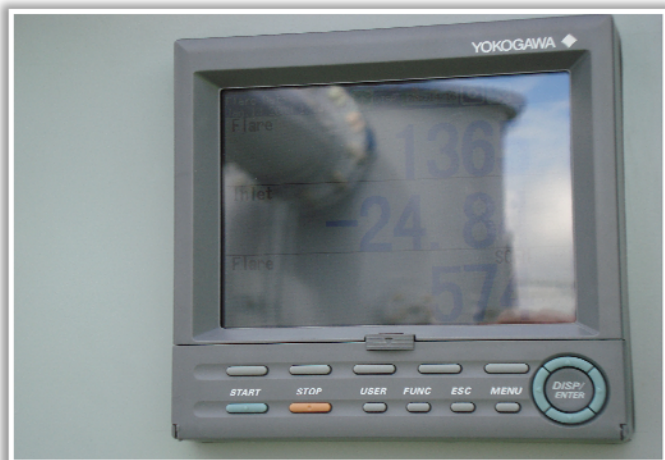
Photo 7: Display depicted in photo 5 showing -24.8 vacuum and 1365 degree F flare temperature

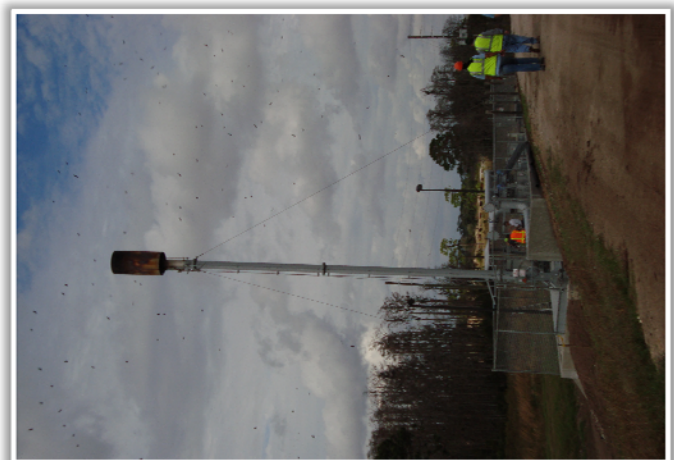
Photo 8: North view of collection and control system.

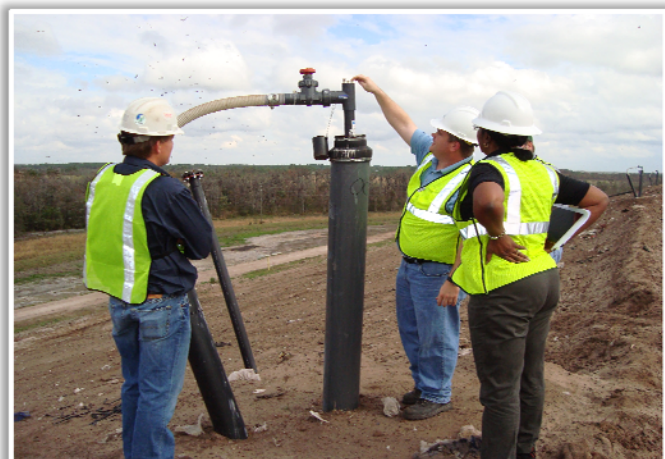
Photo 9: Gas collection well #007 in area at final grade. Liner, cover soil and sod is yet to be placed. Pitot tubes are installed in all the wells.

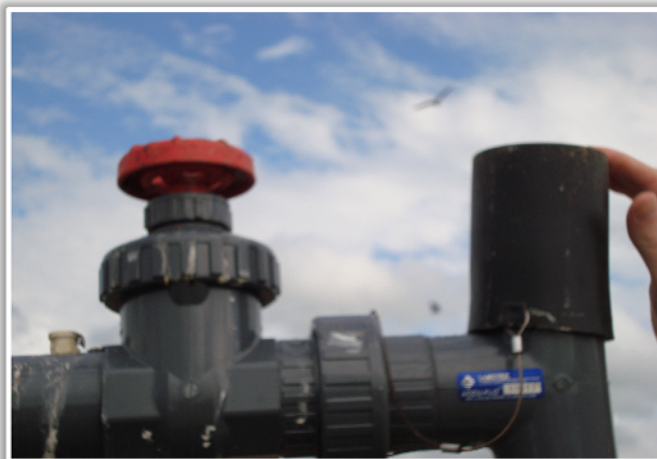
Photo 10: Top of well #007 showing black cover(right) in place that is removed and hanging down in photo 9. Red valve (middle) enables temperature/air adjustments. White connection (left) enables header pressure measurements. This same configuration is used on all gas collection wells.

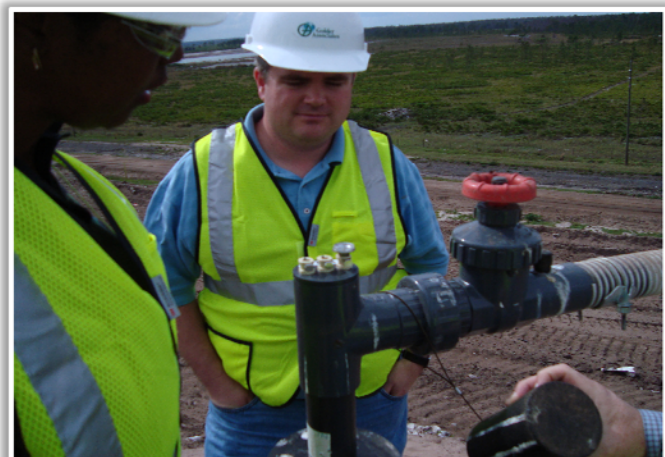
Photo 11: Top of typical well showing monitoring points (center of photo) located under removed black cover. Liner, cover soil and sod is yet to be placed.

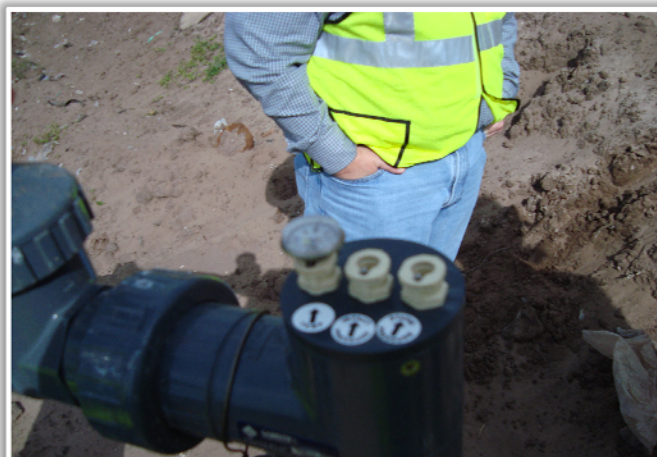
Photo 12: Top of typical well showing temperature point (left), impact point (center) and static vacuum point (right). The thermometer is removable for reading. Liner, cover soil and sod is yet to be placed.

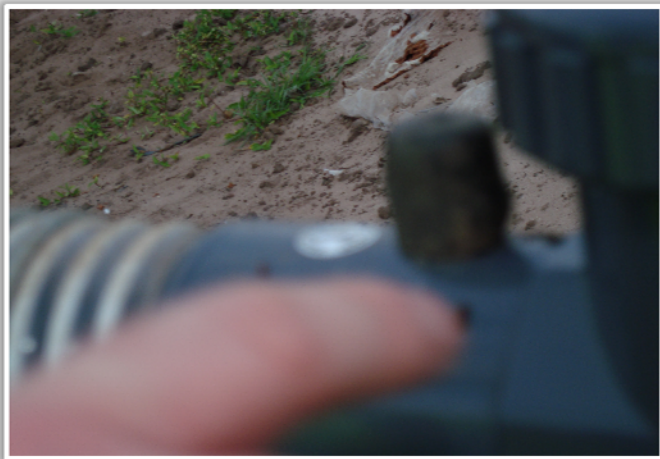
Photo 13: Black cover over header system measurement point on well. It was explained that birds typically pick off the covers.

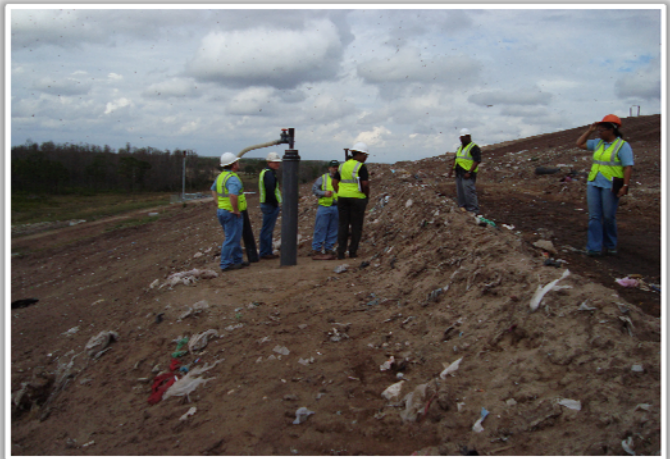
Photo 14: North view of a typical well. Gas collection system and flare are in background. Liner, soil and sod yet to be placed.

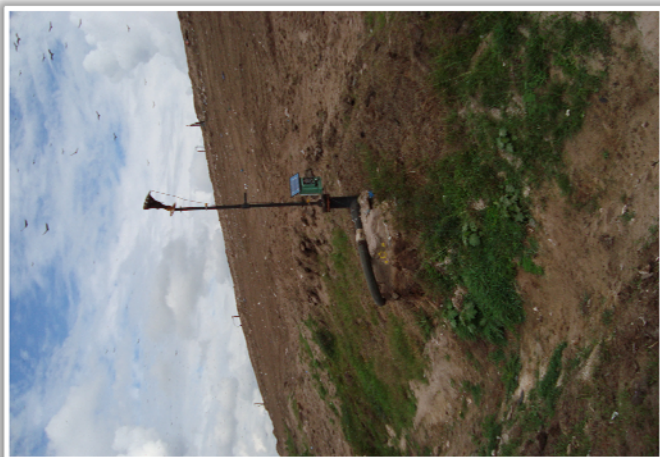
Photo 15: NNE view of leachate odor control station used before collection and control system became operational.

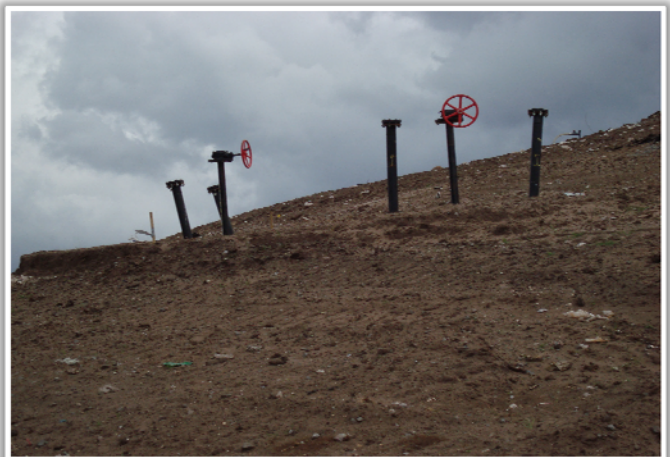
Photo 16: ENE view of gas isolation valves located near collection system.

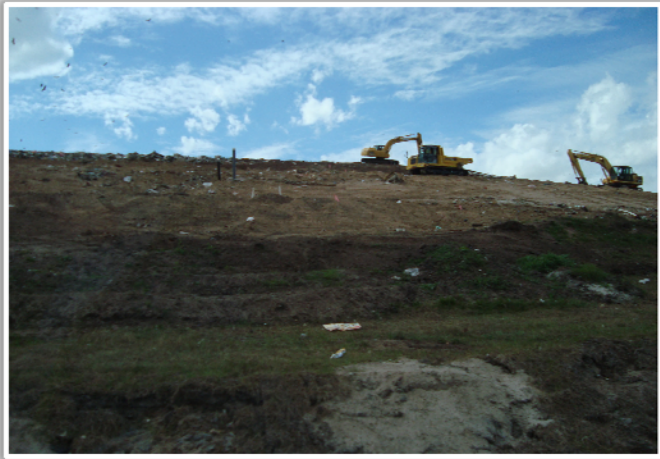
Photo 17: W view of active landfill cell.

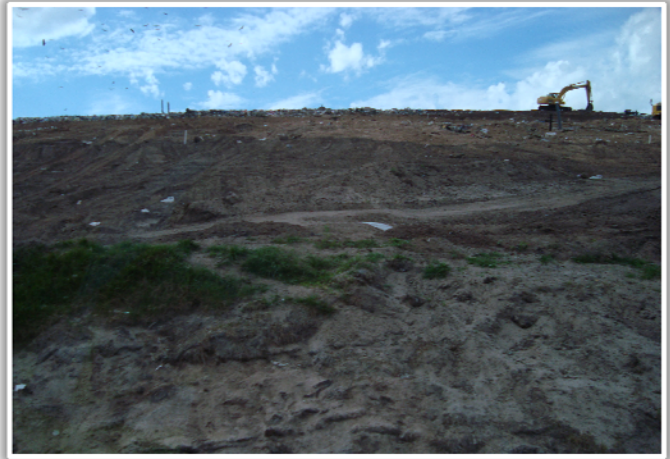
Photo 18: W view of active landfill cell.
