DIGITAL PHOTOGRAPHIC LOG

1. **Facility Name:** Ajax Paving Industries, LLC, Asphalt Plant in Odessa, FL
2. **County / AIRS ID No:** Pasco County / 1010027
3. **Inspection Type:** INS3: Compliance Inspection and Stack Test Audit
4. **Inspection Date:** 04/10/2012
5. **Date Photographic Log was completed:** 04/19/2012
6. **Camera Used:** Olympus Camedia Digital Camera, 5.0 Megapixel, C-50 ZOOM, S/N 115248297.
7. **Recording Media:** FUJIFILM xD-Picture Card, 128 MB, S/N DPC-128, R31695 5RZ7, 0244 MAD.
8. **All Digital Photos Were Copied To:** Hard Disk of Computer DEP 143271; some photos were copied to this Digital Photographic Log (some unnecessary photos were left out of this photo log).
9. **Original Copy Is Stored In/On:** Hard disk of computer DEP 143271.
10. **Were the photos altered?:** NO YES explain yes:
11. **Photographer:** Amaury Betancourt
12. **Signature of Photographer:** _____

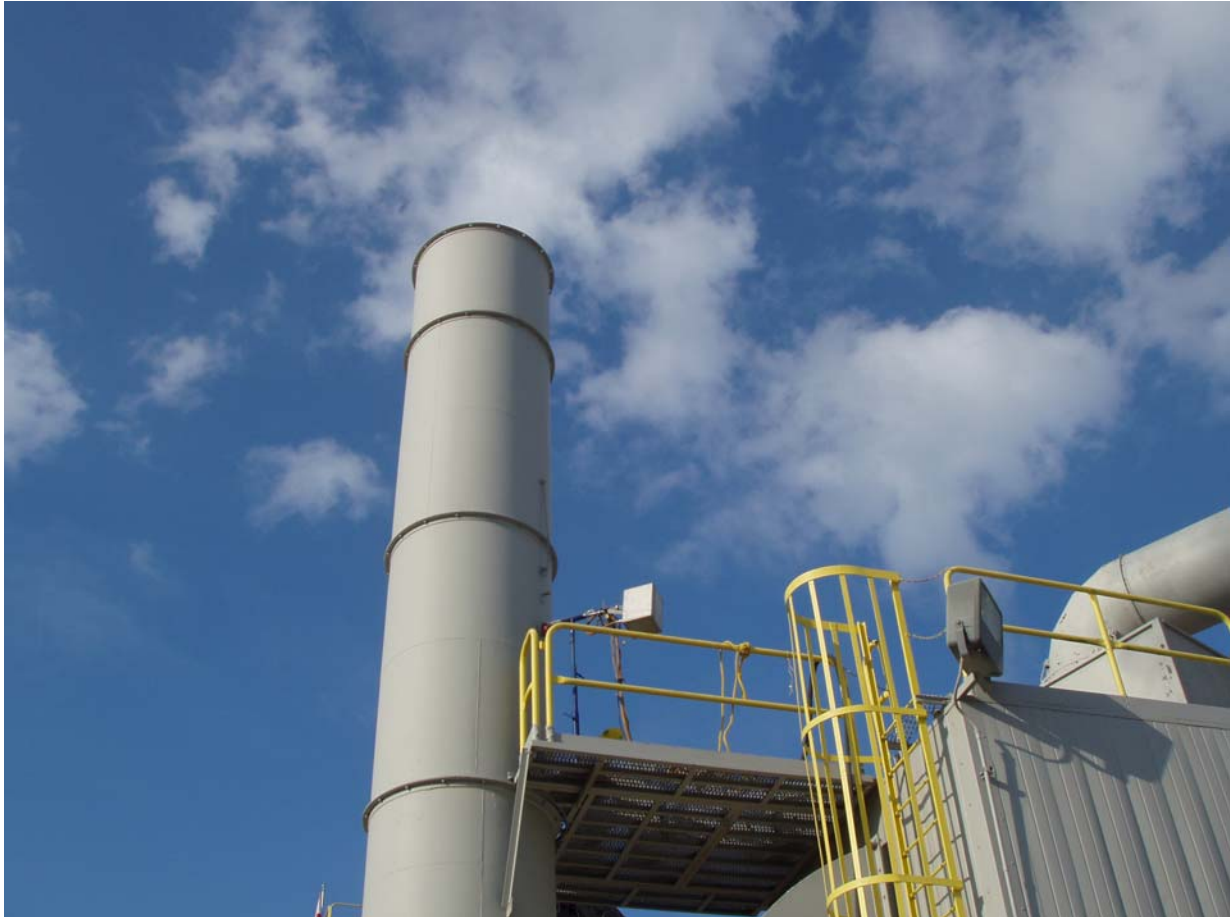
Photo ID No: 1010027_Photo_04_10_2012-001

Stack at Ajax Paving Industries, LLC, Asphalt Plant in Odessa, FL (air operating facility ID 1010027). A white plume is visible (foreground, not to be confused with white clouds in background) exiting from the stack. In addition, the probe and hot box for the stack test measurements are shown in a position during the early part of the second half of stack test run #2. The camera is facing approx. SW.

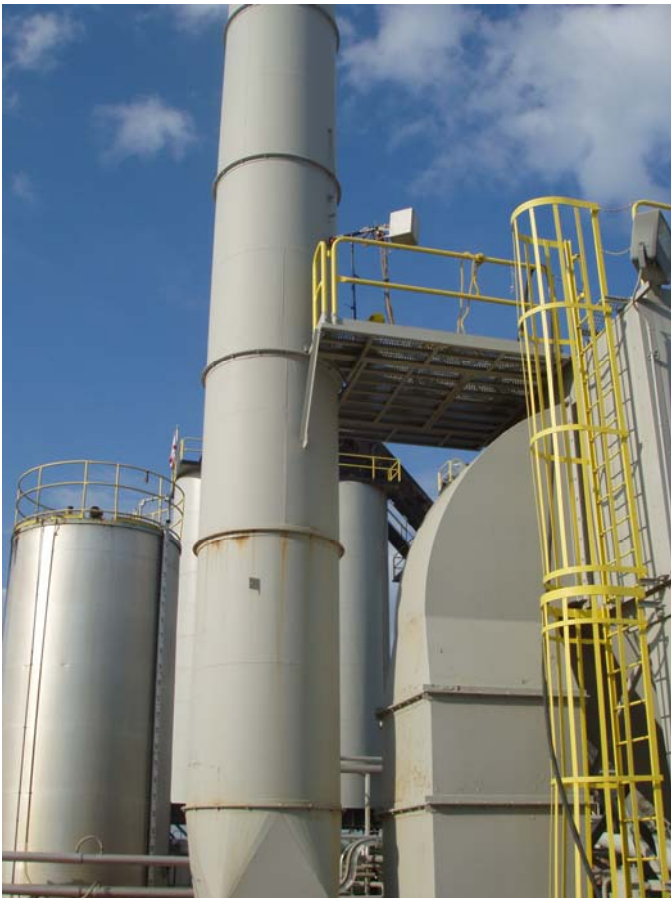
Photo ID No: 1010027_Photo_04_10_2012-003
Time: Approx. 09:30 AM
View of stack, middle portion. The camera is facing approx. SW.

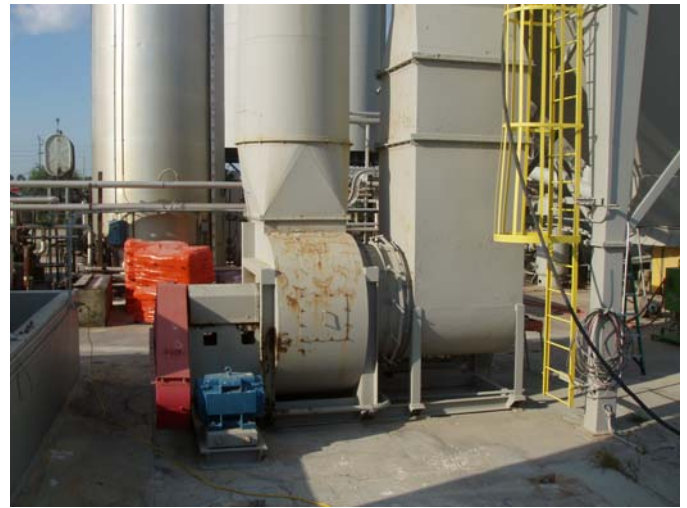
Photo ID No: 1010027_Photo_04_10_2012-004
Time: Approx. 09:30 AM
View of stack, base portion. The camera is facing approx. SW. The height of the stack is approximately 30 feet.

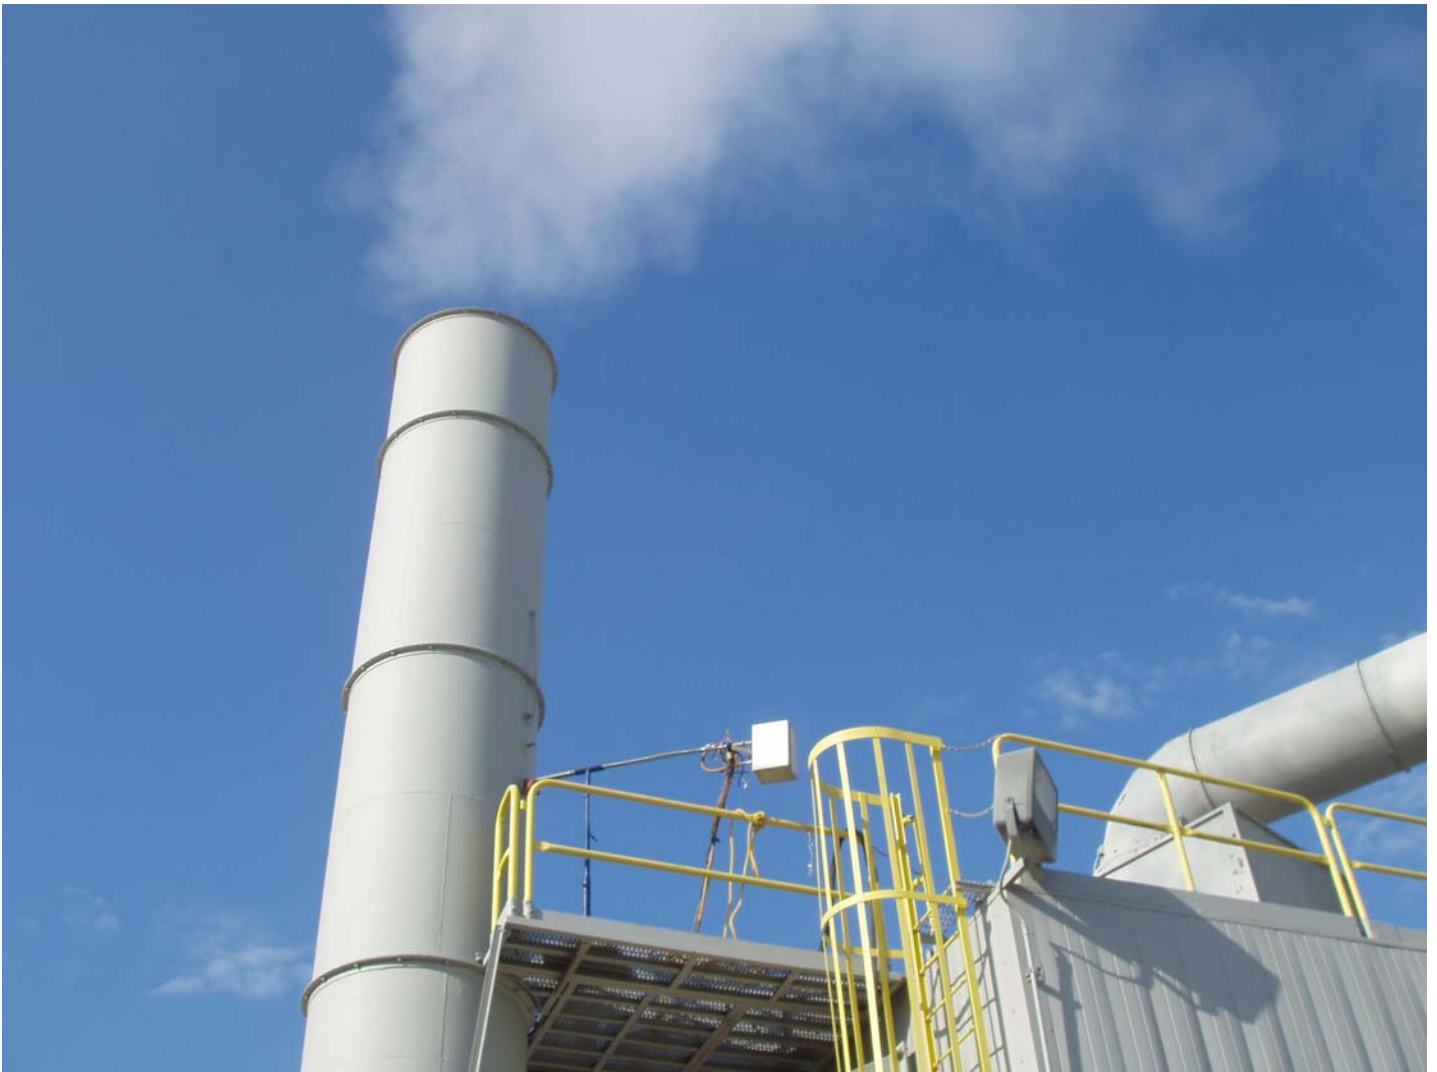
Photo ID No: 1010027_Photo_04_10_2012-009

View of probe and hot box during the last several measurements of the second half of stack test run #2. During this measurement, the probe is further out of the stack test port than during earlier measurements that occurred during the second half of stack test run #2. The probe is testing a point closer to the inside stack wall than in earlier measurements that occurred during the second half of stack test run #2. The camera is facing approx. SW.

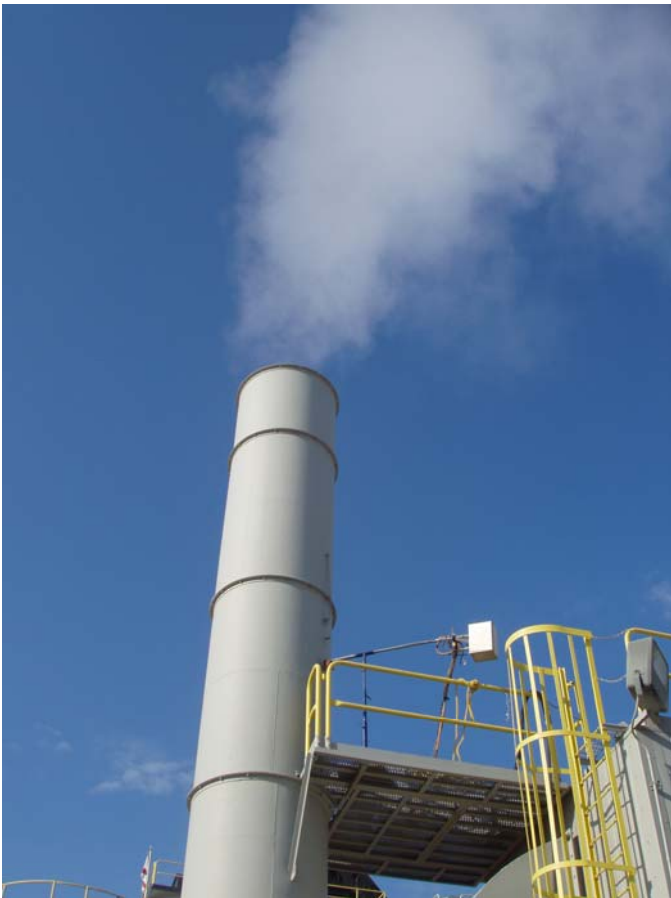
Photo ID No: 1010027_Photo_04_10_2012-010
Time: Approx. 10:15 AM
Photo taken near the end time of stack test run #2. The camera is facing approx. SW.

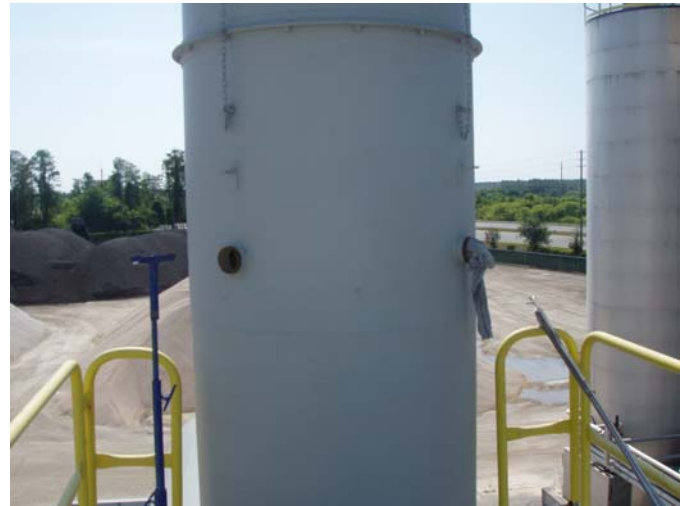
Photo ID No: 1010027_Photo_04_10_2012-011
Time: Approx. 11:00 AM
View of the two stack port holes on the stack, where the probe is used to conduct the stack test. During testing, the port hole not used for each portion of the tests would be covered with a rag. The camera is facing approx. E.

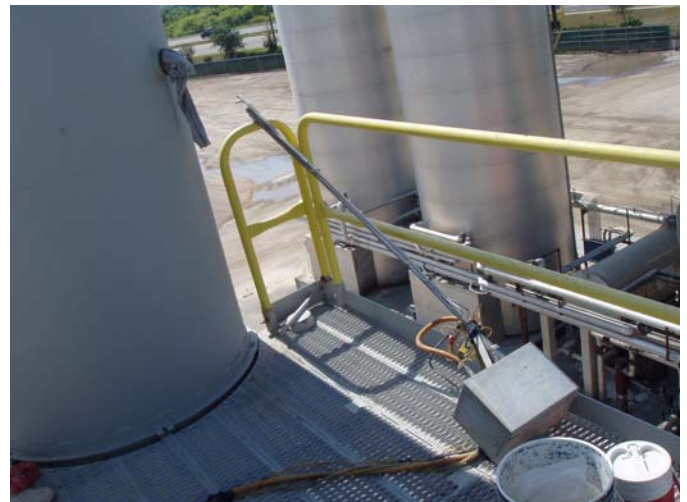
Photo ID No: 1010027_Photo_04_10_2012-012
Time: Approx. 11:00 AM
View of the probe after stack test run #2. The camera is facing approx. SE.

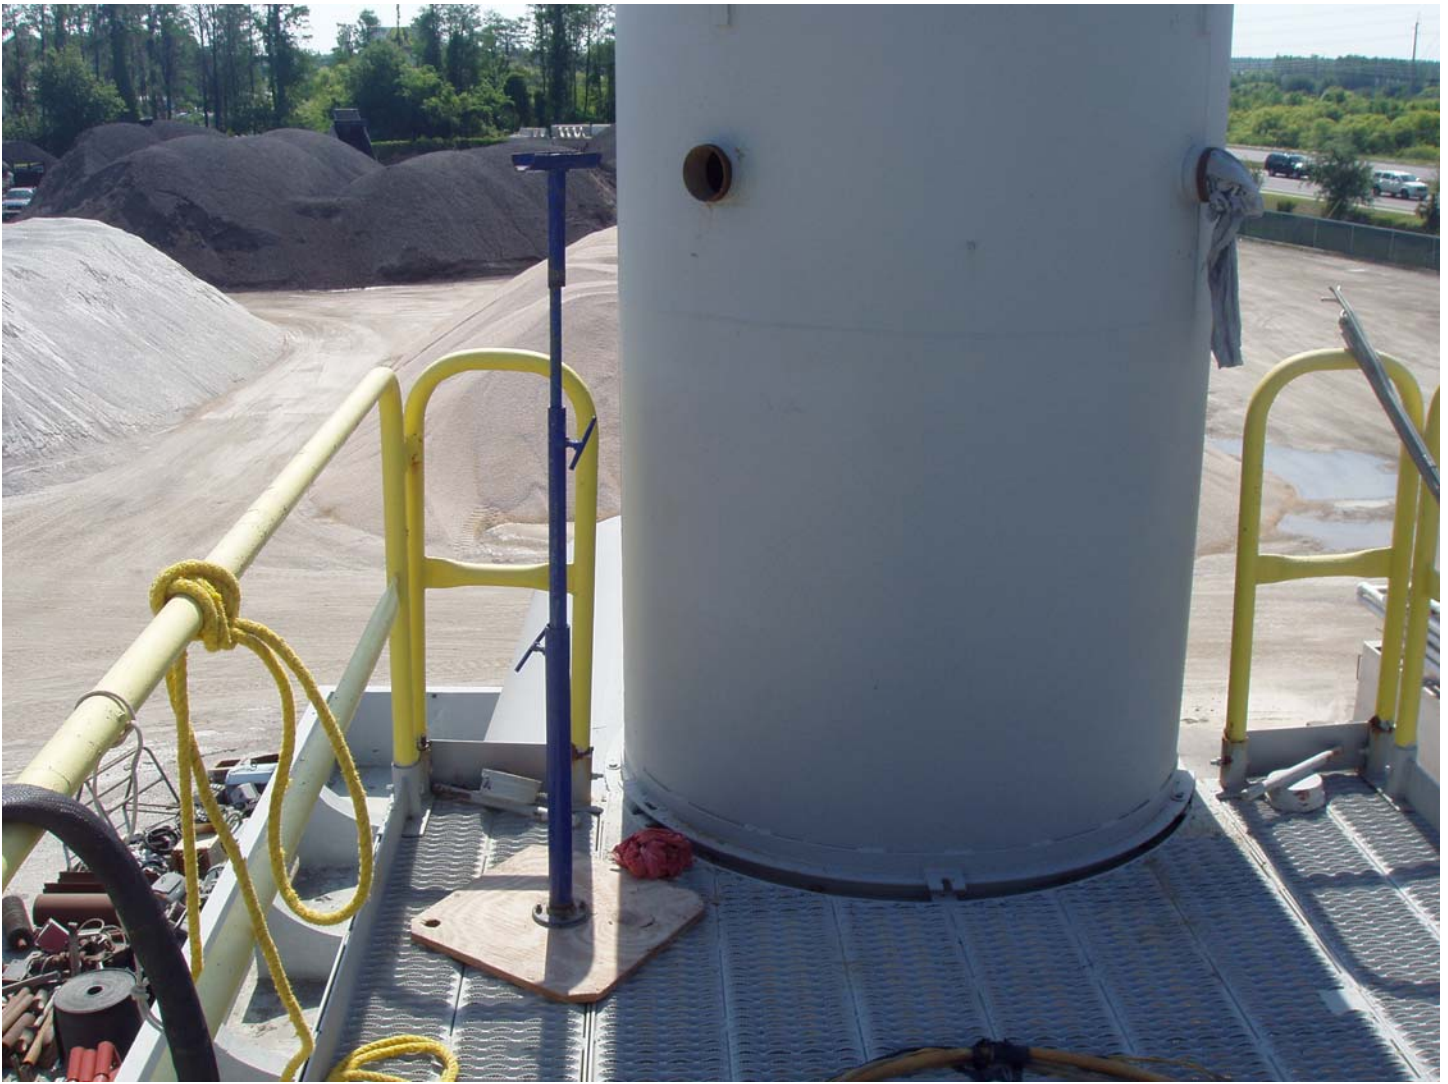
Photo ID No: 1010027_Photo_04_10_2012-014

View of stand to hold stack test probe during stack test. Photo taken after stack test run #2. The camera is facing approx. E.

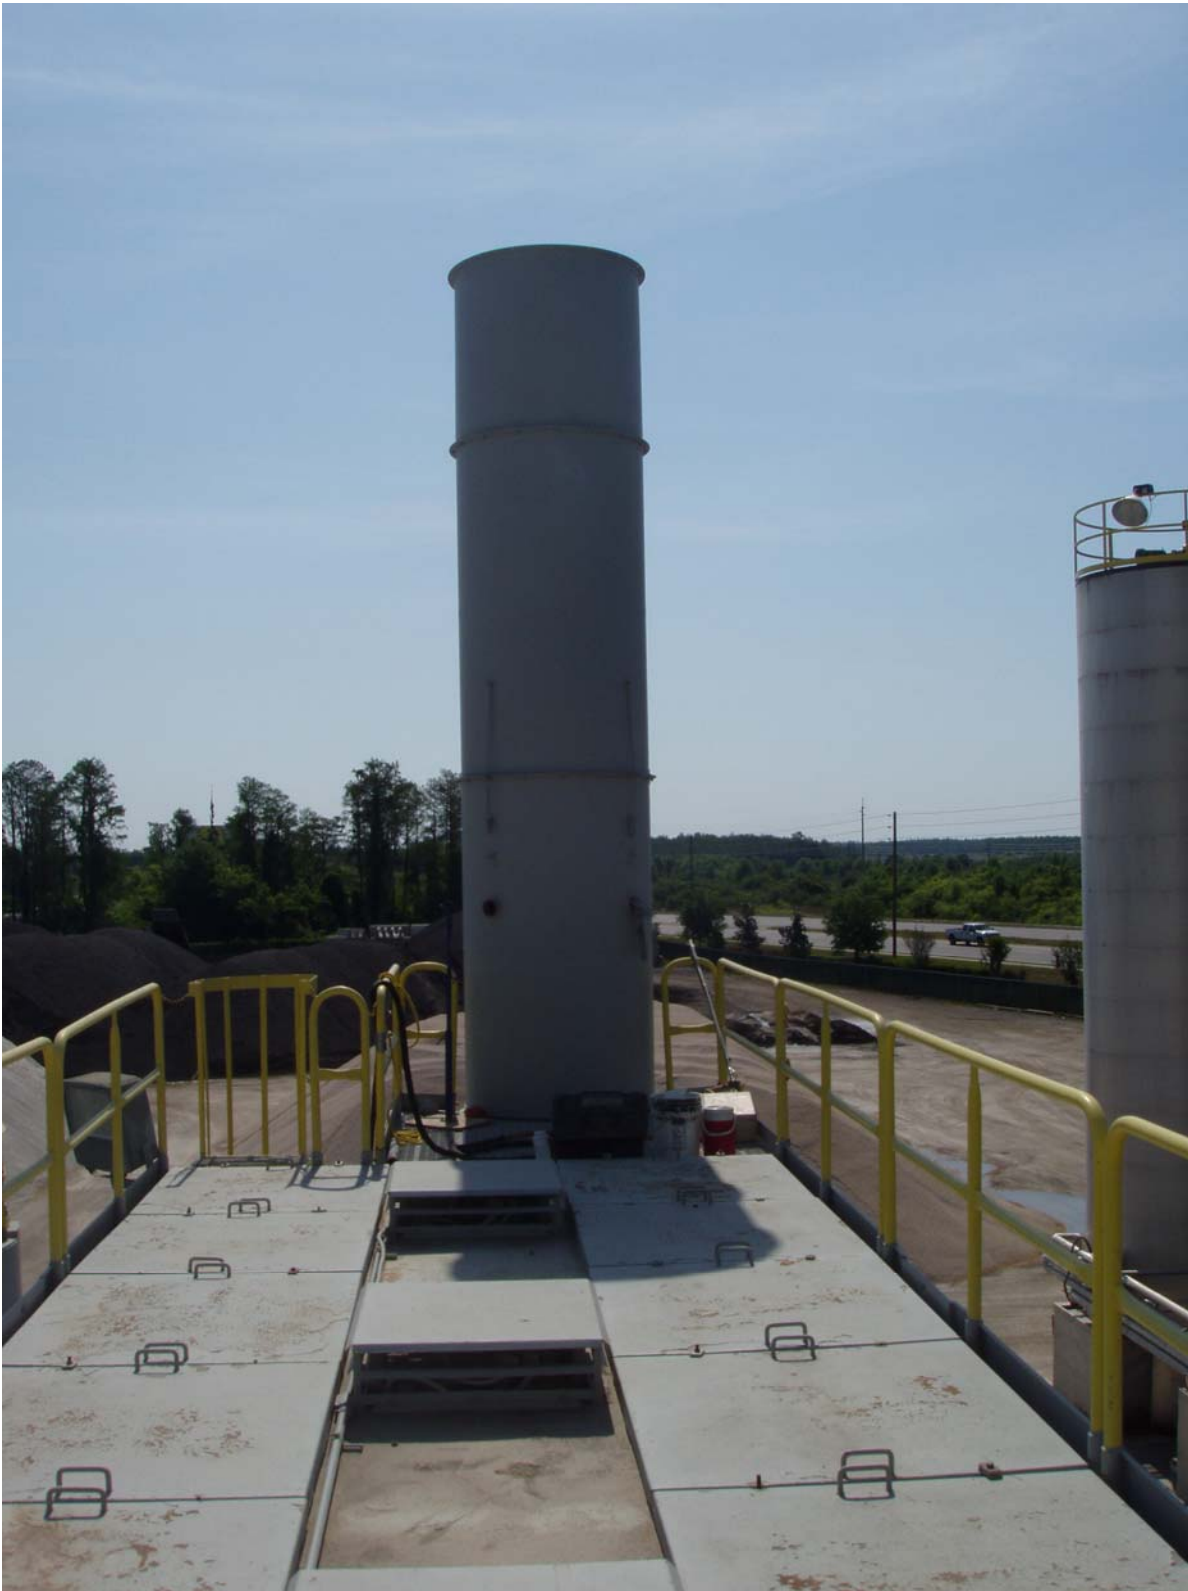
Photo ID No: 1010027_Photo_04_10_2012-015
Time: Approx. 11:00 AM
View of top of stack and stack testing equipment, shortly after stack test run #2. The camera is facing approx. E.

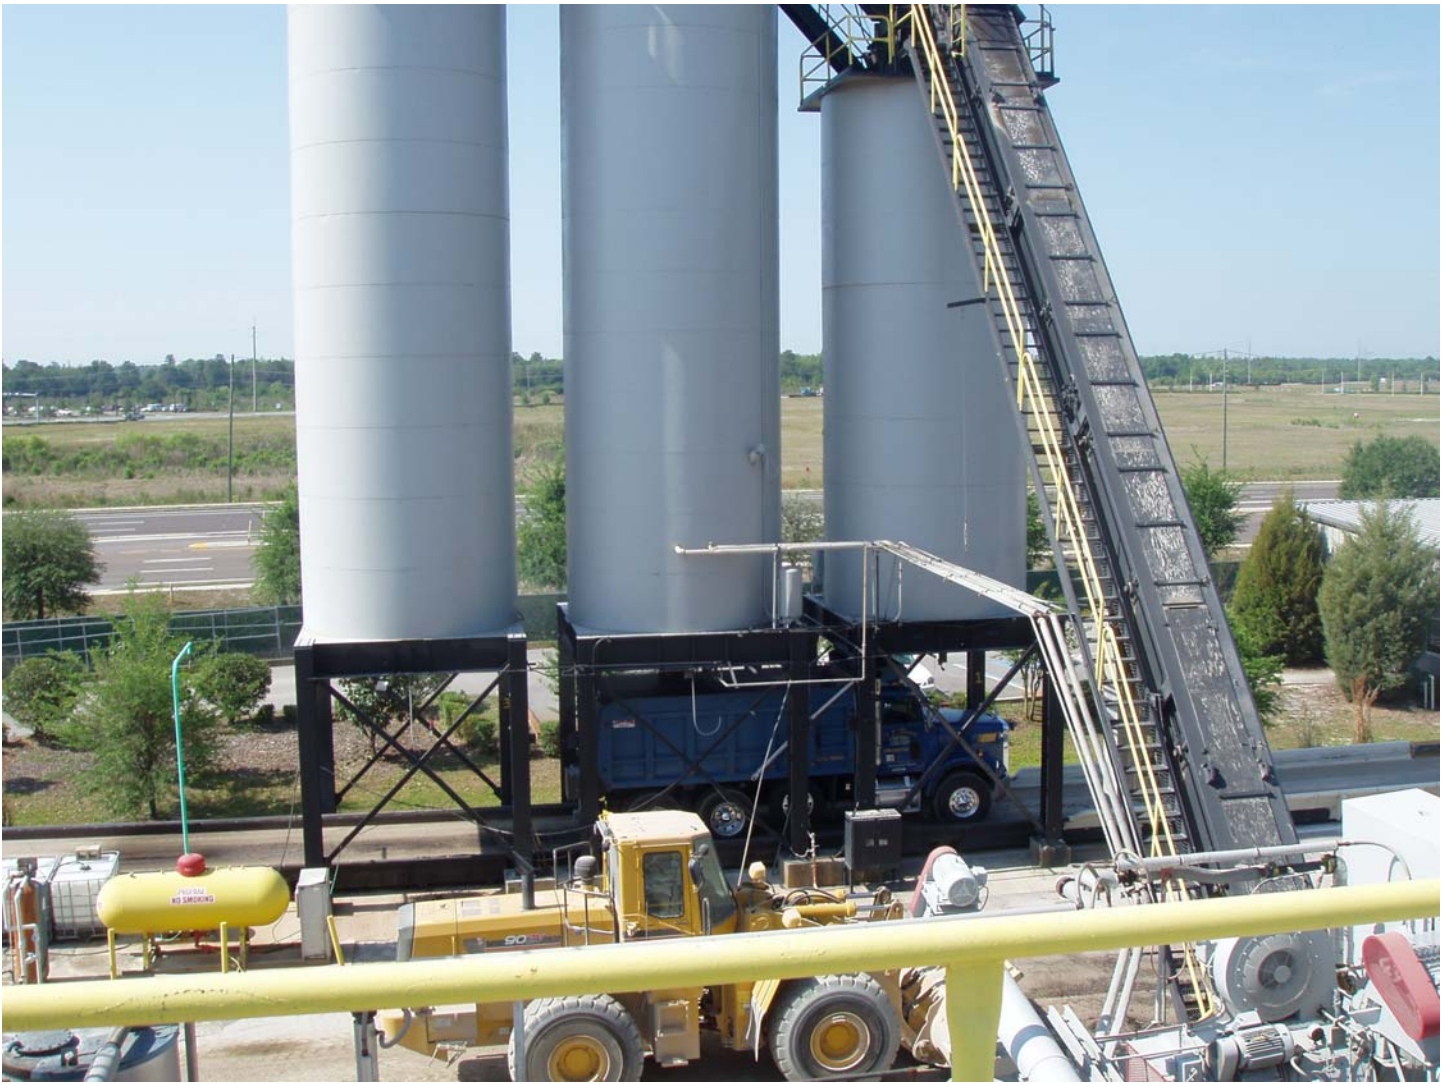
Photo ID No: 1010027_Photo_04_10_2012-018
Time: Approx. 11:00 AM
Asphalt storage silos. Truck loadout was occurring during the end of the compliance inspection (truck is visible beneath silos). The camera is facing approx. SW.

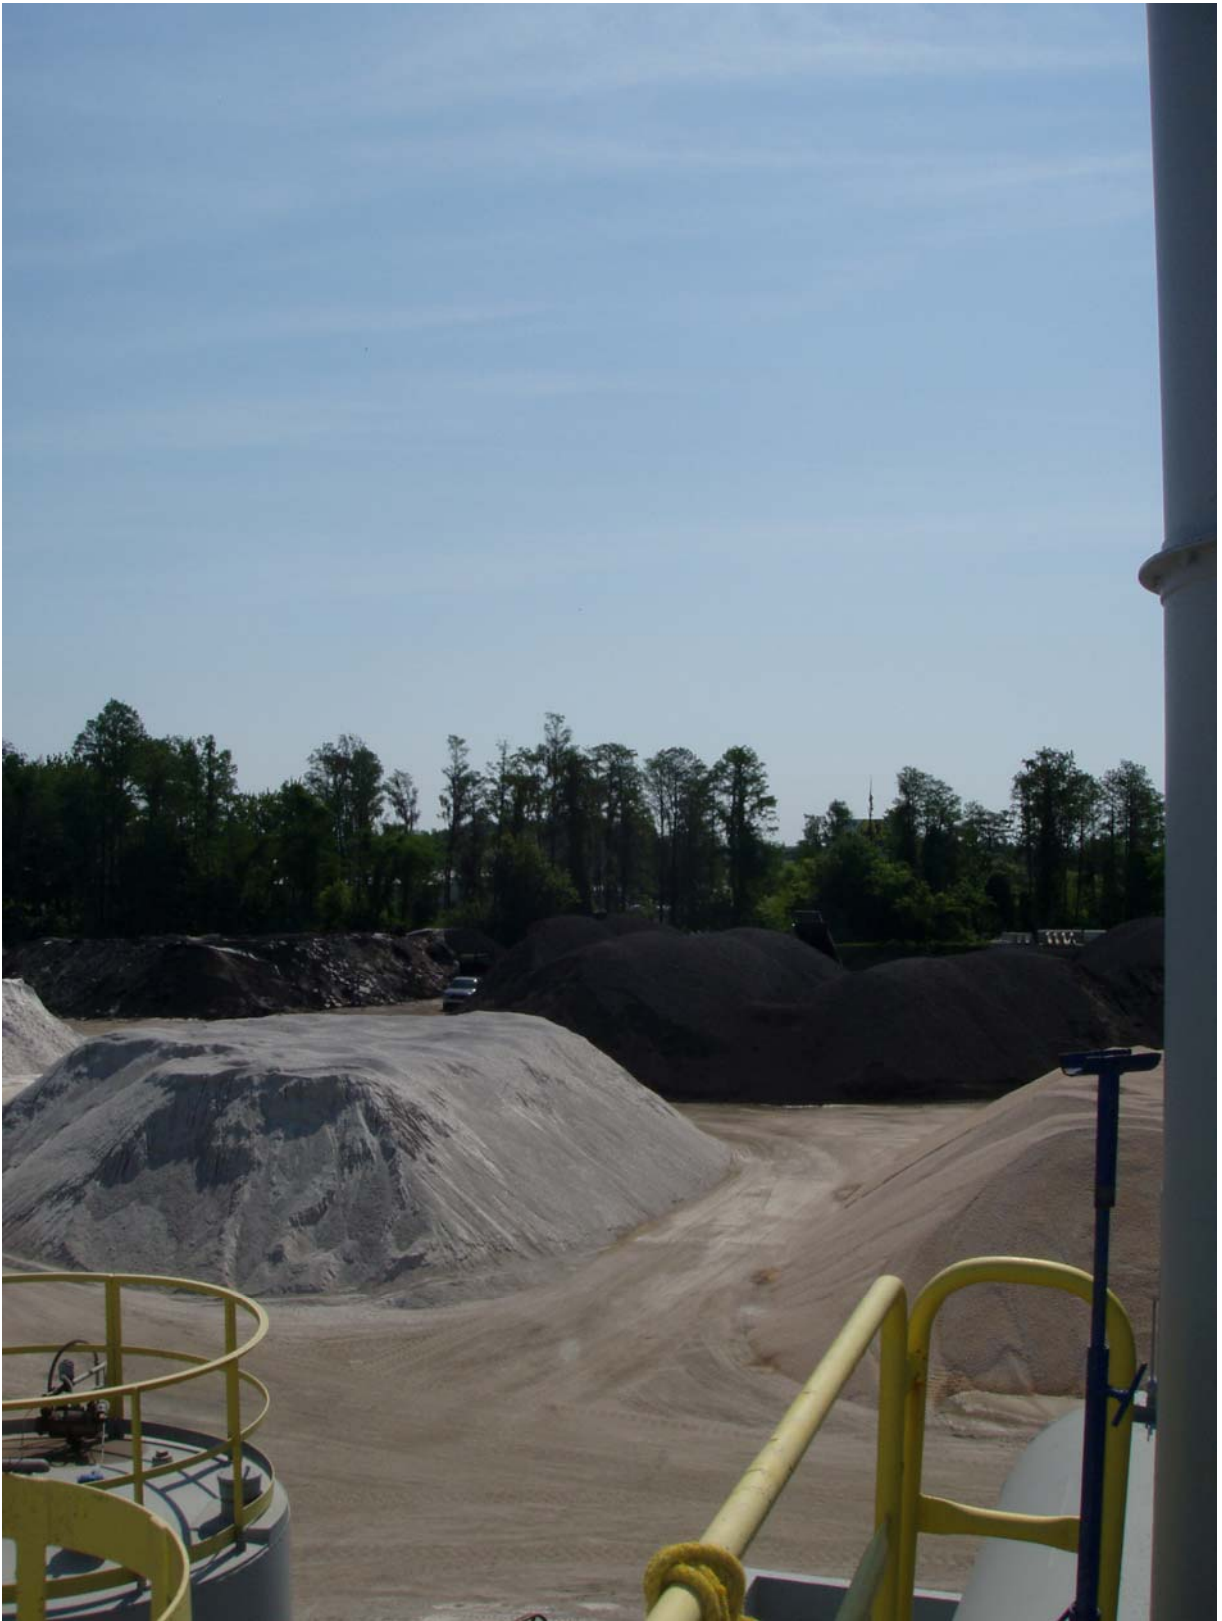
Photo ID No: 1010027_Photo_04_10_2012-020
Time: Approx. 11:00 AM
Storage piles for raw materials and broken pieces of asphalt and crushed pieces of asphalt. The camera is facing approx. E.
