DIGITAL PHOTOGRAPHIC LOG

- 1. Facility Name: Pallet One, Inc. (Bartow, FL)
- 2. County / AIRS ID No: Polk County / 1050128
- 3. **Inspection Type:** INS2 (Facility walkthrough & records review), Full Compliance Evaluation (FCE), and Permit Inspection
- 4. Inspection Date: 03/29/2012
- 5. Date Photographic Log was completed: 04/02/2012
- 6. Camera Used: Olympus Camedia Digital Camera, 5.0 Megapixel, C-50 ZOOM, S/N 115248297.
- 7. Recording Media: FUJIFILM xD-Picture Card, 128 MB, S/N DPC-128, R31695 5RZ7, 0244 MAD.
- 8. All Digital Photos Were Copied To: Hard Disk of Computer DEP 143271; most photos were copied to this Digital Photographic Log (redundant photos were left out of this photo log).
- 9. Original Copy Is Stored In/On: Hard disk of computer DEP 143271.
- 10. Were the photos altered?: NO X YES explain yes:
- 11. Photographer: Amaury Betancourt
- 12. Signature of Photographer:_

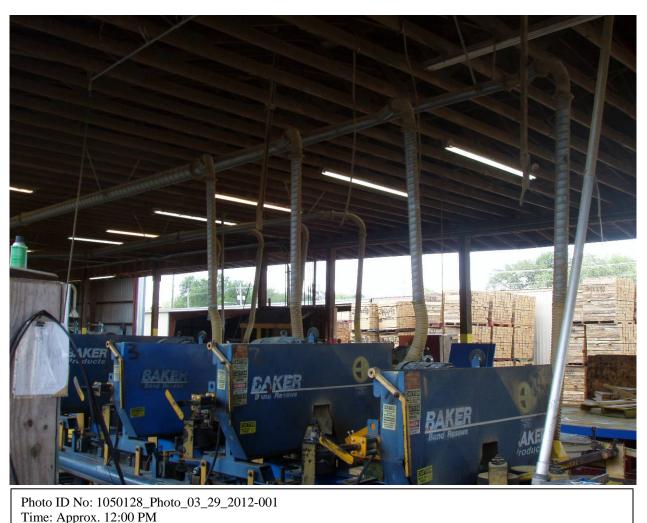
Small West cutting shed; photo shows saws with pickup points for dust. The pickup points are the vertical pipes with flexible ends that attach to the equipment to pick up dust generated from sawing. The camera is facing approx. SW.

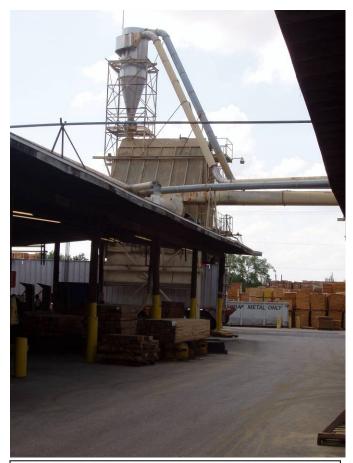
Photo ID No: 1050128_Photo_03_29_2012-002 Time: Approx. 12:00 PM View of cyclone on top of sawdust truck loading area. In the foreground of the photo, the small East cutting shed is visible. The camera is facing approx. SSE.

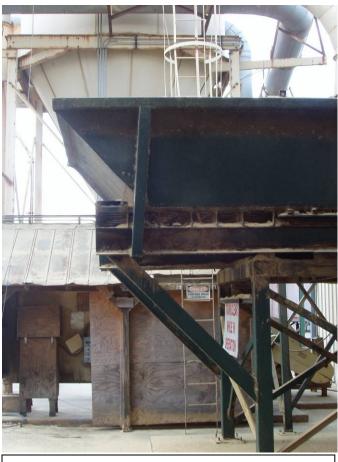
Photo ID No: 1050128_Photo_03_29_2012-005 Time: Approx. 12:15 PM Loading area with green loading bin for hammer hog. The central baghouse for the facility is shown in the background of the photo. The camera is facing approx. S.

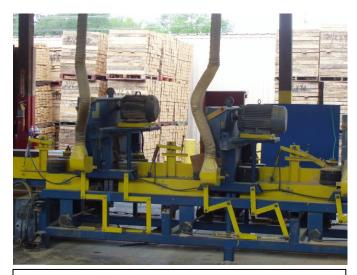
Photo ID No: 1050128_Photo_03_29_2012-004 Time: Approx. 12:00 PM Sawing equipment located inside small West cutting shed. Pickup points for dust are shown in the photo. The camera is facing approx. WSW.

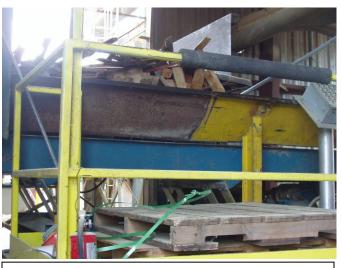
Photo ID No: 1050128_Photo_03_29_2012-006 Time: Approx. 12:15 PM Waste wood ready to be loaded onto the mechanical shaking pad that leads to the hammer hog; located inside hammer hog building. The camera is facing approx. SE.

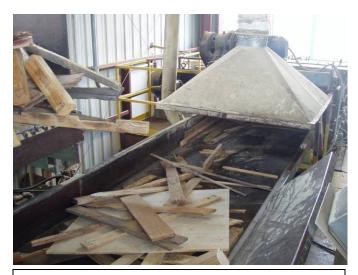
Photo ID No: 1050128_Photo_03_29_2012-008 Time: Approx. 12:15 PM Close-up photo of the mechanical shaking pad with wood waste leading to hammer hog. The hood for picking up dust, prior to wood waste entering the hammer hog, is visible over the mechanical shaking pad. The camera is facing approx. SE.

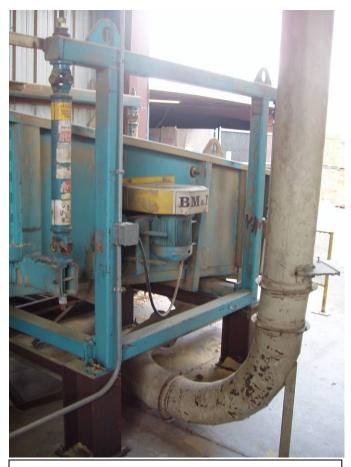
Photo ID No: 1050128_Photo_03_29_2012-007 Time: Approx. 12:15 PM View of dust pickup point (vertical pipe with curved bottom) for picking up dust from the bottom of the screener for wood chips, located after exit of hammer hog. The screener screens out small particles. The camera is facing approx. NW.

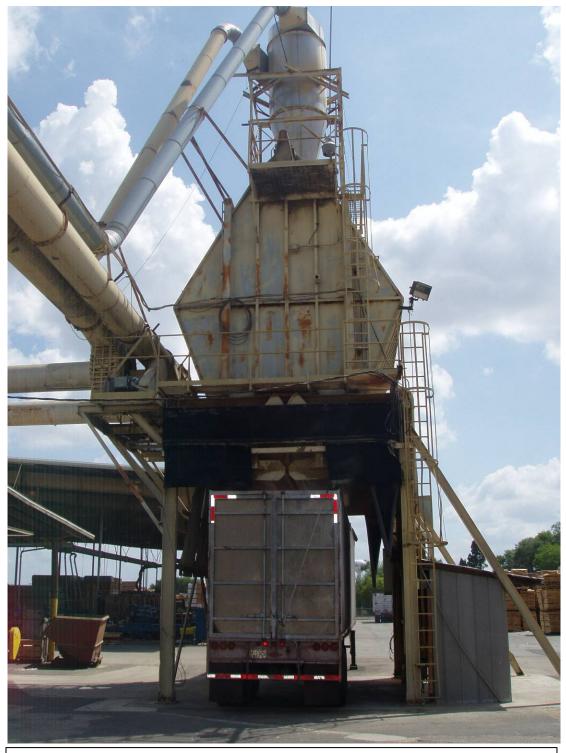
Photo ID No: 1050128_Photo_03_29_2012-009 Time: Approx. 12:30 PM Truck load-out area for loading sawdust; located u suppressing fugitive dust are located above truck l

Truck load-out area for loading sawdust; located under sawdust storage silo. Rubber curtains, for suppressing fugitive dust, are located above truck bin and on either side of truck bin. During inspection, these curtains were observed to be damaged and minimally functional. The facility's authorized representative opened the sawdust bin as a demonstration, and significant fugitive dust was observed. Department inspectors informed the facility authorized representative that these curtains must be replaced and maintained to help prevent fugitive dust emissions for sawdust loading onto trucks. The camera is facing approx. E.

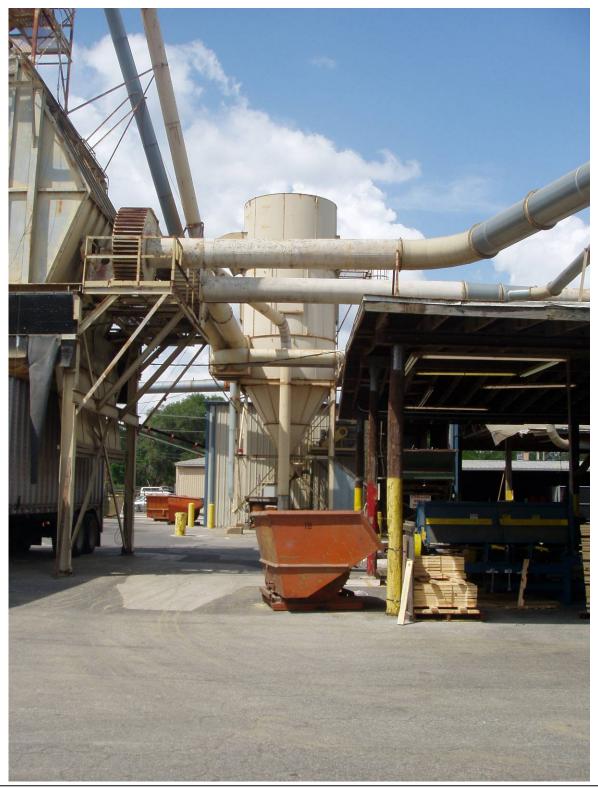
Photo ID No: 1050128_Photo_03_29_2012-017 Time: Approx. 12:30 PM View, facing West, of the central baghouse at the facility (visible in the background of the photo). The central baghouse collects dust from sawing operations at the facility. Pipe lines that pick up sawdust from sawing operations are visible over the top of one of the cutting sheds (foreground of photograph). These pipe lines lead to the central baghouse (background and center of photograph). Sawdust exits to the bottom of the central baghouse and then leads to the cyclone that is located over the top of the truck loading area for sawdust (partially visible in photograph, just Southeast of the central baghouse). The camera is facing approx. W.

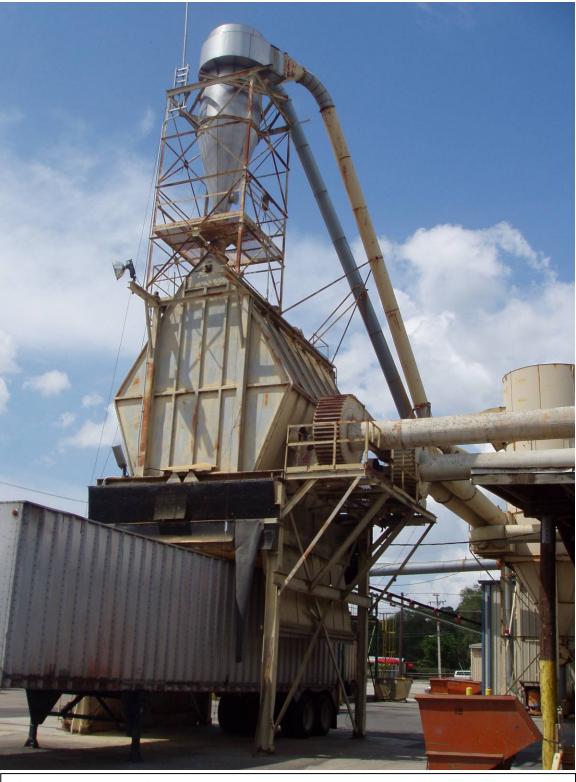
Photo ID No: 1050128_Photo_03_29_2012-016 Time: Approx. 12:30 PM View, facing Southwest, of cyclone on top of truck loading area for sawdust loading. The central baghouse, which sends sawdust to the cyclone, is located just NW of the cyclone. The camera is facing approx. SW.

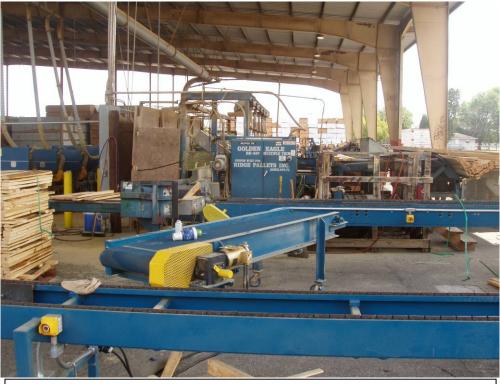
Photo ID No: 1050128_Photo_03_29_2012-014 Time: Approx. 12:30 PM Sawing equipment in the Big Shed at the facility. The camera is facing approx. E.

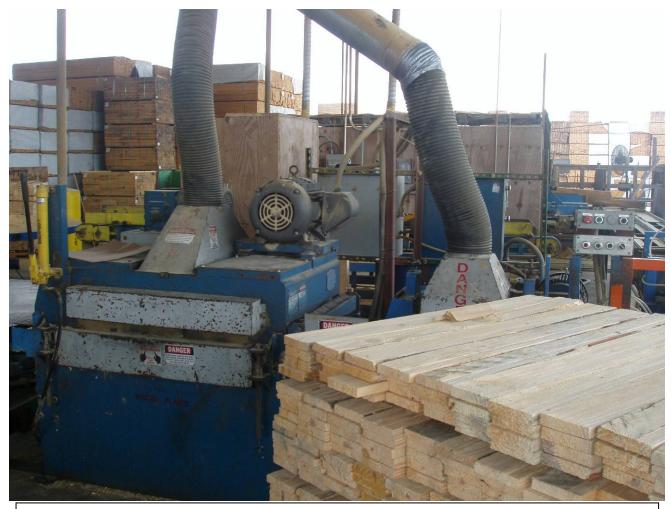
Photo ID No: 1050128_Photo_03_29_2012-018 Time: Approx. 12:40 PM Additional sawing equipment in the facility's Big Shed. The camera is facing approx. ENE.

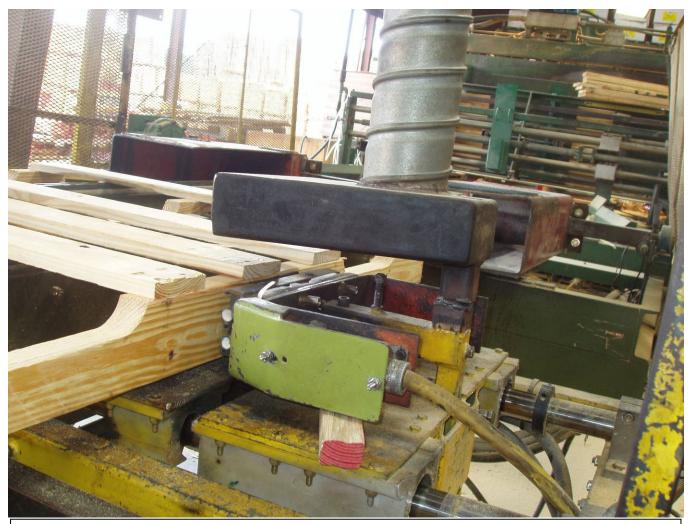
Photo ID No: 1050128_Photo_03_29_2012-019 Time: Approx. 12:45 PM

Wood burning equipment for branding pallets, located in the assembly building at the facility. The branding plate is shown against the wood pallet. Smoke generated from wood burning is picked up by the vertical pipe above the burning equipment and dispersed outside the assembly building. The camera is facing approx. SE.

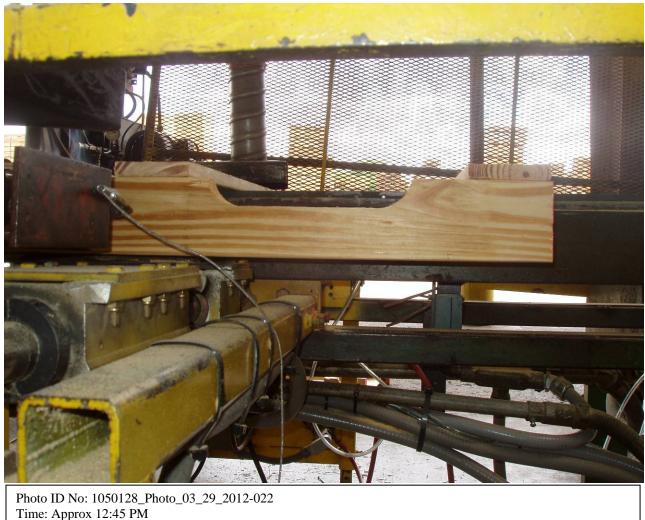
Wood burning equipment for branding wood pallets. Smoke generated from the wood burning process is slightly visible above and on the side of the pallet in this photo (above the branding equipment). The camera is facing approx. E.

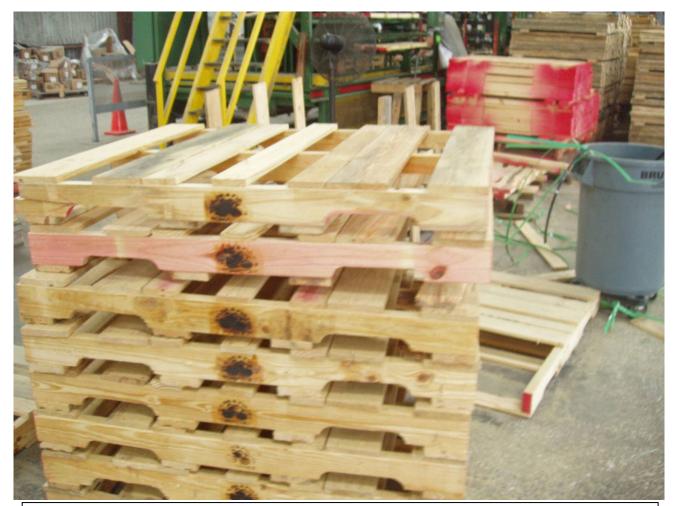
Photo ID No: 1050128_Photo_03_29_2012-026 Time: Approx. 12:45 PM Samples of wood pallets that have been branded with wood burning equipment. The brand is visible on the center of one of the notched side beams on each pallet. The camera is facing approx. NW.

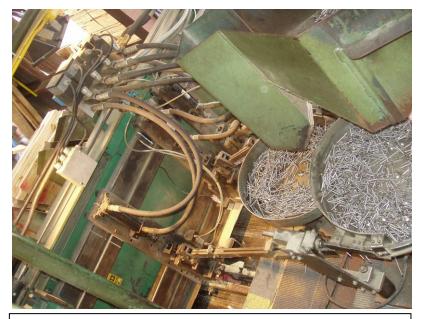
Photo ID No: 1050128_Photo_03_29_2012-023 Time: Approx. 12:45 PM Mechanical assembly equipment for assembling pallets, located in the pallet assembly building of the facility. Pallets are assembled, then branded (if applicable), and then stacked. The nails used for the pallet assembly have horizontal thread lines so that the nails have a stronger grip with the wood in each wooden piece of each pallet; the nails do not have pointed tips either, which helps to prevent each wood piece from splitting when nails are driven into the wooden pieces of a pallet.

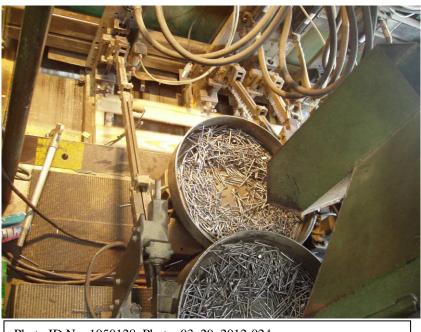
Photo ID No: 1050128_Photo_03_29_2012-024 Time: Approx. 12:45 PM Another view of the mechanical assembly equipment for assembling pallets, located in the pallet assembly building at the facility. Pallets are assembled, then branded (if applicable), and then stacked.

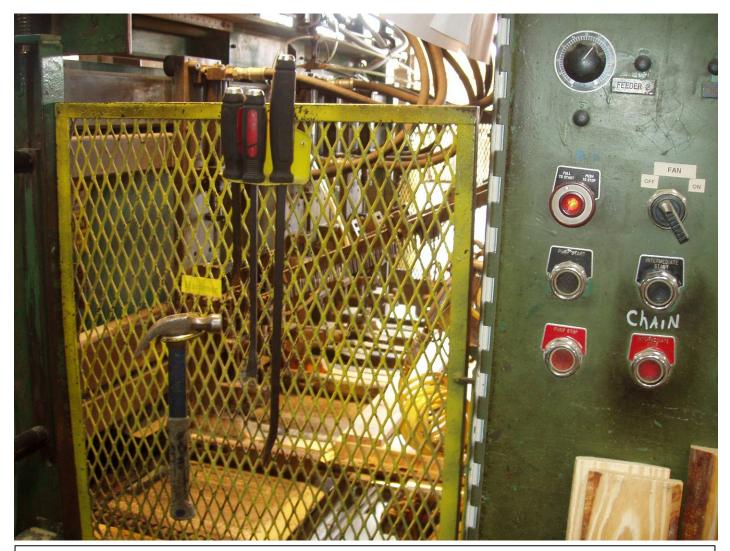
Photo ID No: 1050128_Photo_03_29_2012-025

Another view of mechanical assembly equipment for assembling pallets, located in the pallet assembly building at the facility. Behind the yellow gate (with the hanging hammer), a diagonal line of nails is visible. This line of nails leads to the part of the equipment used for assembling the pallets. As described above, the nails for assembling pallets have horizontal threads (for gripping the wood pieces of each pallet) and no points (to help prevent wood pieces of pallets from splitting). The pallet assembly operation is followed by branding of the pallets, if applicable, and stacking the pallets.
