**Florida Department of Environmental Protection, Southwest District
Division of Air Resource Management**

DIGITAL PHOTOGRAPHIC LOG

1. **Facility Name:** Sunbelt Forest Products Corporation
2. **County / AIRS ID No:** Polk County / 1050244
3. **Inspection Type:** INS2: Facility walkthrough inspection and visible emissions (VE) test audit.
4. **Inspection Date:** 05/15/2012
5. **Date Photographic Log was completed:** 05/23/2012
6. **Camera Used:** Olympus Camedia Digital Camera, 5.0 Megapixel, C-50 ZOOM, S/N 115248297.
7. **Recording Media:** FUJIFILM xD-Picture Card, 128 MB, S/N DPC-128, R31695 5RZ7, 0244 MAD.
8. **All Digital Photos Were Copied To:** Hard Disk of Computer DEP 143271; some photos copied to this Digital Photographic Log.
9. **Original Copy Is Stored In/On:** Hard disk of computer DEP 143271.
10. **Were the photos altered?:** NO YES _____ explain yes:
11. **Photographer:** Amaury Betancourt
12. **Signature of Photographer:** _____

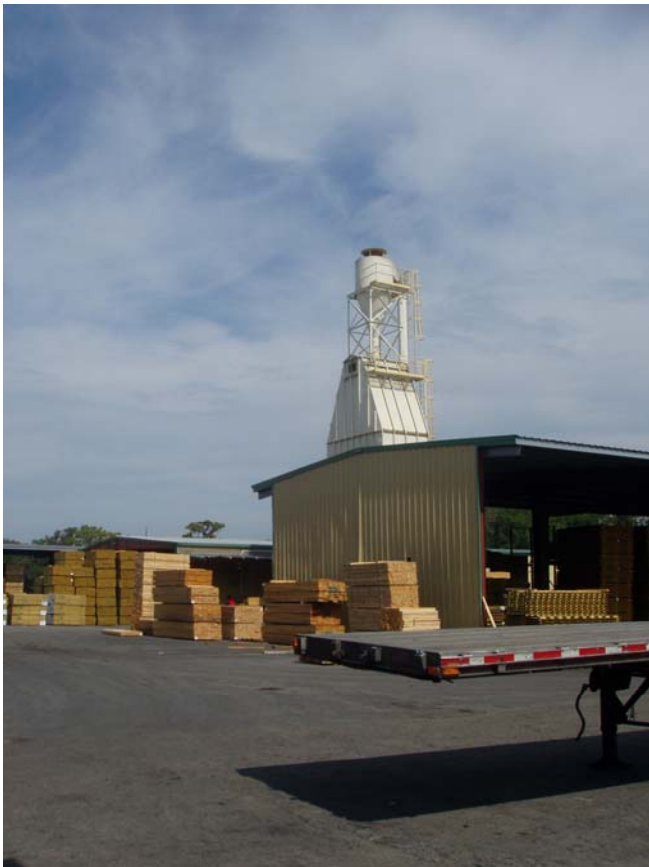
Photo ID No: 1050244_Photo_05_15_2012-001
Time: Approx. 10:15 AM
Approximate perspective from where the visible emissions (VE) test was conducted by Mr. Dale T. McDonough of S.E. McDonough and Associates, Inc., the engineering consultant for Sunbelt Forest Products Corporation. The camera is facing approx. NW.

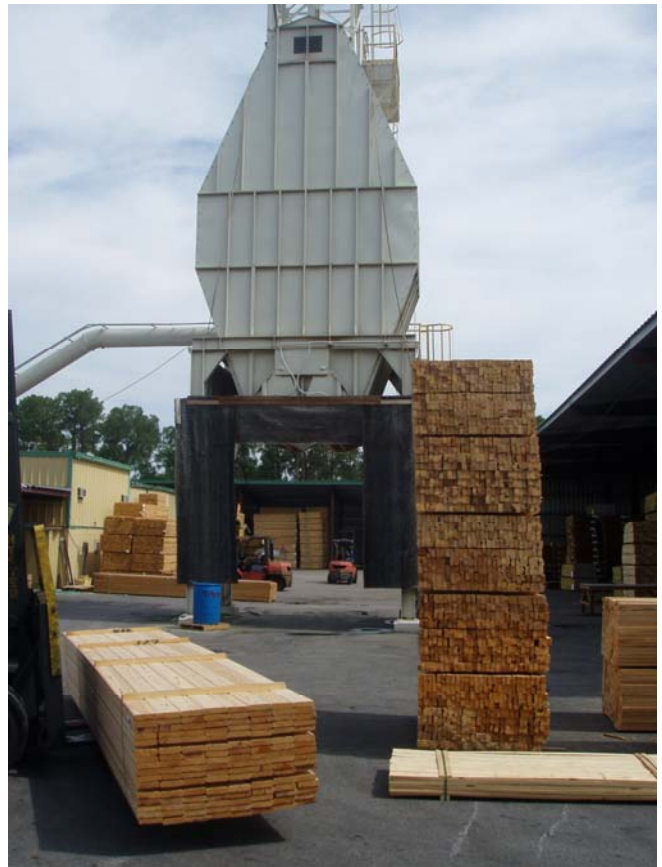
Photo ID No: 1050244_Photo_05_15_2012-002
Time: Approx. 10:45 AM
Photograph of the sawdust storage silo. The camera is facing approx. N. Rubber curtains, to minimize fugitive dust emissions while loading sawdust into a truck, are on the South face of the truck loading area. The area appeared to be clean and well maintained.

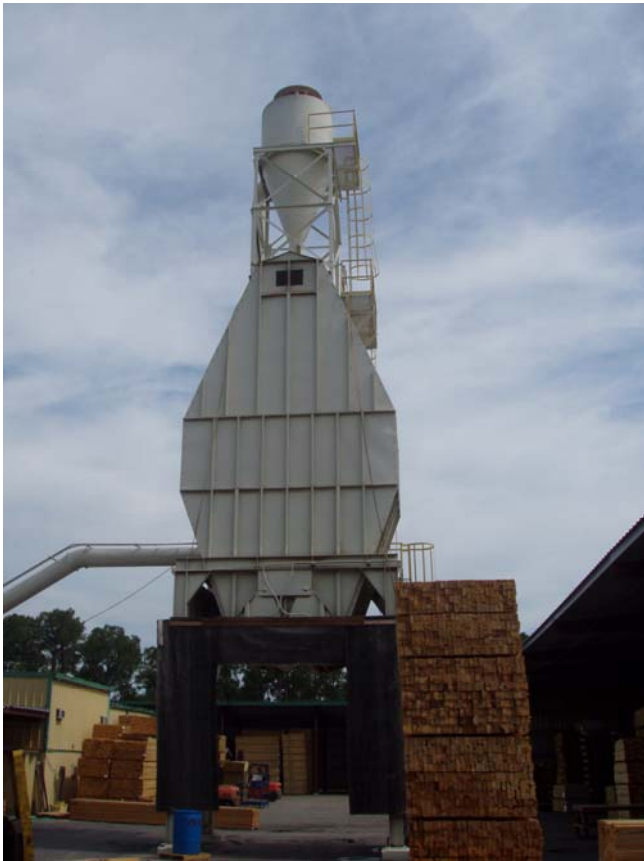
Photo ID No: 1050244_Photo_05_15_2012-003
Time: Approx. 10:45 AM
 A U.S. Metal Works, Inc., 7' diameter cyclone separator is installed on top of the 20 unit sawdust storage bin at this facility, which is visible in this photograph. The cyclone controls particulate matter (PM) from dust pickup points that send sawdust from sawing operations at the facility to the sawdust storage bin. The camera is facing approx. N.

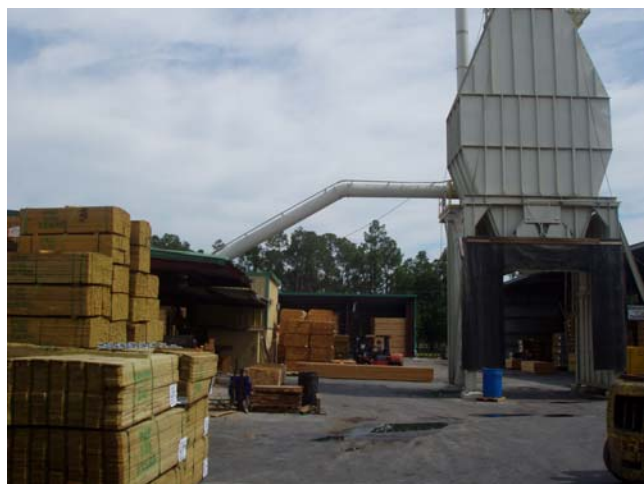
Photo ID No: 1050244_Photo_05_15_2012-004
Time: Approx. 10:45 AM
 Main sawdust pickup line from facility sawing operations to cyclone and sawdust storage bin. The camera is facing approx. N.

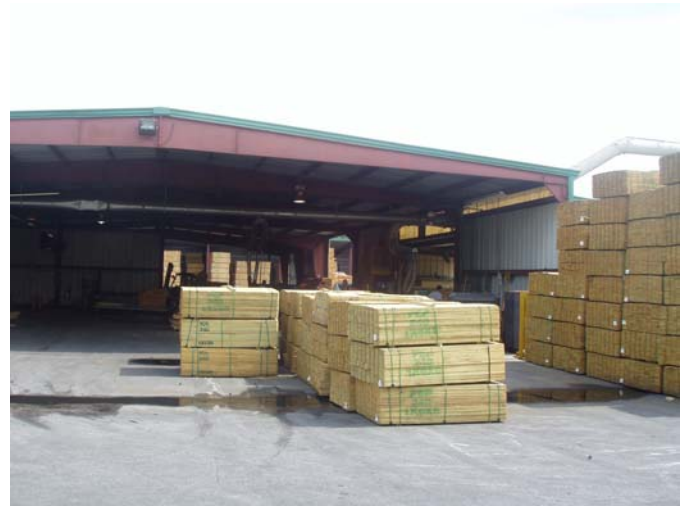
Photo ID No: 1050244_Photo_05_15_2012-005
Time: Approx. 10:45 AM
 East side of building containing sawing equipment for sawing lumber. The camera is facing approx. N. The sawdust storage silo (not visible in the photograph) is just East of this building (the main sawdust pickup line is visible outside the building in the photograph).

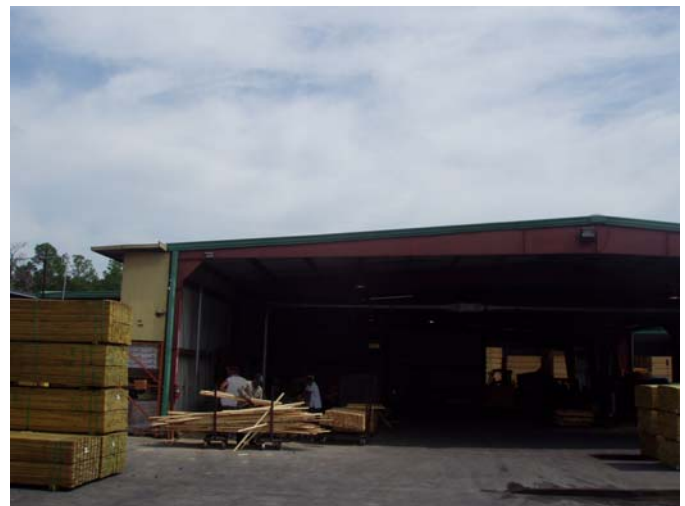
Photo ID No: 1050244_Photo_05_15_2012-006
Time: Approx. 10:45 AM
 West side of building containing sawing equipment. The camera is facing approx. N.

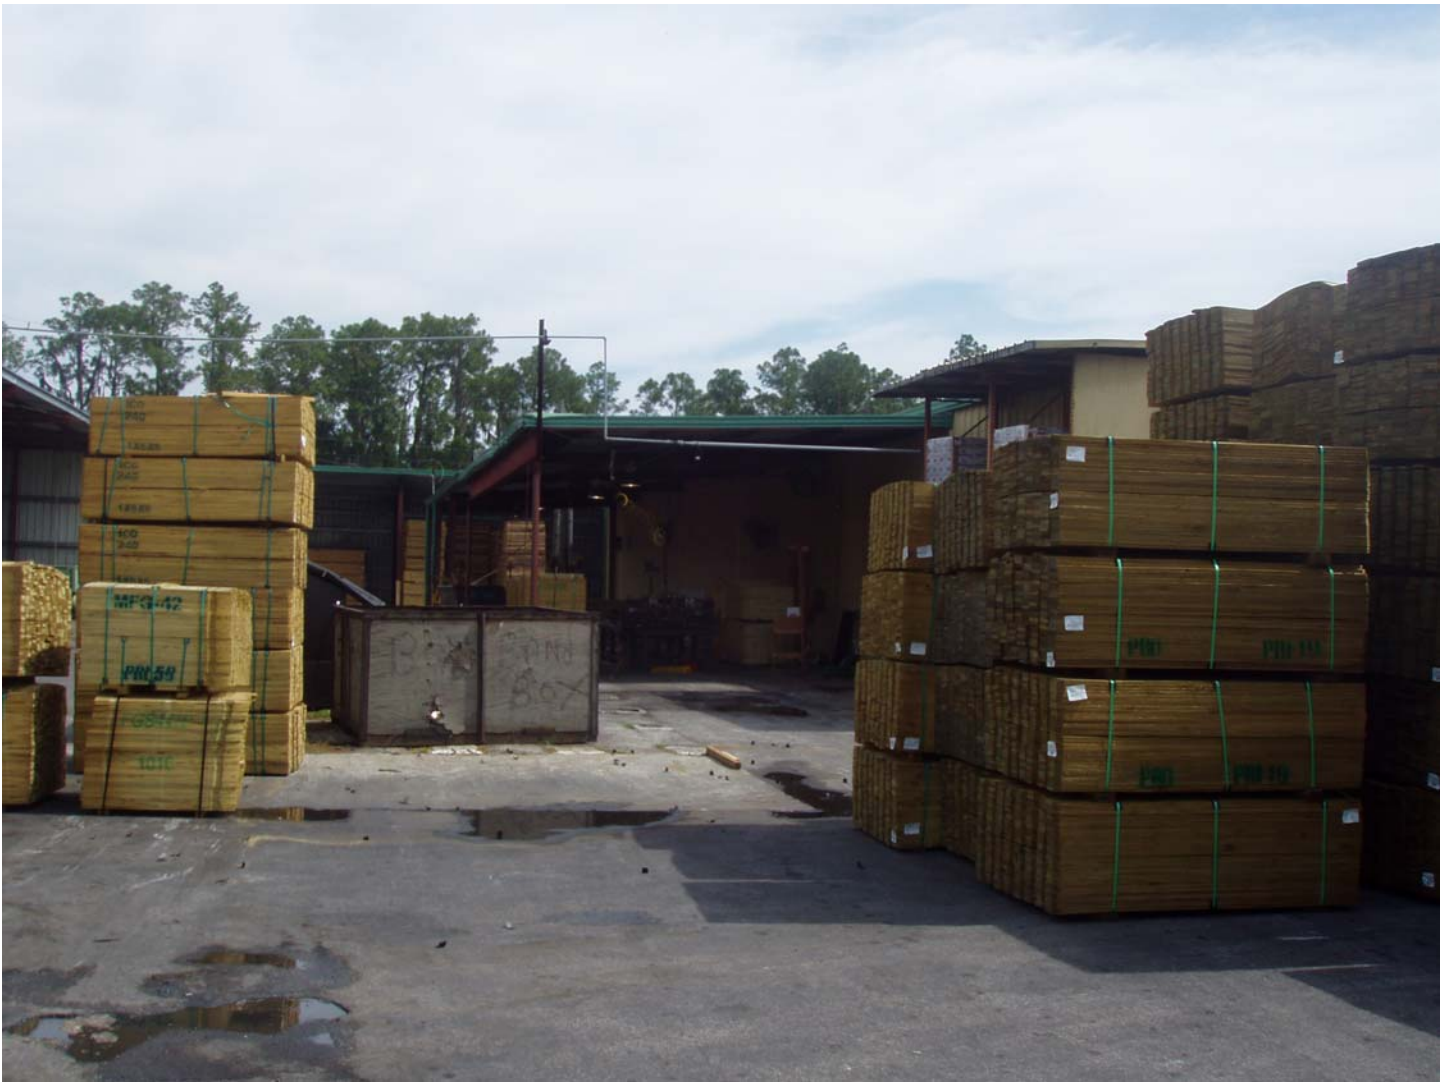
Photo ID No: 1050244_Photo_05_15_2012-007

Far West side of the building containing sawing equipment. The fence building machine, which does not generate significant sawdust, is visible under the roof of the building. The camera is facing approx. N.

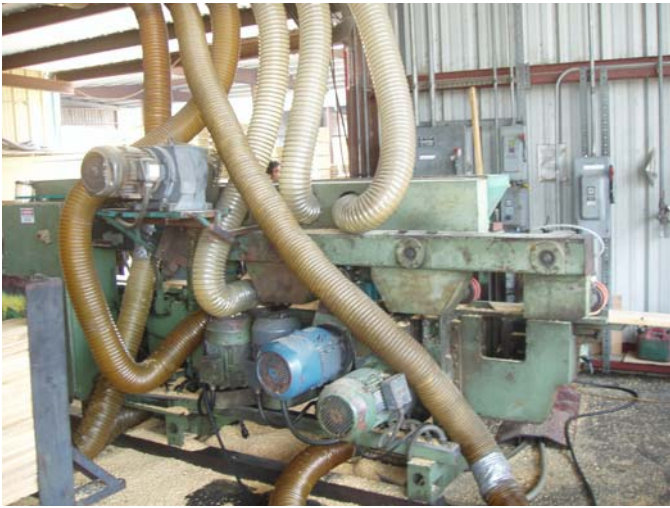
Photo ID No: 1050244_Photo_05_15_2012-008
Time: Approx. 12:00 PM
Dust pickup points from sawing and moulding operations.
The camera is facing approx. NE.

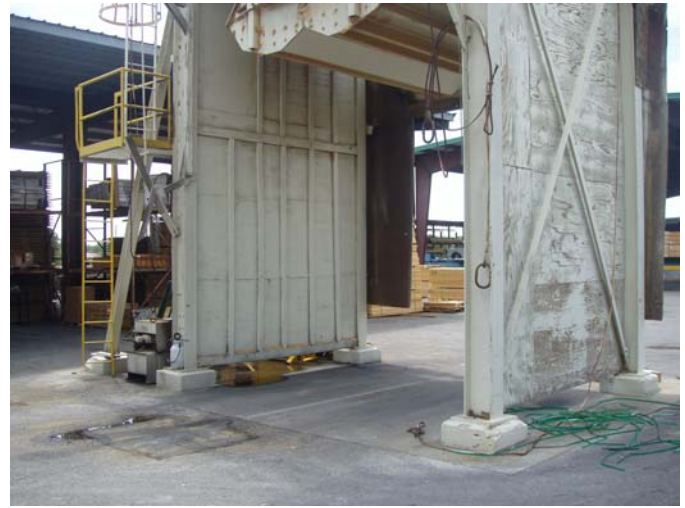
Photo ID No: 1050244_Photo_05_15_2012-009
Time: Approx. 12:15 PM
Truck loading area for sawdust loading from sawdust storage bin. The camera is facing approx. SE.

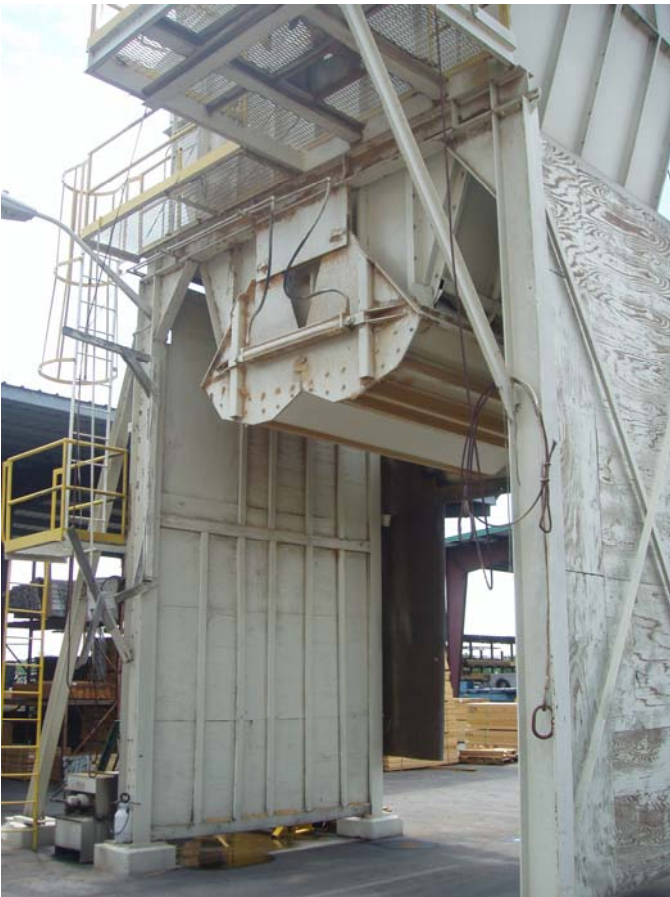
Photo ID No: 1050244_Photo_05_15_2012-010
Time: Approx. 12:15 PM
Opening of the sawdust storage bin. The camera is facing approx. SE.

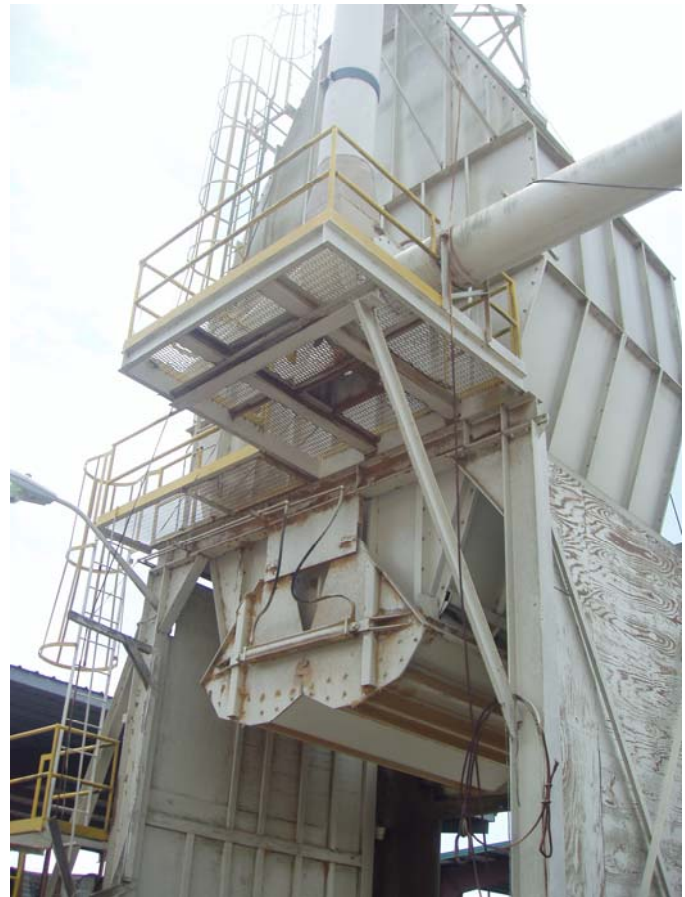
Photo ID No: 1050244_Photo_05_15_2012-011
Time: Approx. 12:15 PM
View of the opening of the sawdust storage bin and of the main dust pickup line. The camera is facing approx. SE.

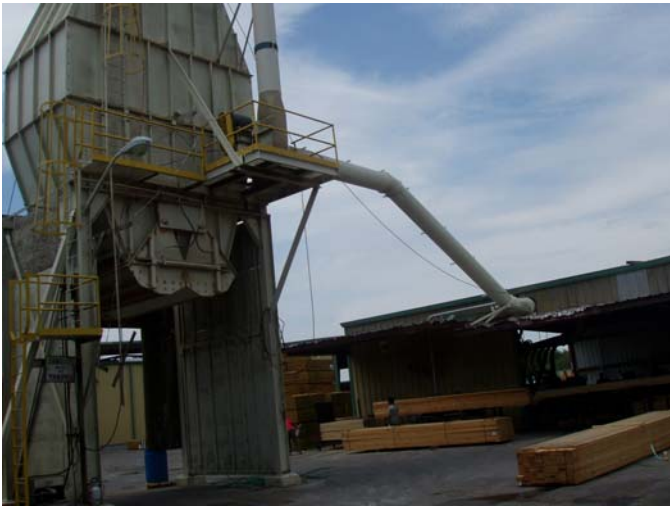
Photo ID No: 1050244_05_15_2012-012
Time: Approx. 12:15 PM
Sawdust storage bin with main dust pickup line. The camera is facing approx. SW.

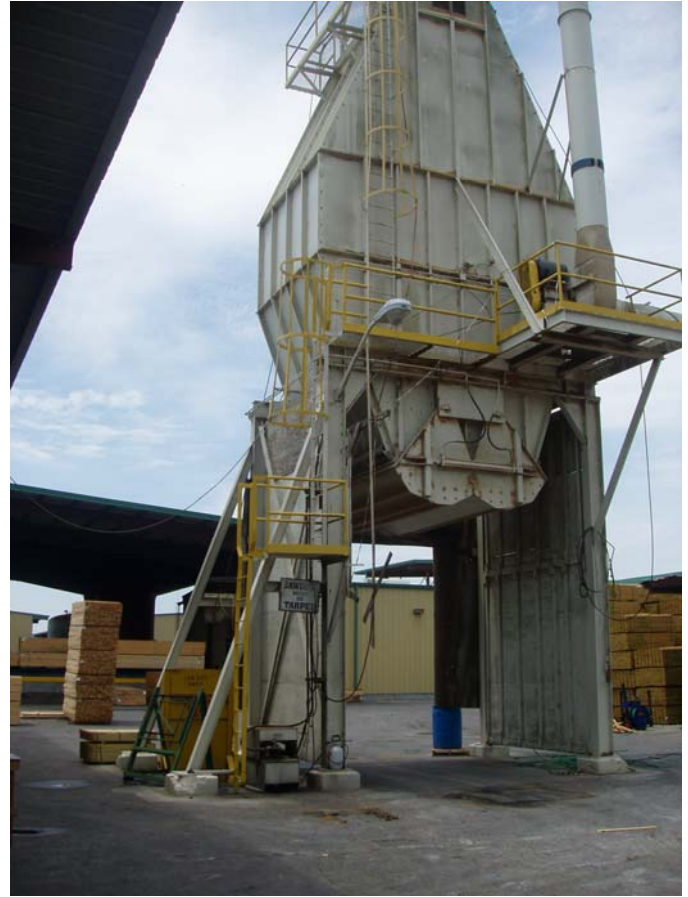
Photo ID No: 1050244_Photo_05_15_2012-014
Time: Approx. 12:15 PM
Sawdust storage bin at facility. The camera is facing approx. SW.

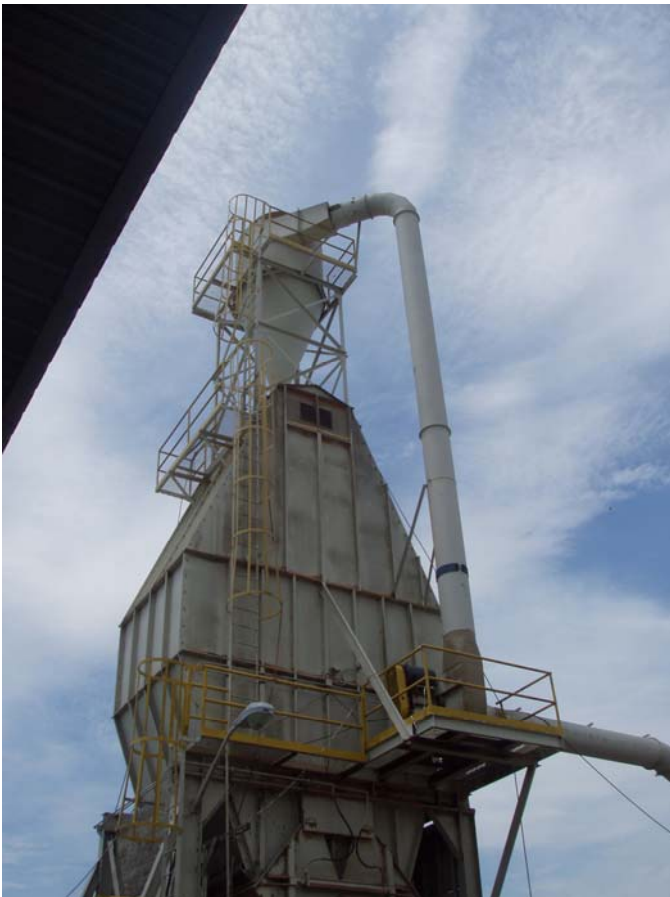
Photo ID No: 1050244_Photo_05_15_2012-013
Time: Approx. 12:15 PM
Sawdust storage bin with main dust pickup line and line leading to cyclone. The camera is facing approx. SW.

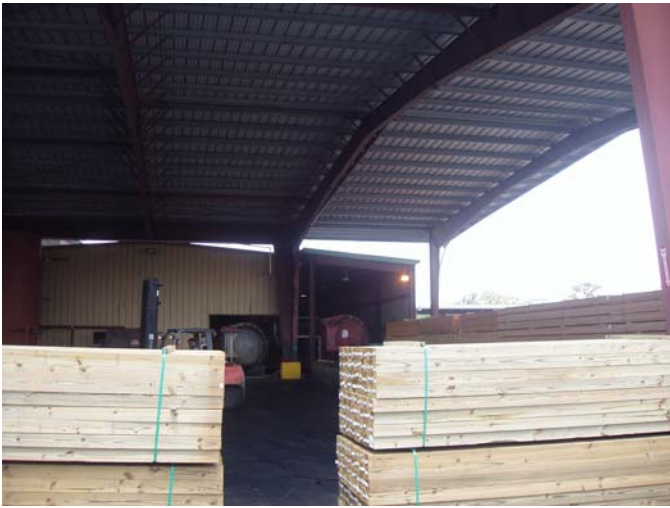
Photo ID No: 1050244_Photo_05_15_2012-015

This facility pressure treats lumber (preserves wood), but is not subject to 40 CFR 60 Subpart QQQQQQ (National Emission Standards for Hazardous Air Pollutants for Wood Preserving Area Sources) because the facility uses chemicals, such as Amine Copper Quat (ACQ) and Ecolife, that do not contain hazardous air pollutants (HAPs). HAPs commonly used in wood preserving, but not at this facility, include the chemicals dioxin, chromium, arsenic, and methylene chloride. In this photograph, the two pressure treating cylinders are visible, the front side of one (red) and the back side of the other (gray). The camera is facing approx. W.

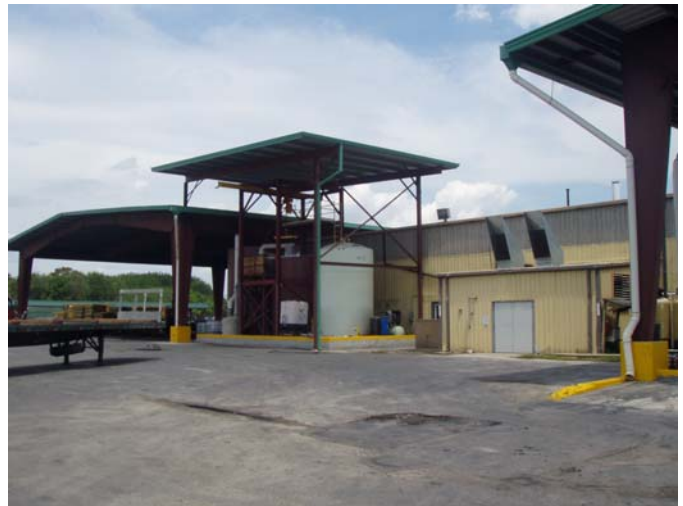
Photo ID No: 1050244_05_15_2012-017

South face of building for lumber pressure treatment. The camera is facing approx. NW.

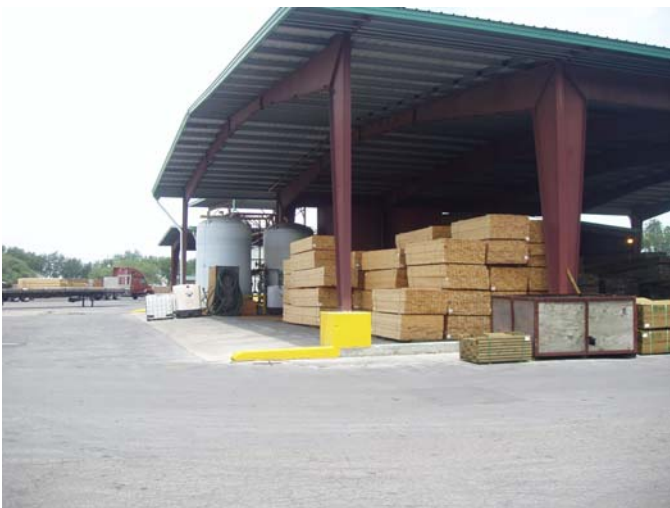
Photo ID No: 1050244_05_15_2012-016

Lumber pressure treating area with tanks (possibly for storage of pressure treating chemicals). The camera is facing approx. W.

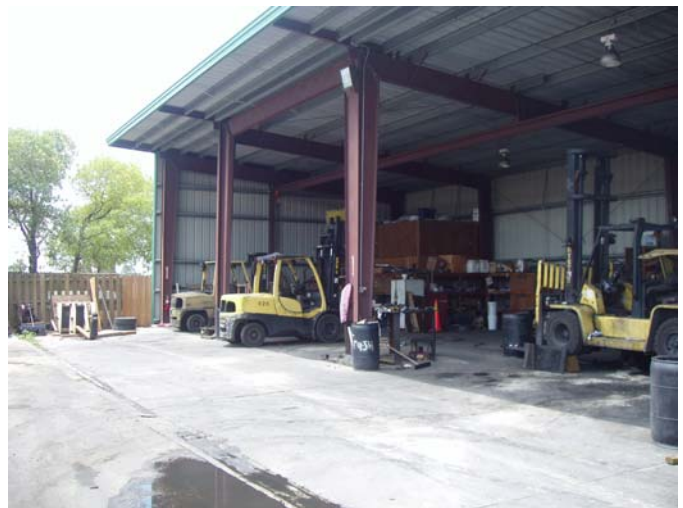
Photo ID No: 1050244_05_15_2012-018

Maintenance, welding, and repair area at facility. The camera is facing approx. SW.

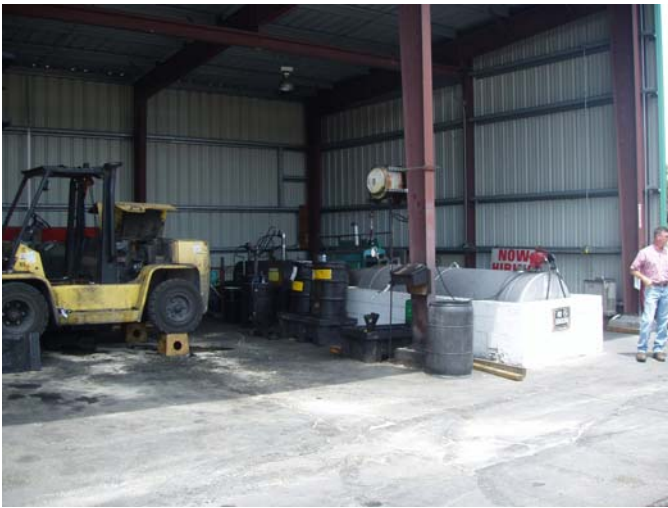
Photo ID No: 1050244_05_15_2012-019

Maintenance, welding, and repair area at facility. The camera is facing approx. NW. This building contains a diesel tank with a capacity of 1,000 gallons, visible near the North wall of the building. Outside the building, on the North wall of the building, there is also a gasoline tank with a capacity of 250 gallons.

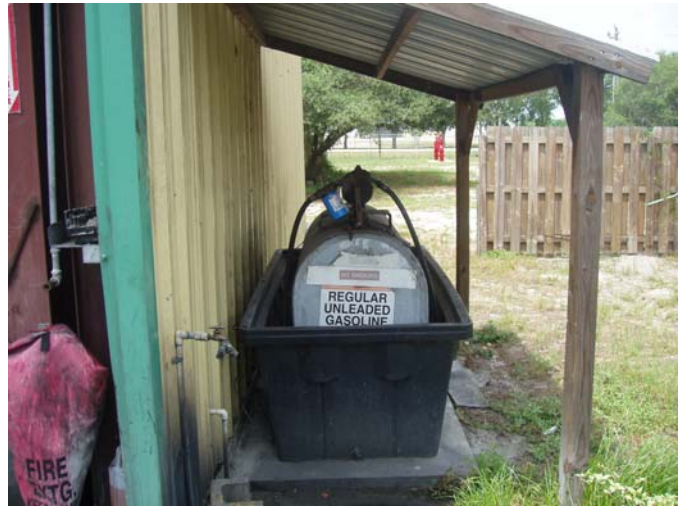
Photo ID No: 1050244_05_15_2012-021

Gasoline tank, with a 250 gallon capacity, on the outside North wall of the maintenance, repair, and welding building at facility. The camera is facing approx. W.

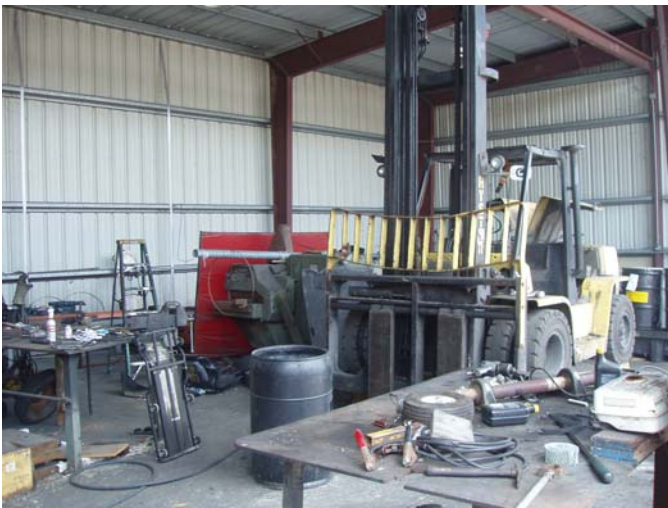
Photo ID No: 1050244_05_15_2012-020

Maintenance, welding, and repair area at facility. The camera is facing approx. NW. A non-operational gang rip saw is visible near the West wall of the building. This gang rip saw had been installed an operational at the facility in the past, but is currently not operating.

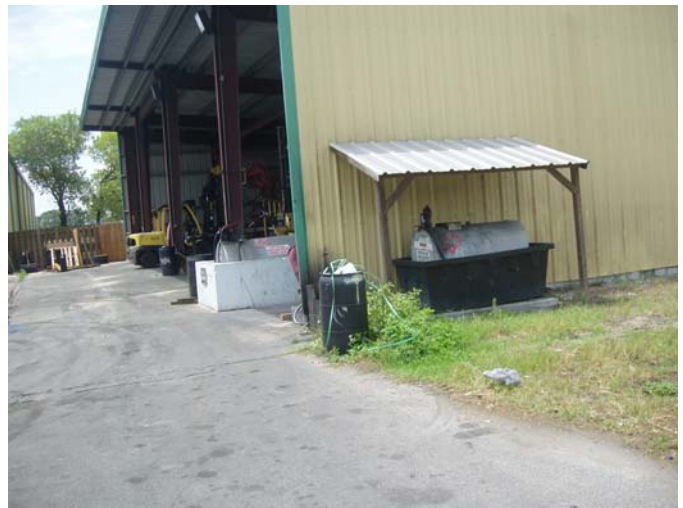
Photo ID No: 1050244_05_15_2012-021

Gasoline tank, with a 250 gallon capacity, on the outside North wall of the maintenance, repair, and welding building at facility. The camera is facing approx. S.
