## DIGITAL PHOTOGRAPHIC LOG

**Facility Name:** Aercon Florida LLC; **Facility ID No:** 1050276; **County:** Polk

**Inspection Type/Date:** INS2: Compliance Walkthrough Inspection & VE Test audit on 05/10/2012 **Page 1 of 5**

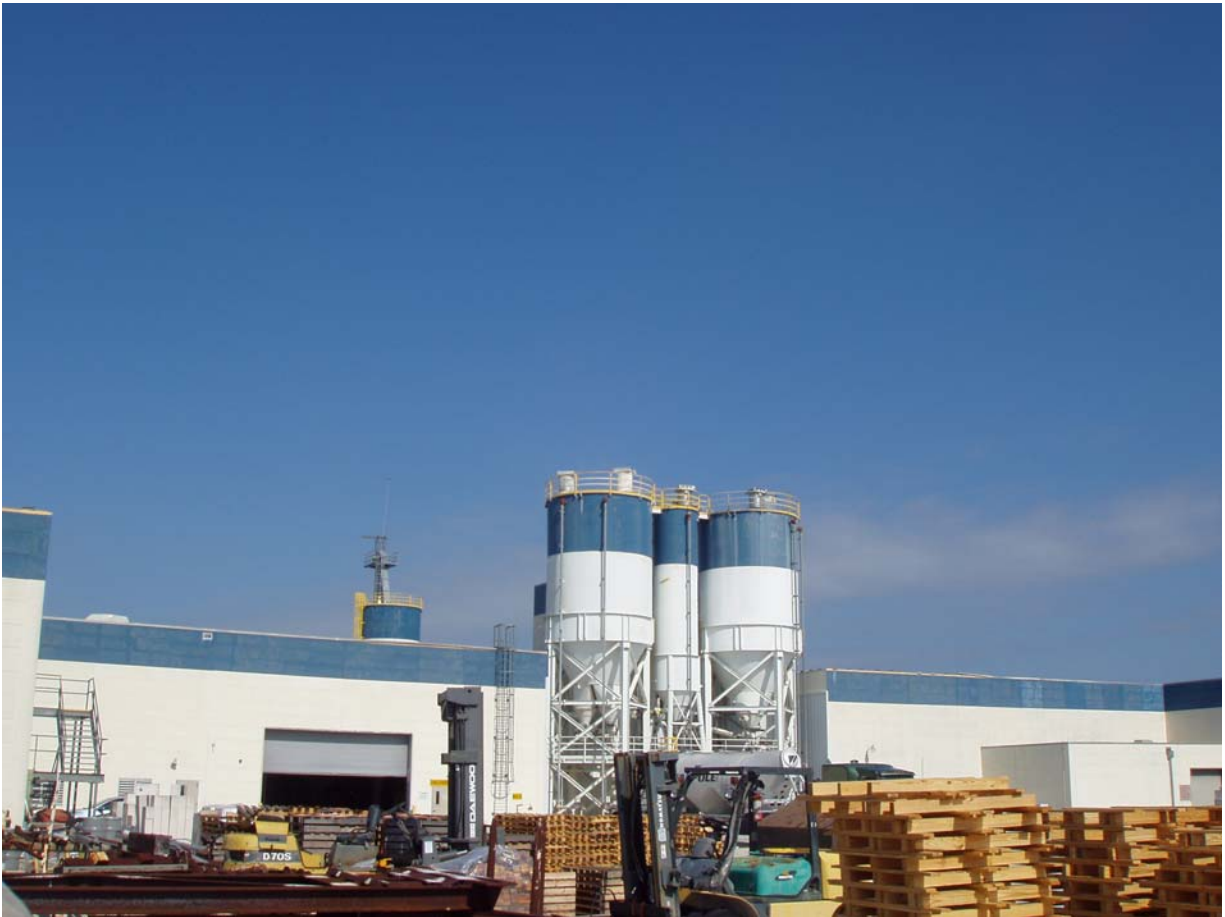
**Photo ID No:** 1050276\_Photo\_05\_10\_2012-001

Approximate perspective of visible emissions (VE) tests conducted for silos at this facility. The camera is facing approximately Northwest. The North silo is emission unit (EU) EU003 and is split into a North compartment for slag (emission point EP002) and a South compartment for cement (EP001). The middle silo is a single compartment silo for anhydrite (EU004). The South silo is a split silo for lime: the North compartment is EP001 and the South compartment is EP002. The visible emissions tests were conducted by Mr. Lynn Robinson of Southern Environmental Sciences, Inc. on 05/10/2012.

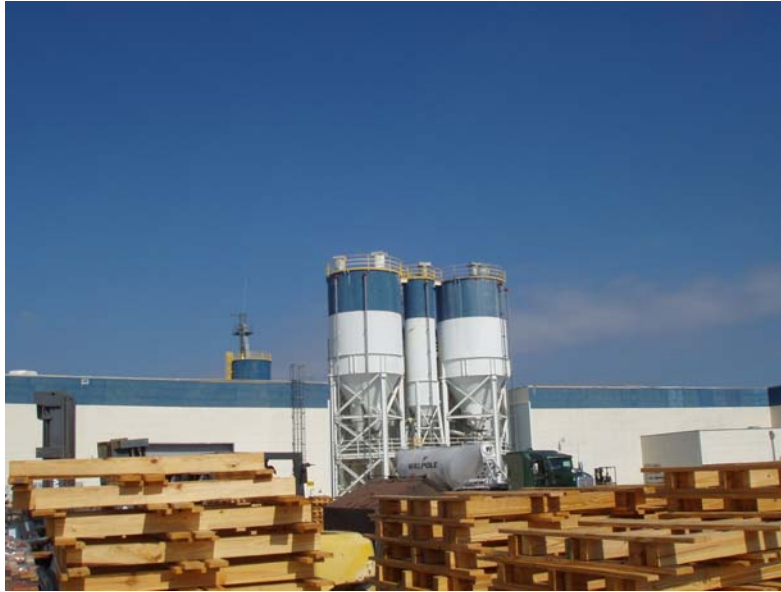
**Photo ID No:** 1050276\_Photo\_05\_10\_2012-002  
**Time:** Approx. 09:45 AM  
Lime being loaded by truck into the North compartment of the South Lime Storage Silo (EU002-EP001). The camera is facing approx. NE.

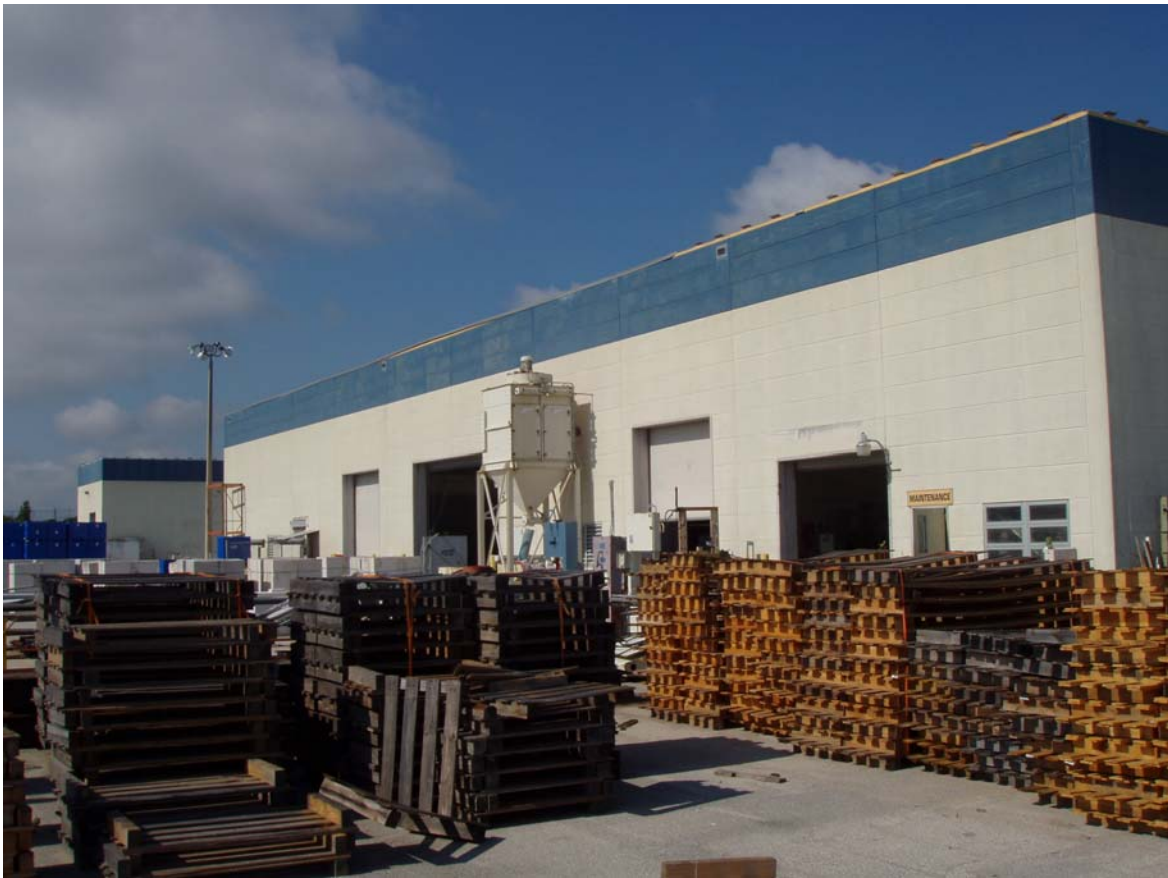
**Photo ID No:** 1050276\_Photo\_05\_10\_2012-003  
**Time:** Approx. 09:45 AM  
The HANDTE Model PF 12-120 cartridge filter baghouse, visible on the center of the face of the building containing the cutting area, controls particulate matter emissions from the cutting area (EU007). The camera is facing approx. SW.

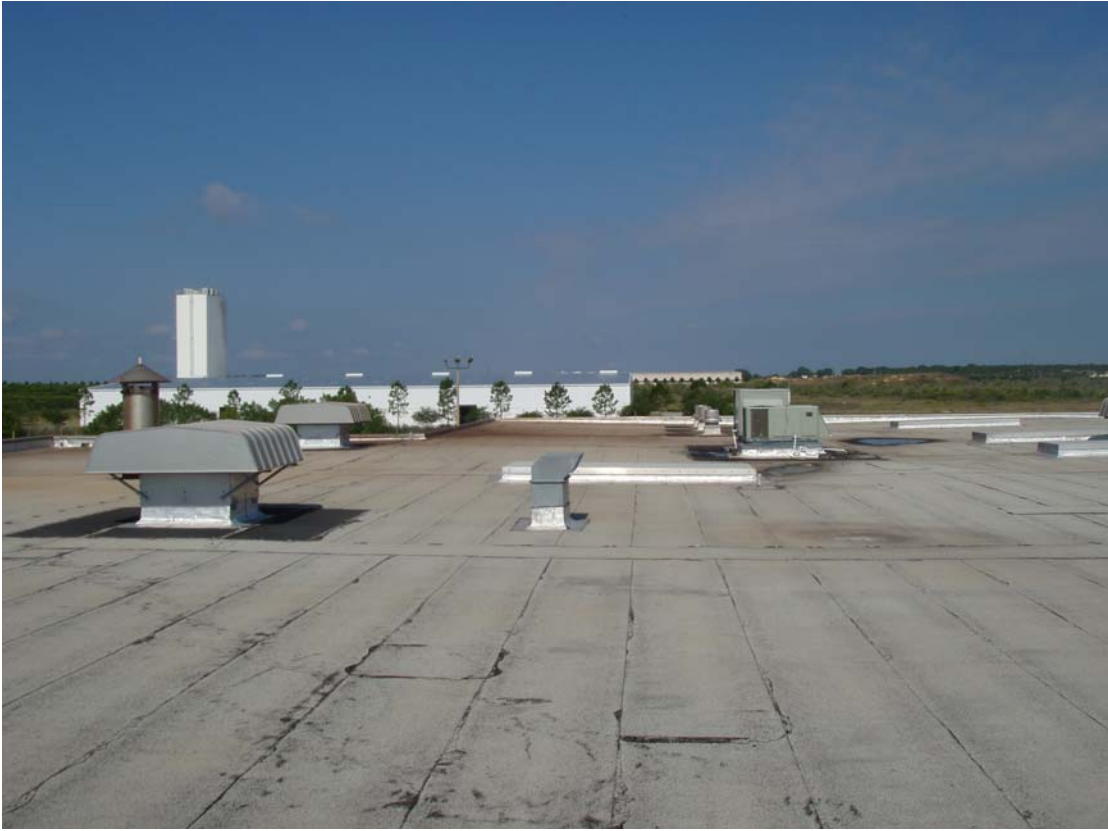
**Photo ID No:** 1050276\_Photo\_05\_10\_2012-004

The camera is facing approximately East. The vent for the boring area (EU005) is visible in the center of the photograph and the vent faces approximately North. The VE test for this EU was conducted on the rooftop of the building containing the boring area.

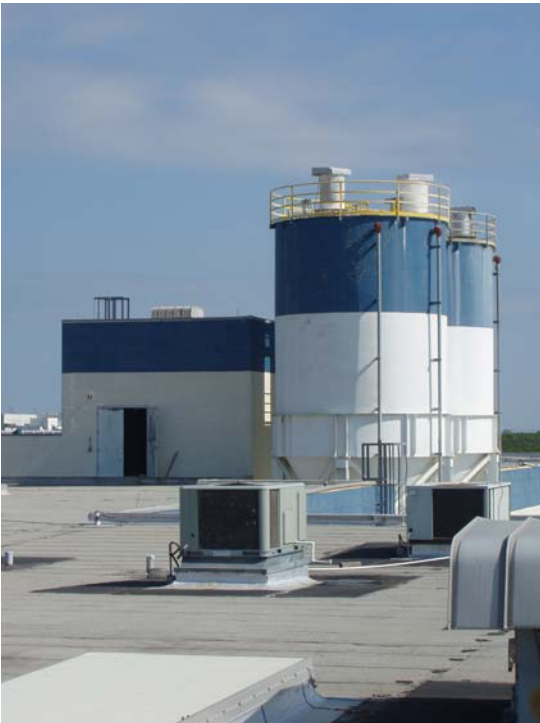
**Photo ID No:** 1050276\_Photo\_05\_10\_2012-005

View, from rooftop, of South Silo. The camera is facing approximately North-northwest. The baghouse of the North compartment of the South silo (EU002-EP001) was emitting puffs of white smoke at an opacity of approximately 10% for a time period of approximately 45 minutes. This baghouse is visible on the right side of the South silo (baghouse appears to be white in color).

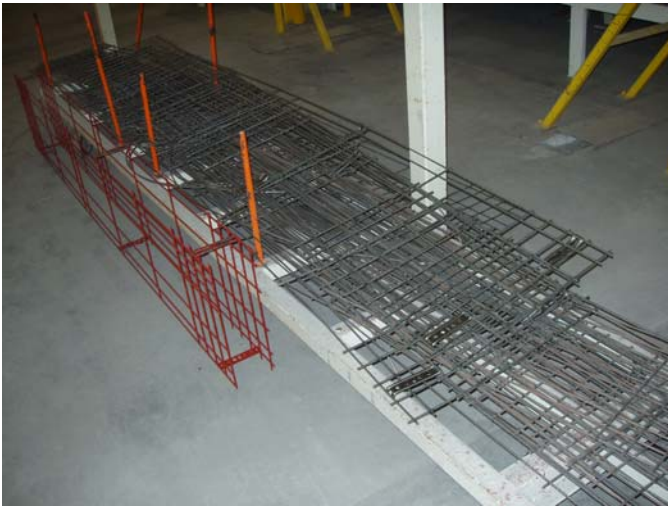
**Photo ID No:** 1050276\_Photo\_05\_10\_2012-006

Parts for steel reinforcement cages used in reinforcing concrete panel products at the facility. The red cage has been coated in red acrylic primer. This red cage is off-specification but may be used in a different product. The camera is facing approximately Northeast.

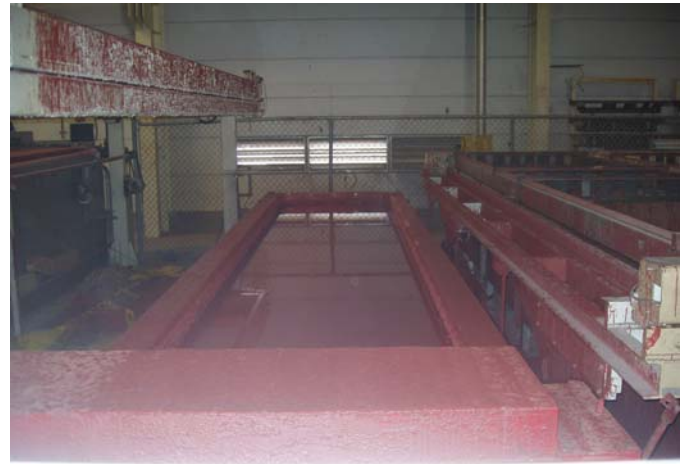
**Photo ID No:** 1050276\_Photo\_05\_10\_2012-008

Tank used for holding red acrylic dipping primer. Steel reinforcement cages, for concrete panel products, are dipped into this tank to coat the reinforcement cages with primer. Then, the reinforcement cages coated with primer are allowed to dry. The camera is facing approx. S.

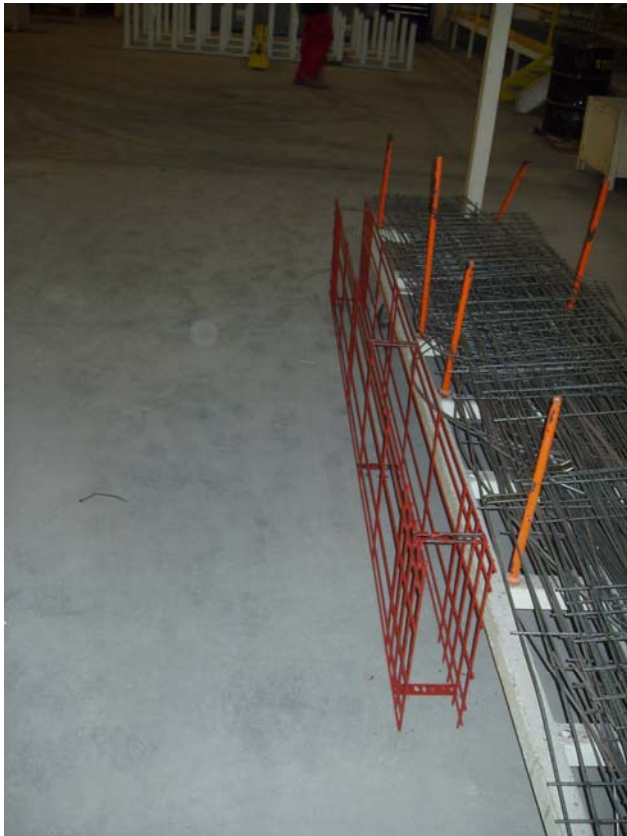
**Photo ID No:** 1050276\_Photo\_05\_10\_2012-007

View of the same off-specification steel reinforcement cage as in photo 1050276\_Photo\_05\_10\_2012-006. The camera is facing approximately North.

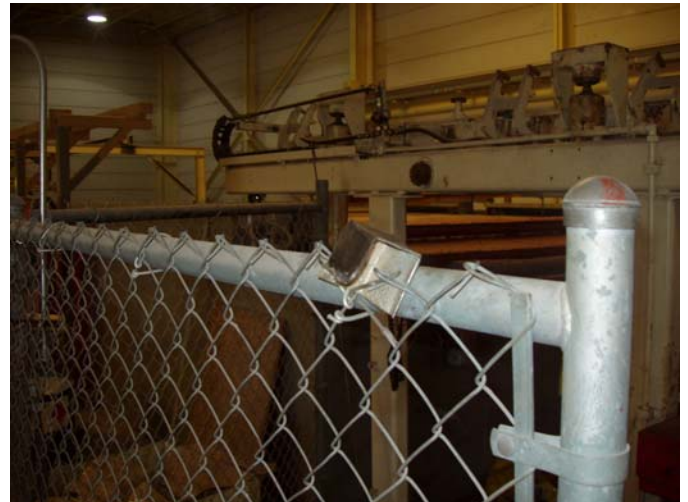
**Photo ID No:** 1050276\_Photo\_05\_10\_2012-009

Part of the dipping area, where steel reinforcement cages are dipped into a tank of red acrylic dipping primer, is fenced off. The camera is facing approx. SE.

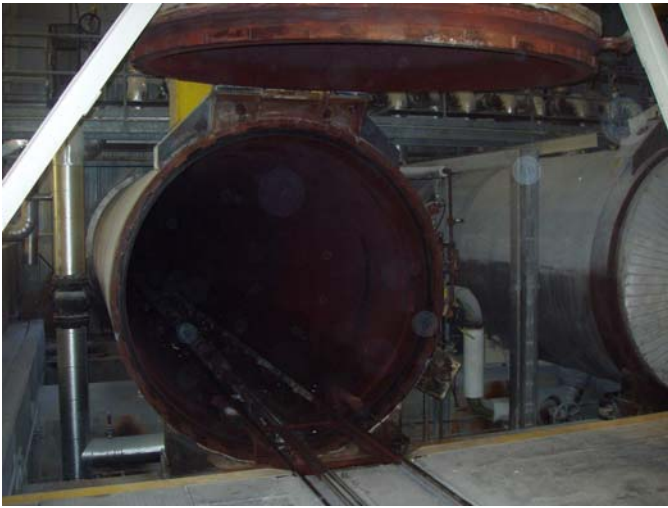
**Photo ID No:** 1050276\_Photo\_05\_10\_2012-010  
**Time:** Approx. 11:15 AM  
Easternmost autoclave in building. Autoclave is open.  
The camera is facing approx. S.

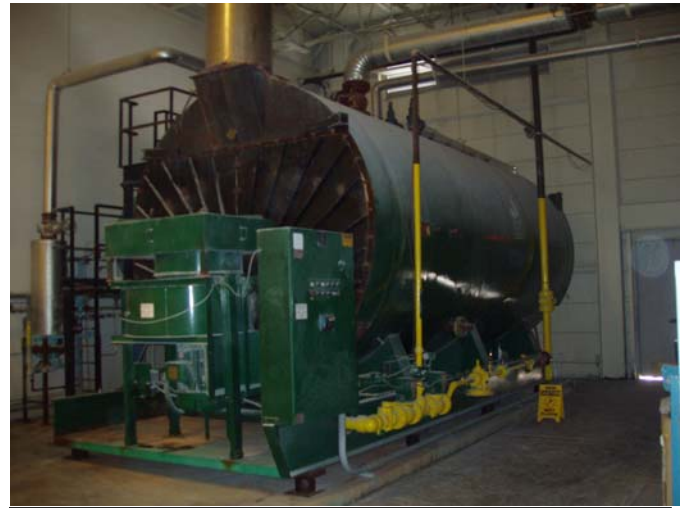
**Photo ID No:** 1050276\_Photo\_05\_10\_2012-012  
**Time:** Approx. 11:30 AM  
The Johnston boiler, exempt from air operating permitting, supplies steam to the autoclaves at the facility. The camera is facing approx. SE.

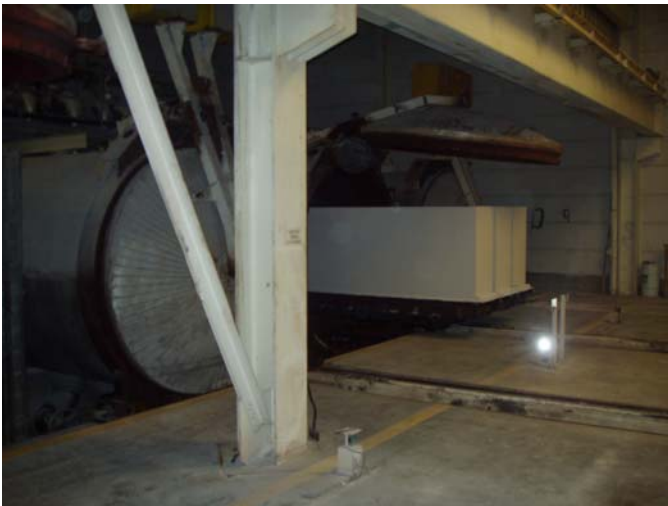
**Photo ID No:** 1050276\_Photo\_05\_10\_2012-011  
**Time:** Approx. 11:15 AM  
Some of the autoclaves at the facility. The camera is facing approx. SW. The third autoclave (from East to West) is open with a load of concrete products sticking out. The fourth autoclave (from East to West) is barely visible in the photograph and is not connected and not operating.

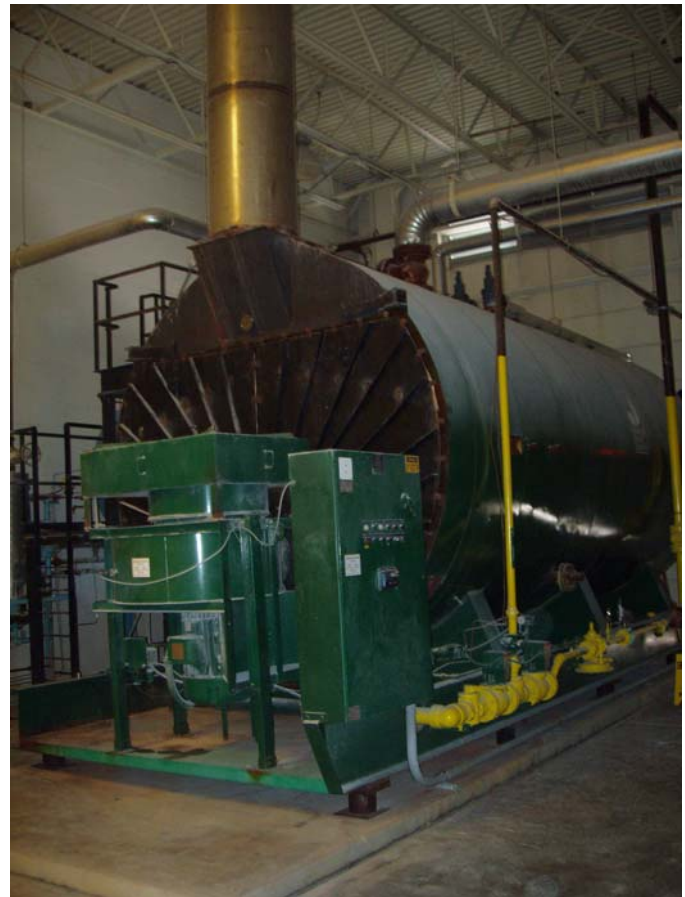
**Photo ID No:** 1050276\_Photo\_05\_10\_2012-013  
**Time:** Approx. 11:30 AM  
Another view of the Johnston boiler, exempt from air operating permitting, which supplies steam to the autoclaves at the facility. The camera is facing approx. SE.
