**Florida Department of Environmental Protection, Southwest District
Division of Air Resource Management**

DIGITAL PHOTOGRAPHIC LOG

Facility Name: ParexUSA (formerly Elite Building Products); **Facility ID No:** 1050386; **County:** Polk
Inspection Type/Date: Compliance Assistance Inspection on 05/11/2012

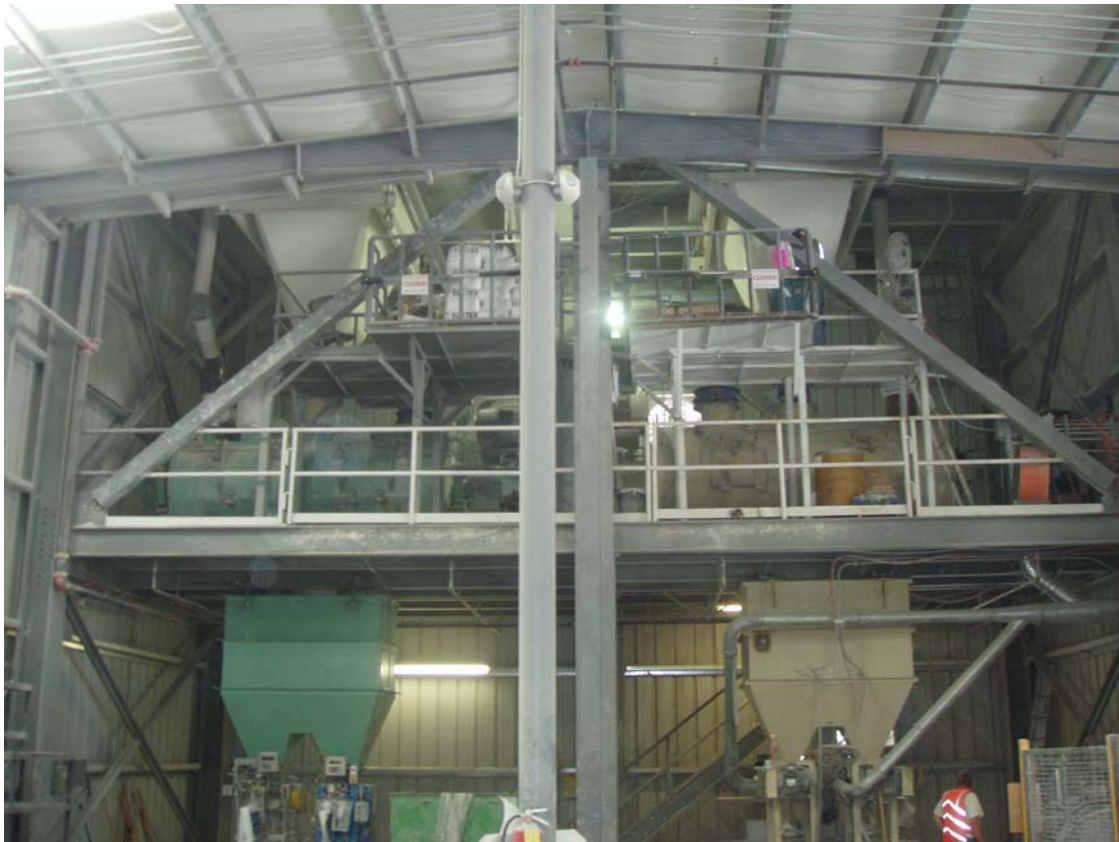
Photo ID No: 1050386_Photo_05_11_2012-001

Two processes at the facility to produce materials. Process on East side (left, green-colored equipment) is new and not yet operating, and process on West side (right, tan-colored equipment) is original process and is currently operating. Each process consists of a weigh hopper (top bin on third floor), a mixer (horizontal cylindrical tank on second floor), and a packing machine (machine on first floor). Materials are fed into weigh hoppers from raw material storage bins (not visible in photo) via feed screws. Material is then packaged and organized onto pallets by another machine (not visible in photo). Each process has a dust collector outside (not visible in photo) to collect dust from mixing and packing operations, and dust pickup lines for the original material processing equipment are visible directly in front of the original packing machine. Camera is facing approx. S.

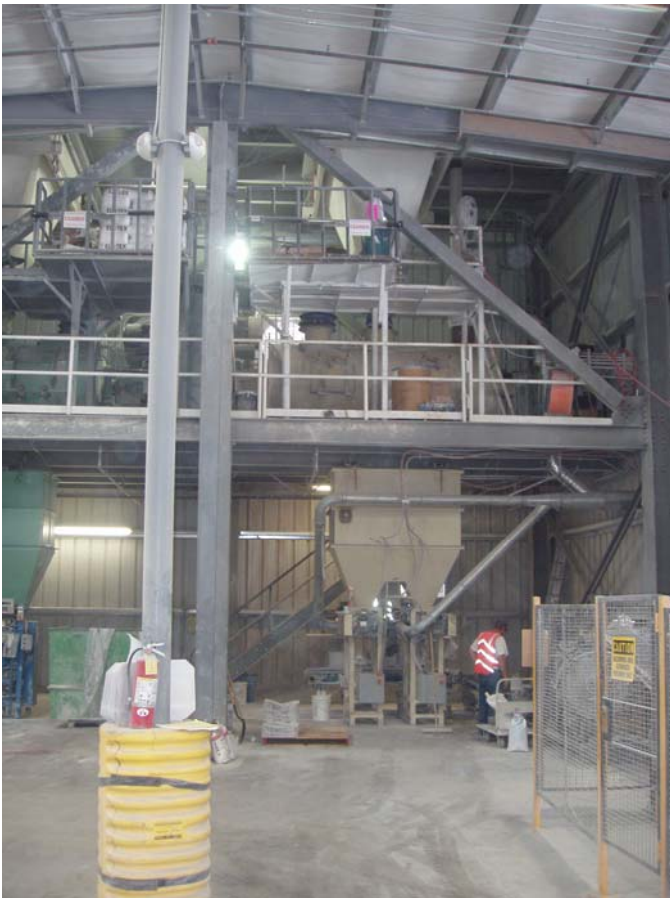
Photo ID No: 1050386_Photo_05_11_2012-002
Time: Approx. 10:45 AM
View of original material processing equipment at facility. Camera is facing approx. S.

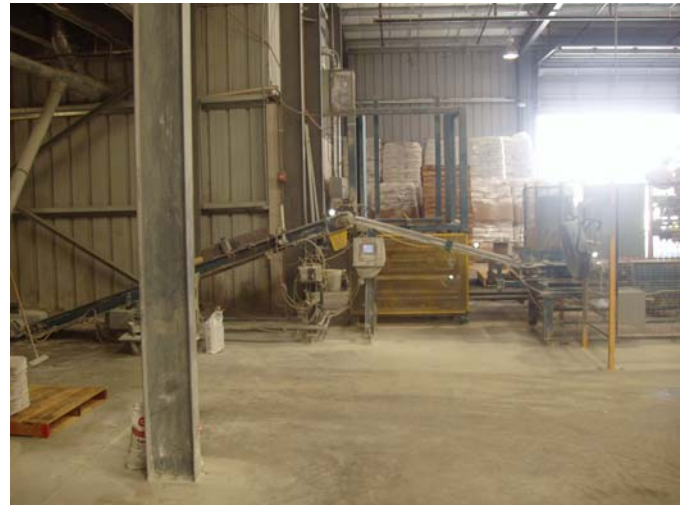
Photo ID No: 1050386_Photo_05_11_2012-006
Time: Approx. 10:45 AM
Conveying equipment to send packaged material from packing machine to the machine that organizes the packaged materials onto pallets (not visible in this photograph). Camera is facing approx. W.

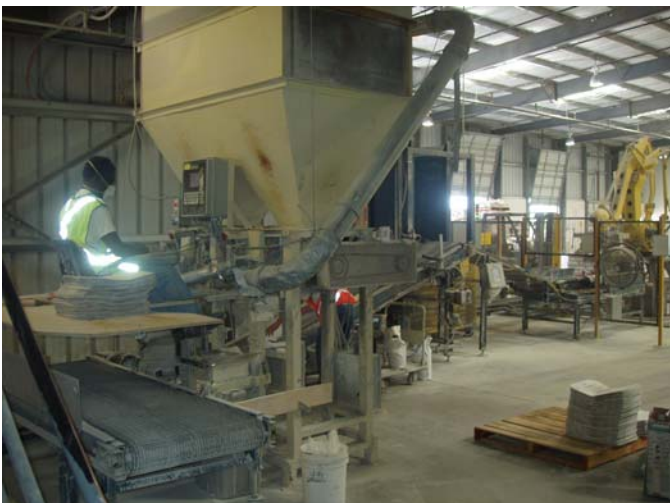
Photo ID No: 1050386_Photo_05_11_2012-004
Time: Approx. 10:45 AM
Original packing machine (operating) and dust pickup line (diagonal gray pipe on side of machine). An operator can process two bags of finished material at a time by hand-feeding bags to machine. Camera is facing approx. NW.

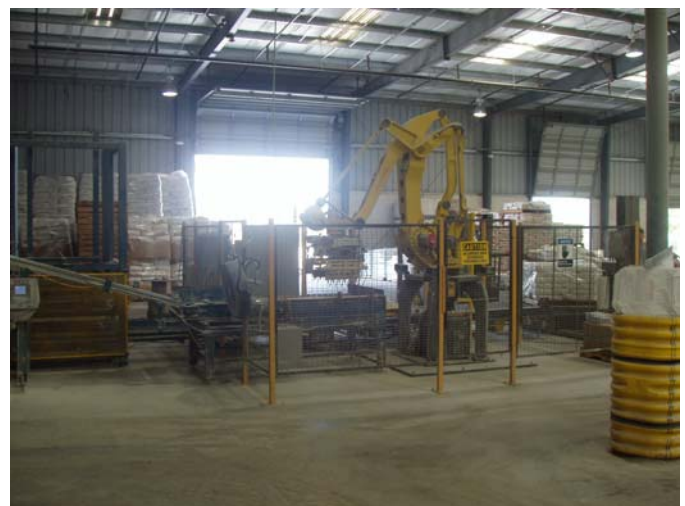
Photo ID No: 1050386_Photo_05_11_2012-007
Time: Approx. 11:00 AM
Material organizing machine (yellow crane-like machine) that sorts material packages onto pallets. This machine is connected to the original material processing equipment at the facility. Camera is facing approx. NW.

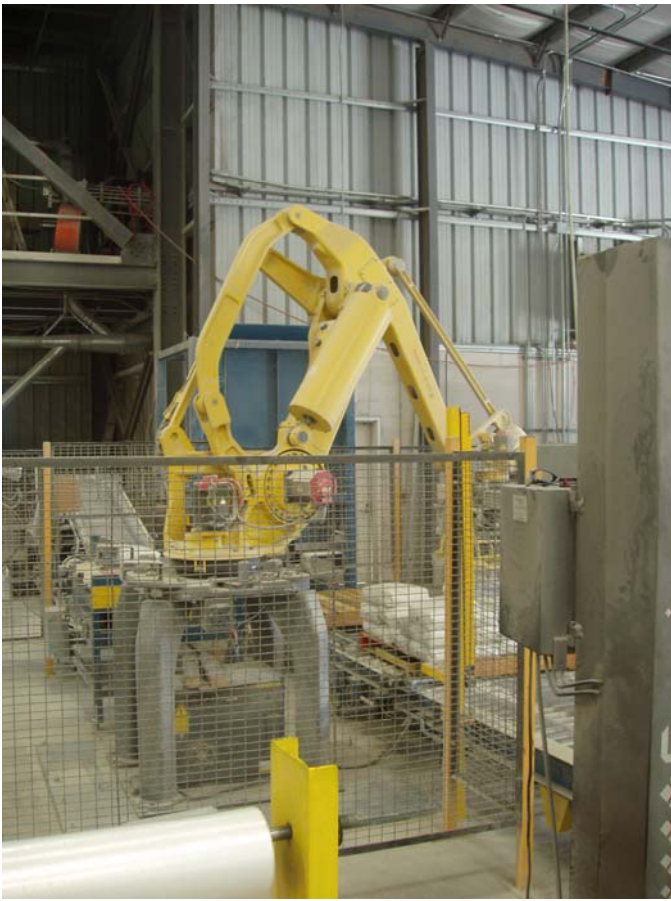
Photo ID No: 1050386_Photo_05_11_2012-013
Time: Approx. 11:00 AM
View of machine for organizing material onto pallets.
Camera is facing approx. SW.

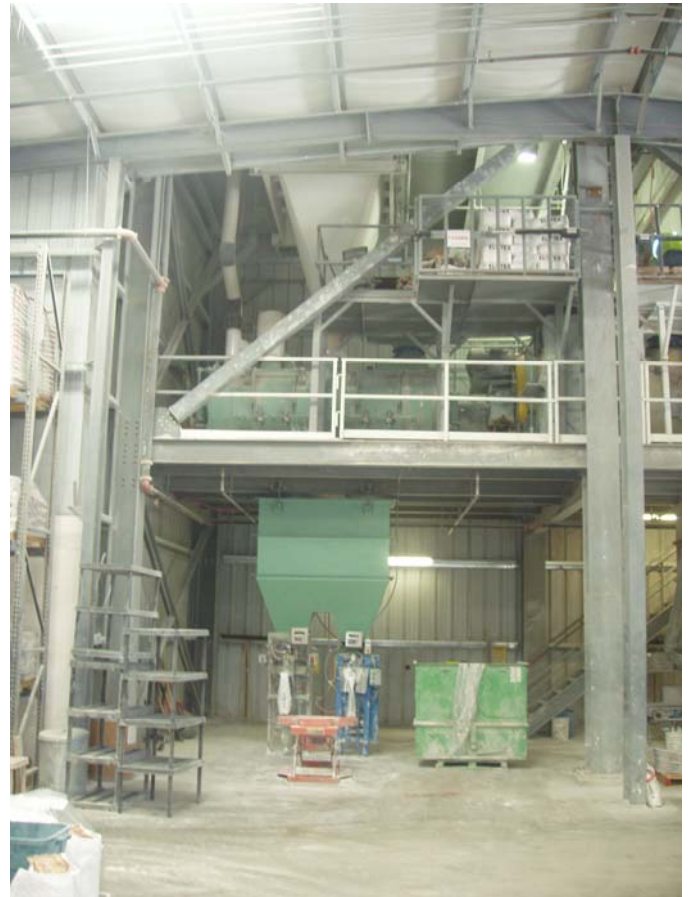
Photo ID No: 1050386_Photo_05_11_2012-010
Time: Approx. 11:00 AM
View of new material processing equipment at facility.
Camera is facing approx. S.

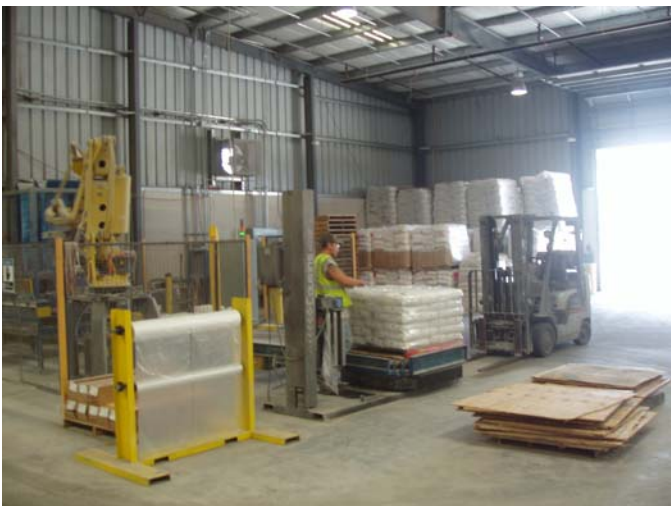
Photo ID No: 1050386_Photo_05_11_2012-0009
Time: Approx. 11:00 AM
View of operations for organizing finished materials.
Camera is facing approx. SW.

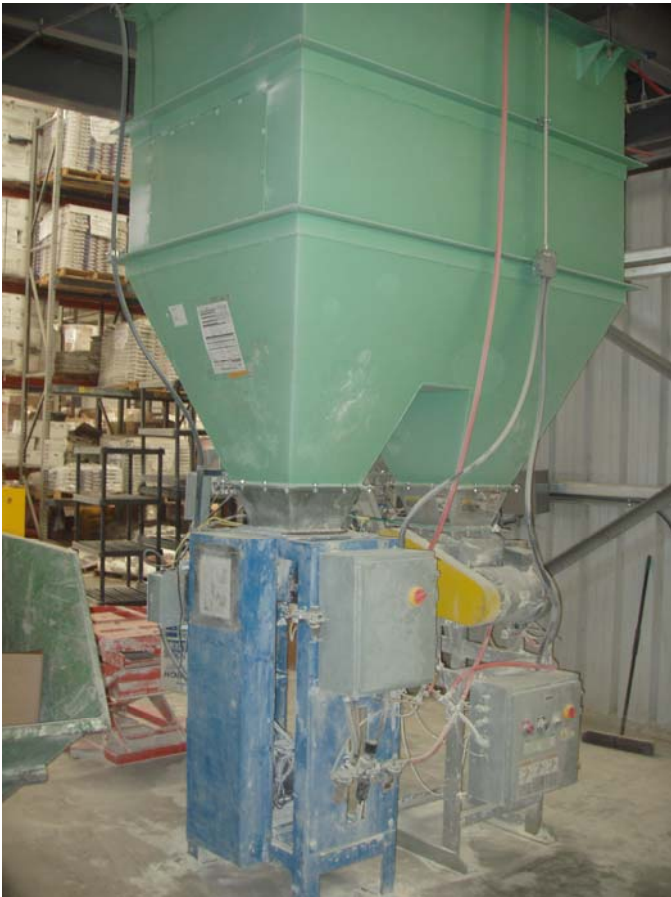
Photo ID No: 1050386_Photo_05_11_2012-005
Time: Approx. 10:45 AM
View of new packing machine, not currently operating.
Camera is facing approx. NE.

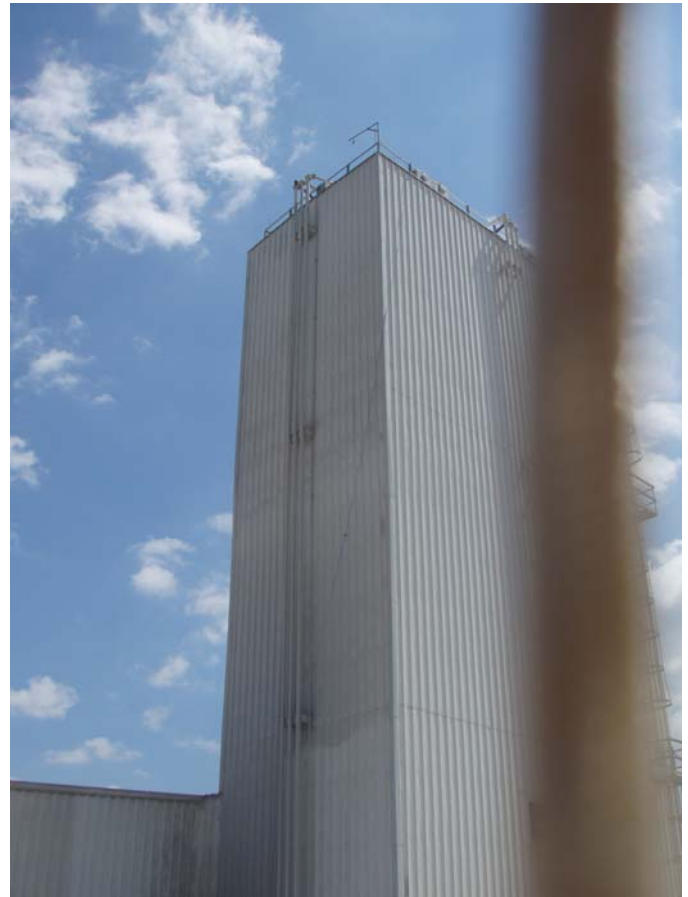
Photo ID No: 1050386_Photo_05_11_2012-015
Time: Approx 11:15 AM
Exterior view of upper West and South sides of tower that contains the nine (9) raw material storage bins. Pipes, which are used to load raw materials into raw material storage bins, are visible on the South and West sides of the building. Bin vents are on top of tower (not visible in photo) and material processing equipment is inside on the bottom of the tower (inside building, not visible in photo). The blurry line in the foreground of the photograph (right side of photo) is the camera strap. Camera is facing approx. NE.

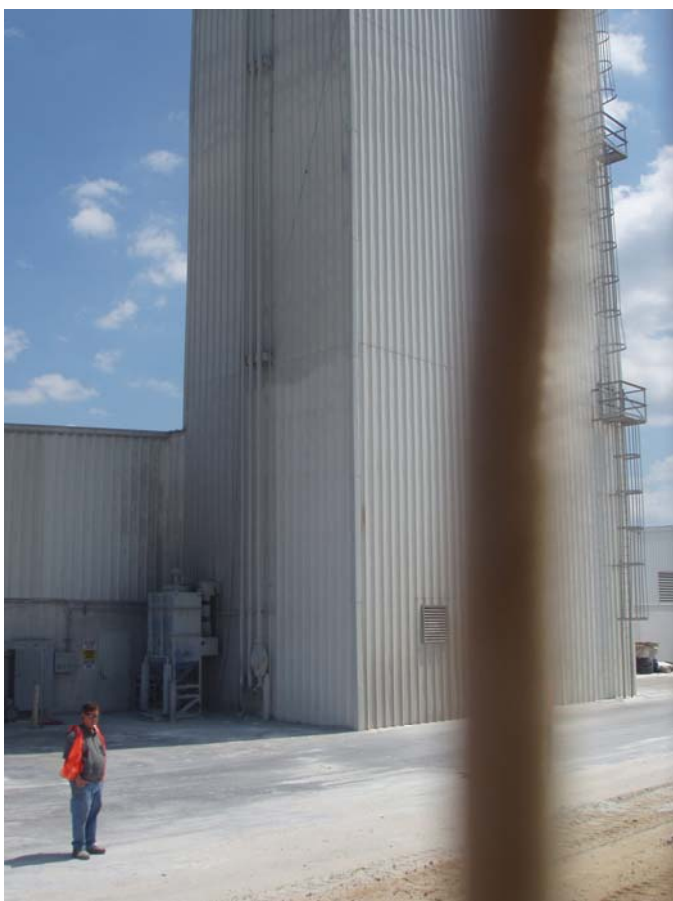
Photo ID No: 1050386_Photo_05_11_2012-016

Exterior view of lower West and South sides of tower that contains the raw material storage bins and material processing equipment. The original dust collector, which collects dust from mixing and packing operations from the original material processing equipment inside the building, is visible next to and East of the tower containing the raw material storage bins. The blurry line in the foreground of the photo (right side of photo) is the camera strap. Camera is facing approx. NE.

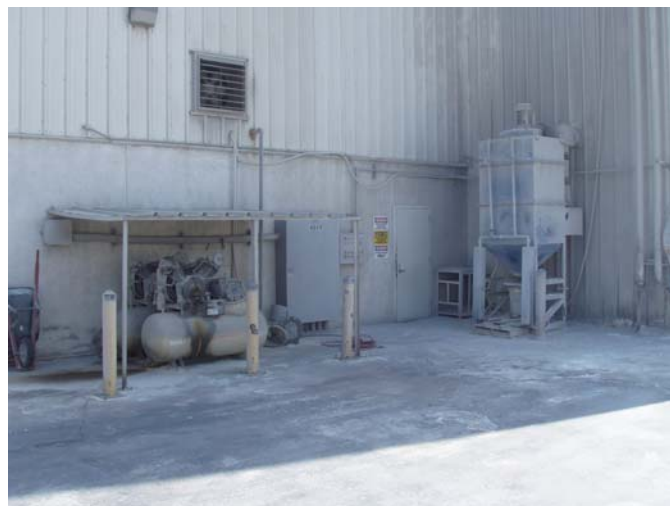
Photo ID No: 1050386_Photo_05_11_2012-014

View of the original dust collector, on the corner of the building, for collecting dust from mixing and packing operations for the original material processing equipment. The dust collector is a Consolidated Stripping and Derusting, Model 4500 CFM dust collector. Camera is facing approx. NE.

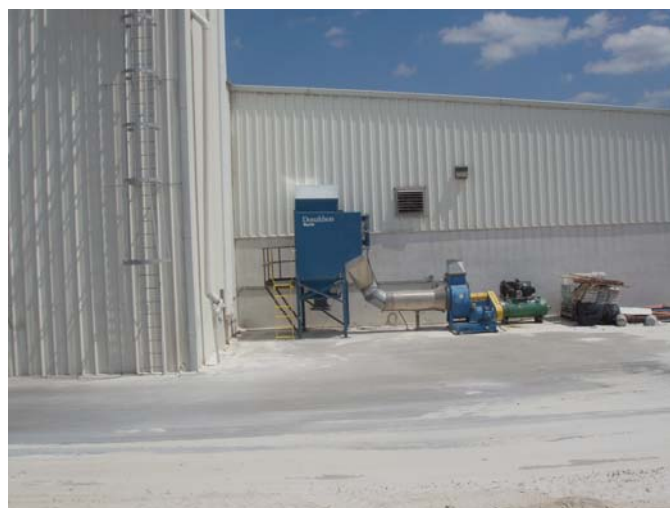
Photo ID No: 1050386_Photo_05_11_2012-017

View of the new dust collector (not currently operating) for the new material processing equipment. This dust collector is located East of the tower that contains the raw material storage bins. Camera is facing approx. N.

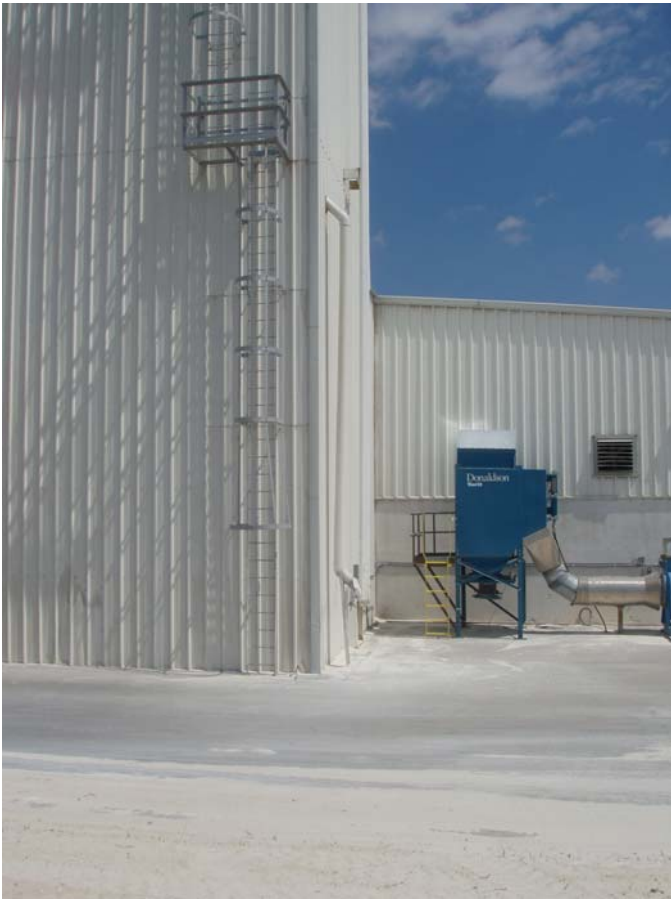
Photo ID No: 1050386_Photo_05_11_2012-018
Time: Approx. 11:30 AM
View of new dust collector (not currently operating) and lower South and East sides of tower containing raw material storage bins. Camera is facing approx. N.

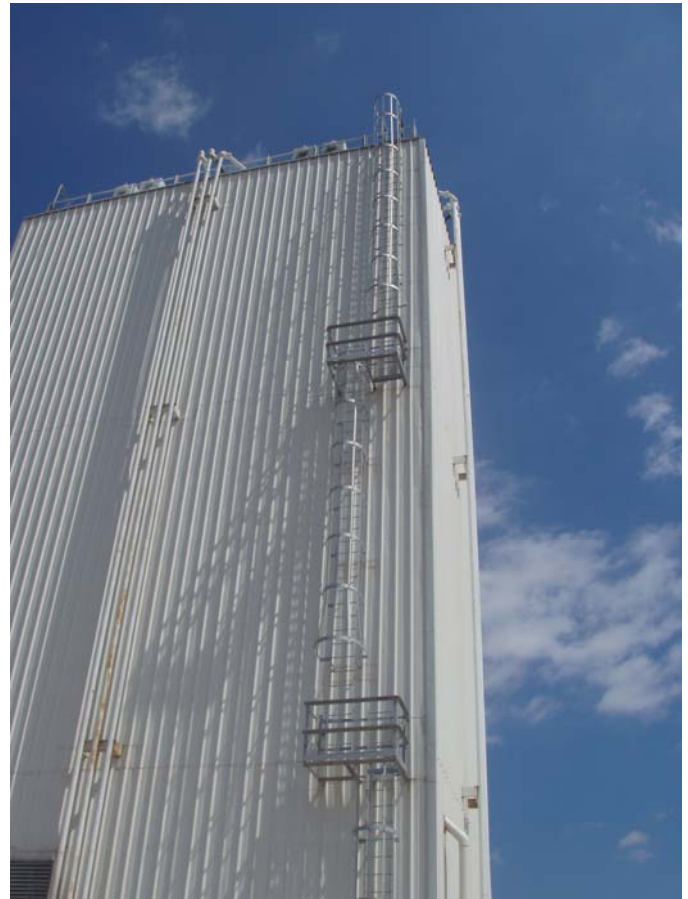
Photo ID No: 1050386_Photo_05_11_2012-019
Time: Approx. 11:30 AM
View of upper South and East sides of tower containing raw material storage bins. Pipes, which are used for loading raw materials into raw material storage bins, are visible on the South and East sides of the building. Camera is facing approx. N.
