DIGITAL PHOTOGRAPHIC LOG

1. **Facility Name:** Robbins Manufacturing Co.
2. **County / AIRS ID No:** Sumter County / 1190011
3. **Inspection Type:** INS2 and Full Compliance Evaluation (FCE).
4. **Inspection Date:** 03/01/2012
5. **Date Photographic Log was completed:** 03/08/2012
6. **Camera Used:** Olympus Camedia Digital Camera, 5.0 Megapixel, C-50 ZOOM, S/N 115248297.
7. **Recording Media:** FUJIFILM xD-Picture Card, 128 MB, S/N DPC-128, R31695 5RZ7, 0244 MAD.
8. **All Digital Photos Were Copied To:** Hard Disk of Computer DEP 143271 and to this Digital Photographic Log.
9. **Original Copy Is Stored In/On:** Hard disk of computer DEP 143271.
10. **Were the photos altered?:** NO X YES _____ explain yes:
11. **Photographer:** Amaury Betancourt
12. **Signature of Photographer:** _____

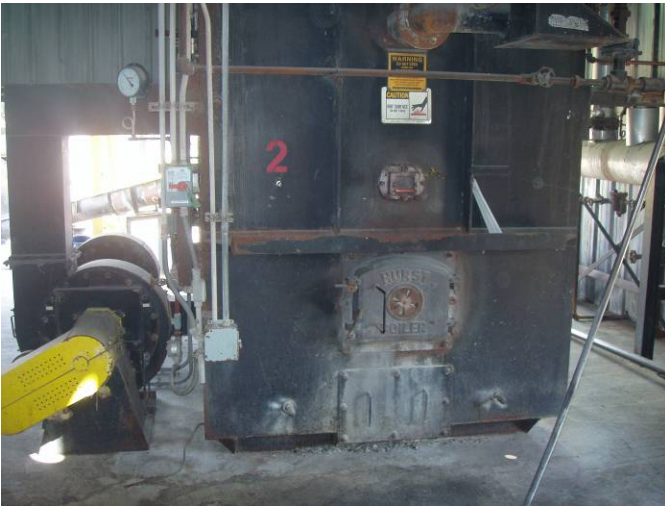
Photo ID No: 1190011_Photo_03_01_2012-001
Time: Approx. 13:45
The Hurst Boiler operating at the facility. The Hurst boiler began operating in December 2011 after the ABCO boiler was damaged due to a power outage that severely damaged the ABCO boiler. The ABCO Boiler (not visible; behind camera) was not operational during the site inspection. The Florida Department of Environmental Protection (FDEP) was to be notified as soon as possible when the Hurst boiler was started up, and a visible emissions (VE) test was to be scheduled to occur within 30 days of starting up and operating the Hurst boiler. These notifications did not occur. It is important to note, nevertheless, that the ABCO boiler and the Hurst boiler have not been operating simultaneously. The camera is facing approx. ESE.

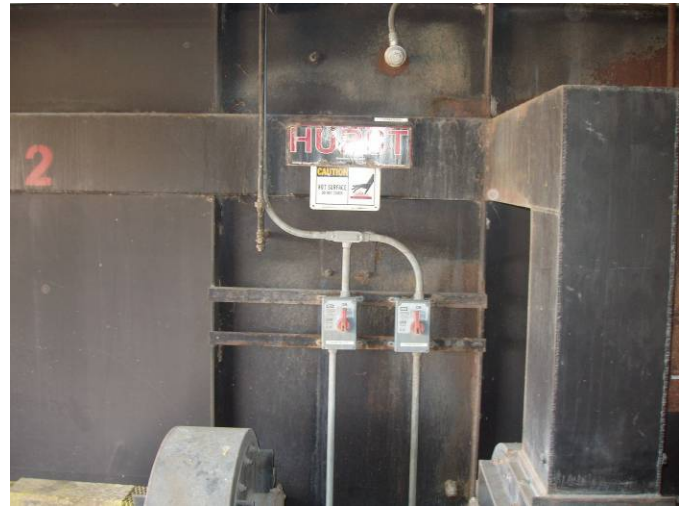
Photo ID No: 1190011_Photo_03_01_2012-002
Time: Approx. 13:45
The Hurst Boiler operating at the facility. The camera is facing approx. S.

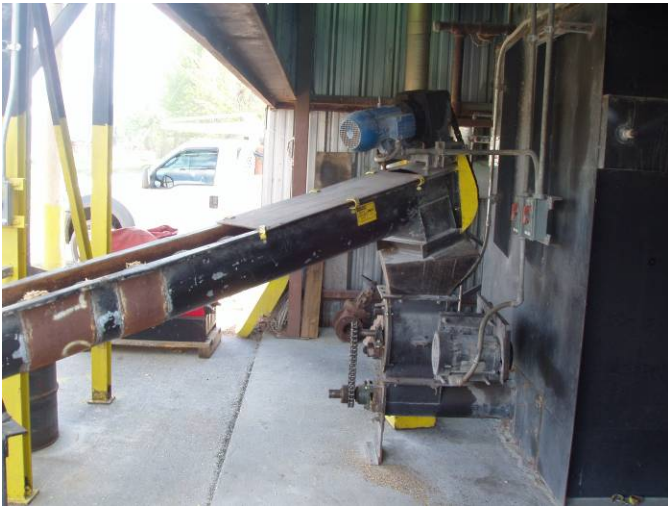
Photo ID No: 1190011_Photo_03_01_2012-003
Time: Approx. 13:45
Auger transporting sawdust for combustion in the Hurst Boiler. The camera is facing approx. S.

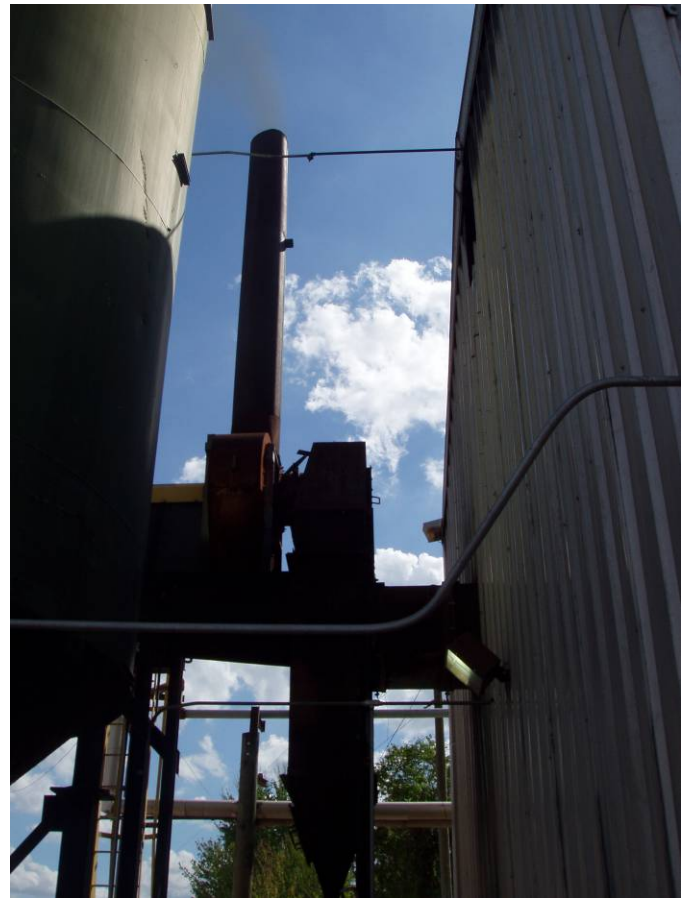
Photo ID No: 1190011_Photo_03_01_2012-005
Time: Approx. 14:00
Stack from Hurst Boiler, visible in between the sawdust storage silo and the building containing the Hurst and ABCO boilers. This stack is located on the East side of the building. Next to and below the stack is the Hurst multicyclone collector, which collects particulate matter from the exhaust of the boiler and transfers the particulate matter into a drum (as described in a diagram from air construction permit 1190011-003-AC). The camera is facing approx. S.

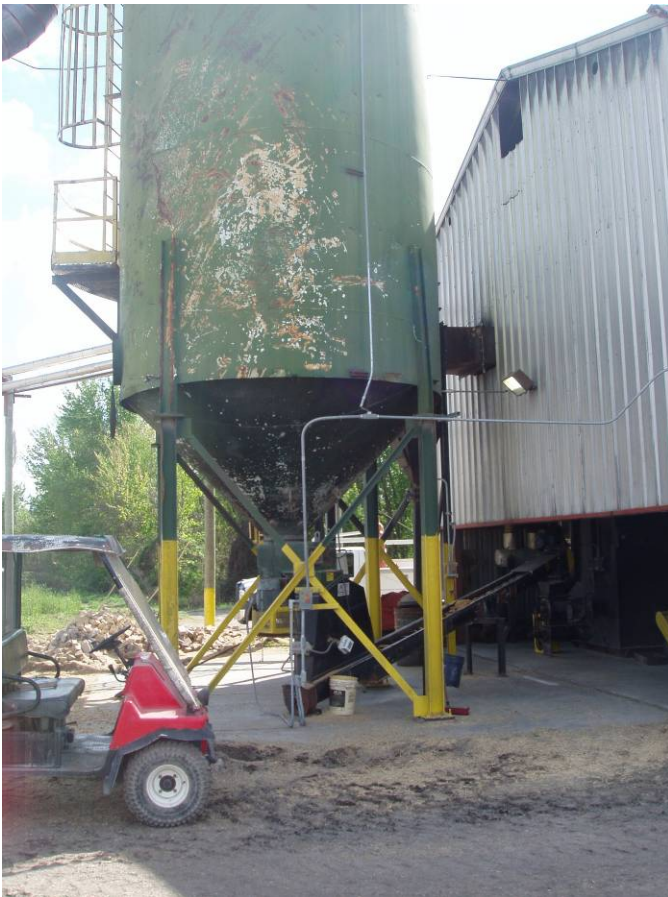
Photo ID No: 1190011_Photo_03_01_2012-004
Time: Approx. 14:00
Sawdust storage silo with auger below to transport sawdust for combustion in the Hurst Boiler. The camera is facing approx. S.

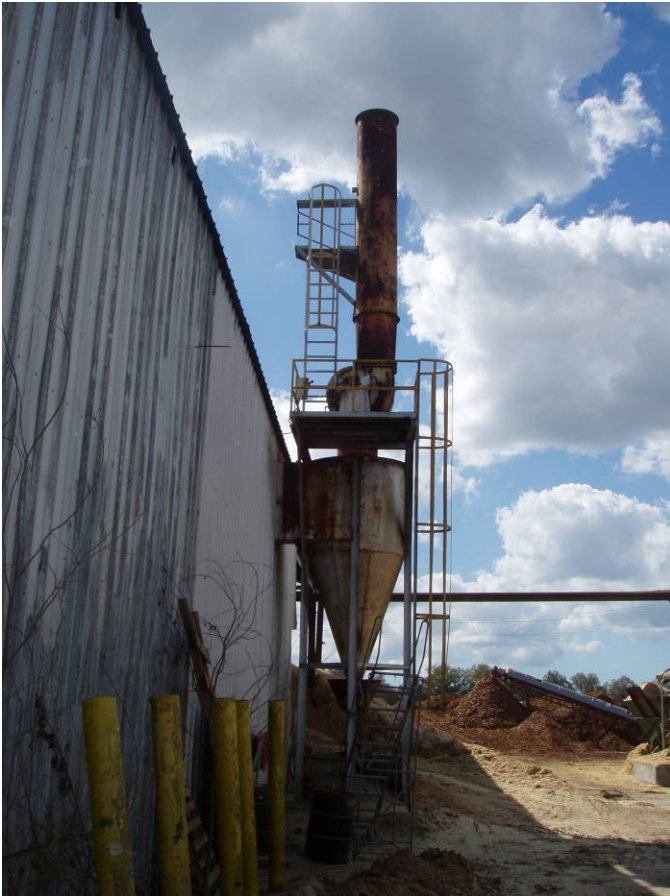
Photo ID No: 1190011_Photo_03_01_2012-006
Time: Approx. 14:00
Stack from ABCO Boiler. The ABCO boiler was being repaired during the inspection and was not operating. The stack is located on the North side of the building that houses the Hurst and ABCO boilers. The camera is facing approx. W.

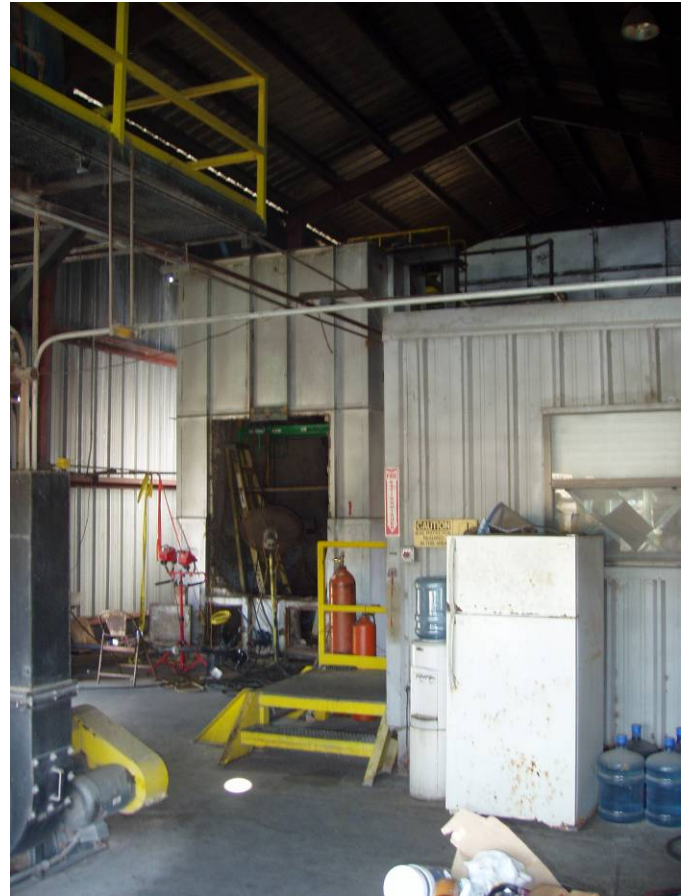
Photo ID No: 1190011_Photo_03_01_2012-007
Time: Approx. 14:00
View of the ABCO boiler and control room for the Hurst and ABCO boilers. The yellow steps lead to the control room. During the site inspection, the ABCO Boiler was in the process of being repaired. In the photograph, the ABCO boiler is the structure with an opening, next to two red tanks. The camera is facing approx. SW.

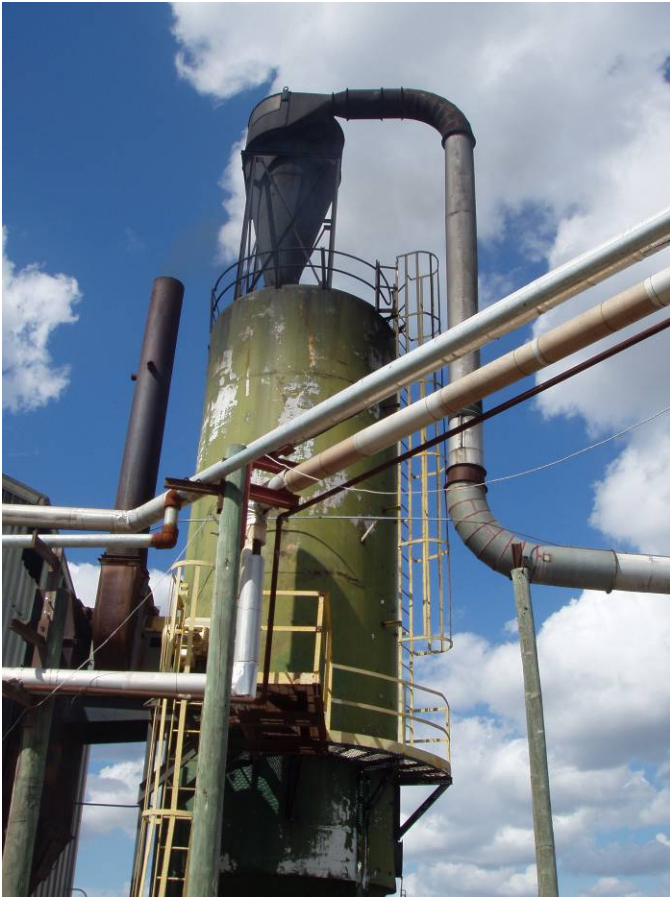
Photo ID No: 1190011_Photo_03_01_2012-008
Time: Approx. 14:15
South face of the sawdust storage silo (green) for the Hurst Boiler and the stack (brown/black) from the Hurst boiler. Pipe lines carry sawdust generated from woodworking operations to the cyclone on top of the sawdust storage silo. The cyclone controls particulate matter emissions from the sawdust storage and transfer operations. Steam generated from the Hurst boiler travels in pipe lines to the kilns, and these steam lines are visible in the foreground of this photograph. The camera is facing approx. N.

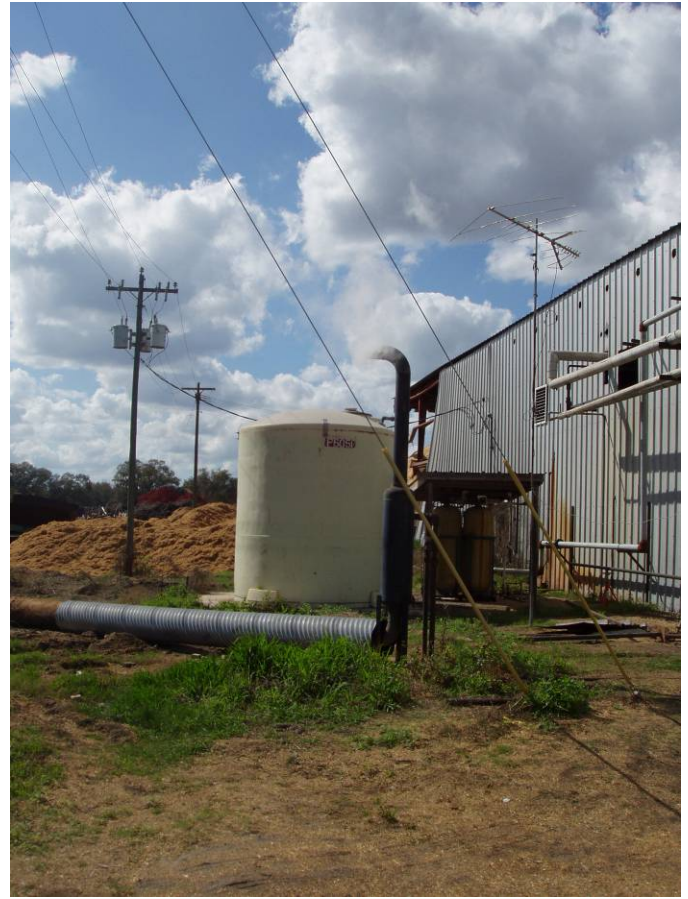
Photo ID No: 1190011_Photo_03_01_2012-009
Time: Approx. 14:15
Blowdown pipe for #####. Camera is facing approx. W.

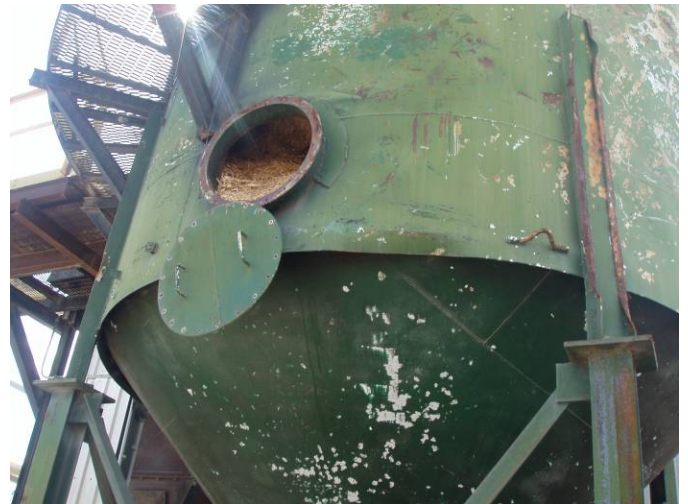
Photo ID No: 1190011_Photo_03_01_2012-010
Time: Approx. 14:15
Hatch for loosening sawdust on East side of sawdust storage silo for the Hurst Boiler. The camera is facing approx. SW.

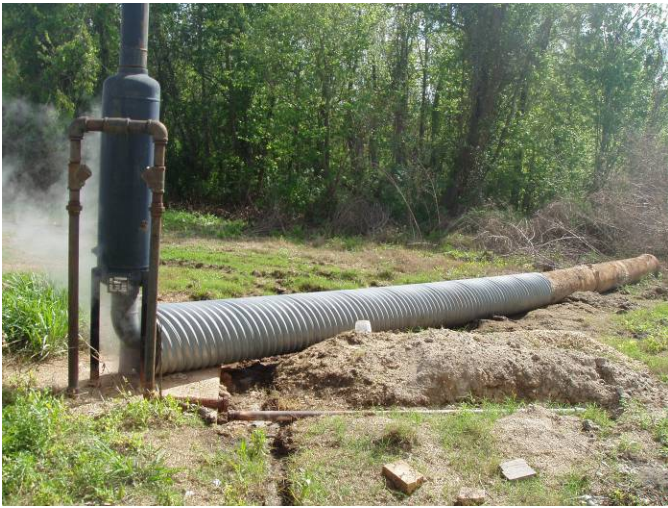
Photo ID No: 1190011_Photo_03_01_2012-011
Time: Approx. 14:15
Blowdown pipe for #####. The camera is facing approx. SW.

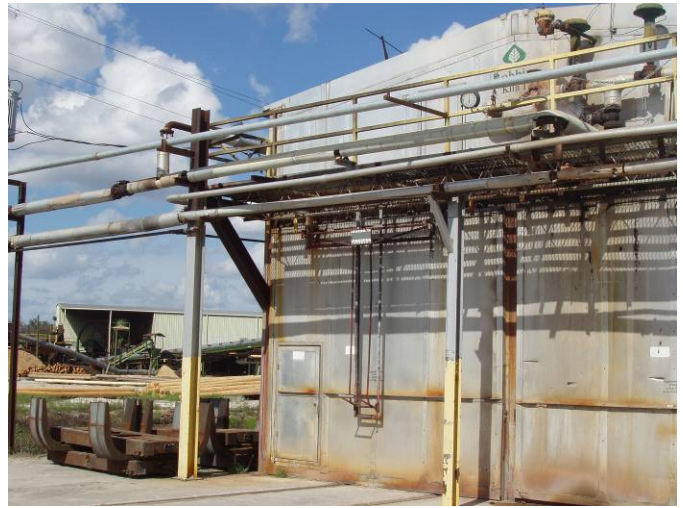
Photo ID No: 1190011_Photo_03_01_2012-013
Time: Approx. 14:30
Kiln 1, EU003 (northeast), used for heat treating lumber.
The camera is facing approx. N.

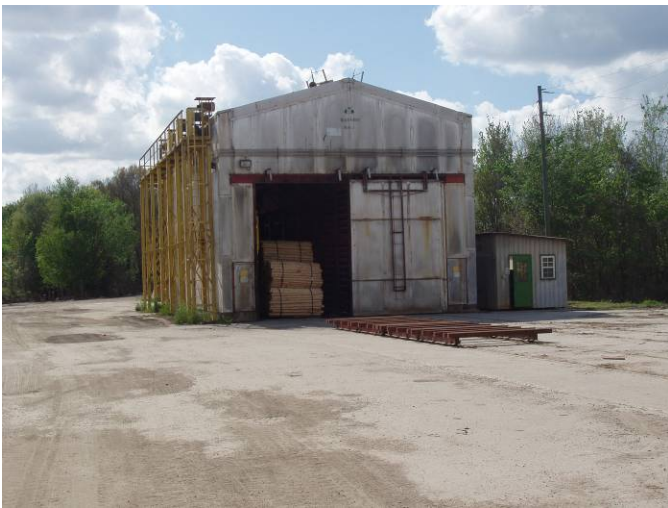
Photo ID No: 1190011_Photo_03_01_2012-012
Time: Approx. 14:30
Kiln 2, emission unit (EU) EU004 (southwest), used for heat treating lumber. The camera is facing approx. W.

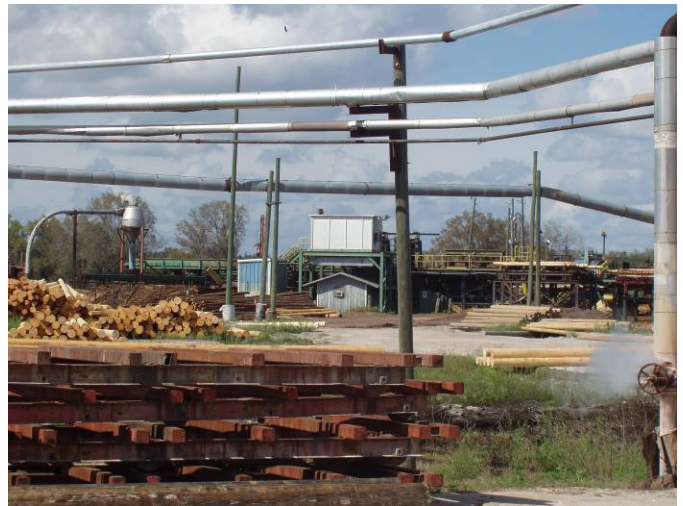
Photo ID No: 1190011_Photo_03_01_2012-014
Time: Approx. 14:30
View of pole manufacturing line in background of photo.
The camera is facing approx. NW.

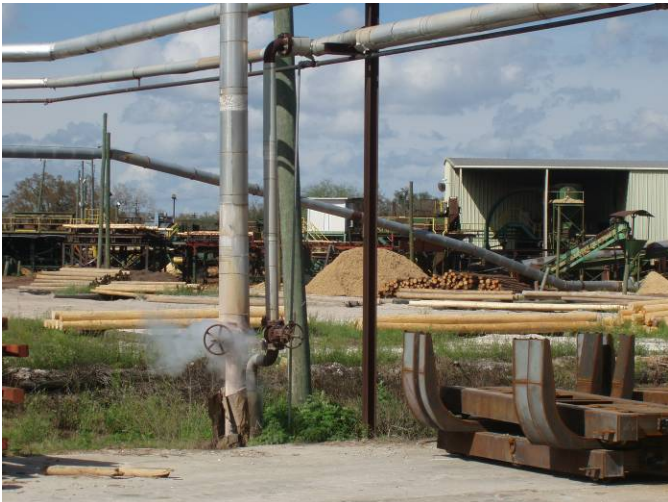
Photo ID No: 1190011_Photo_03_01_2012-015
Time: Approx. 14:30
View of building (background of photo) for manufacturing fencepost and view of pole manufacturing line (around building, background of photo). The camera is facing approx. N.

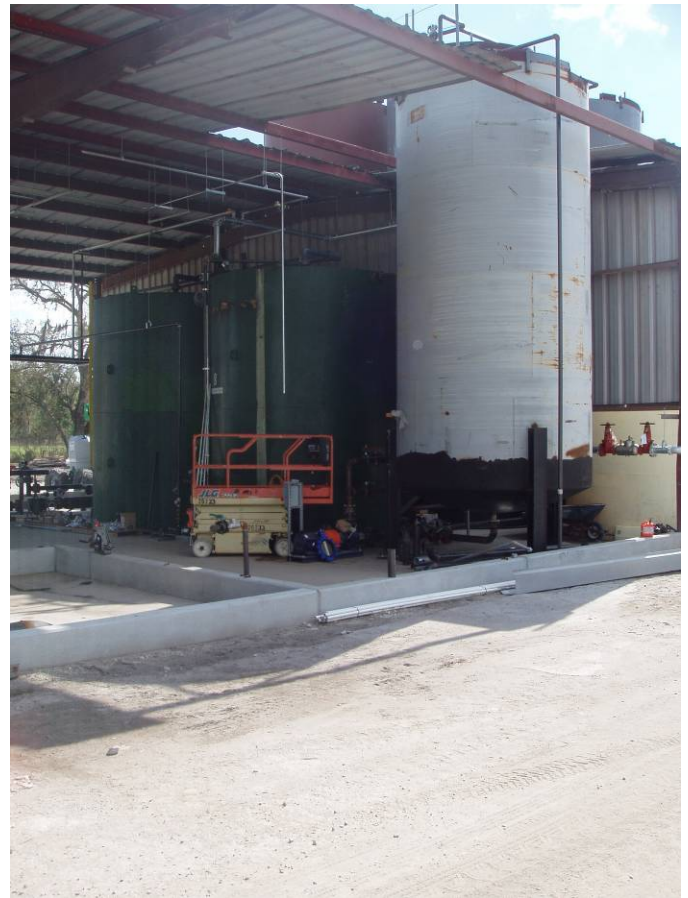
Photo ID No: 1190011_Photo_03_01_2012-017
Time: Approx. 14:45
Construction operations for lumber pressure treatment facility on site of Robbins Manufacturing Co. in Tarrytown, FL (Sumter County). This construction operation does not currently have an air construction permit.

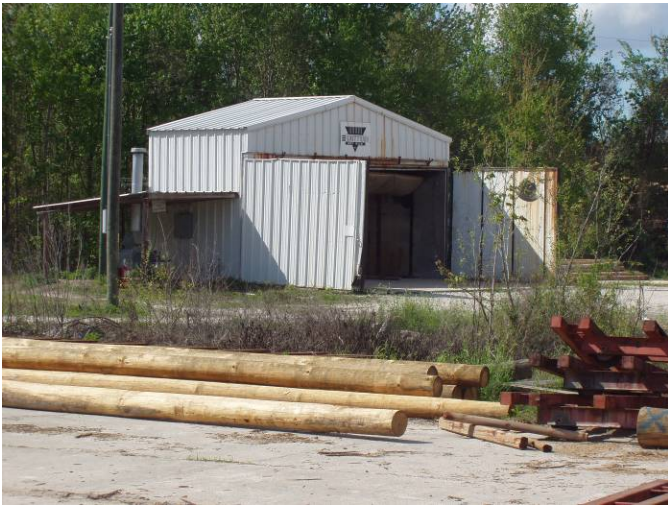
Photo ID No: 1190011_Photo_03_01_2012-016
Time: Approx. 14:45
Dry Kiln located just Northwest of Kiln 2 (EU002, southwest Kiln). The camera is facing approx.W.
