DIGITAL PHOTOGRAPHIC LOG

Facility Name: Cemex (Eaton Park, Lakeland, FL)

Inspection Type/Date: INS2: Facility Walkthrough and Visible Emissions (VE) Test Audit

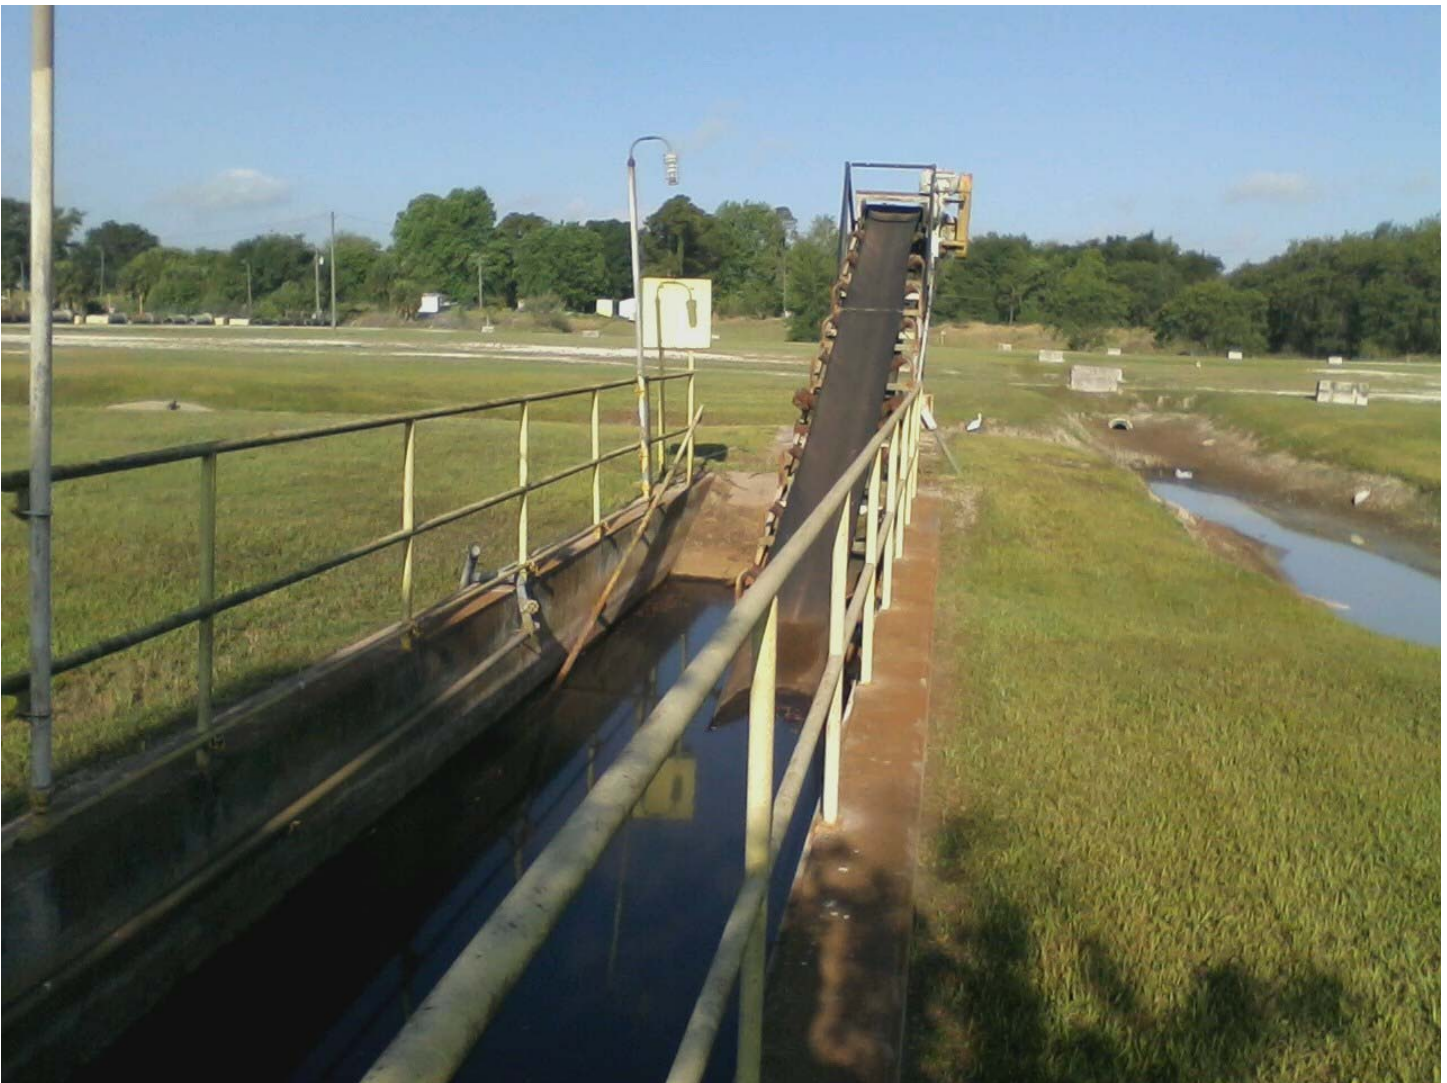
Photo ID No: 1050073_Photo_05_02_2012-001

View of conveyor belt and open channel, which is filled with dark and filmy water. Open channel is on the property of Cemex, but has never been used by Cemex since it was left by the previous property owner's facility. Camera is facing Approx. West.

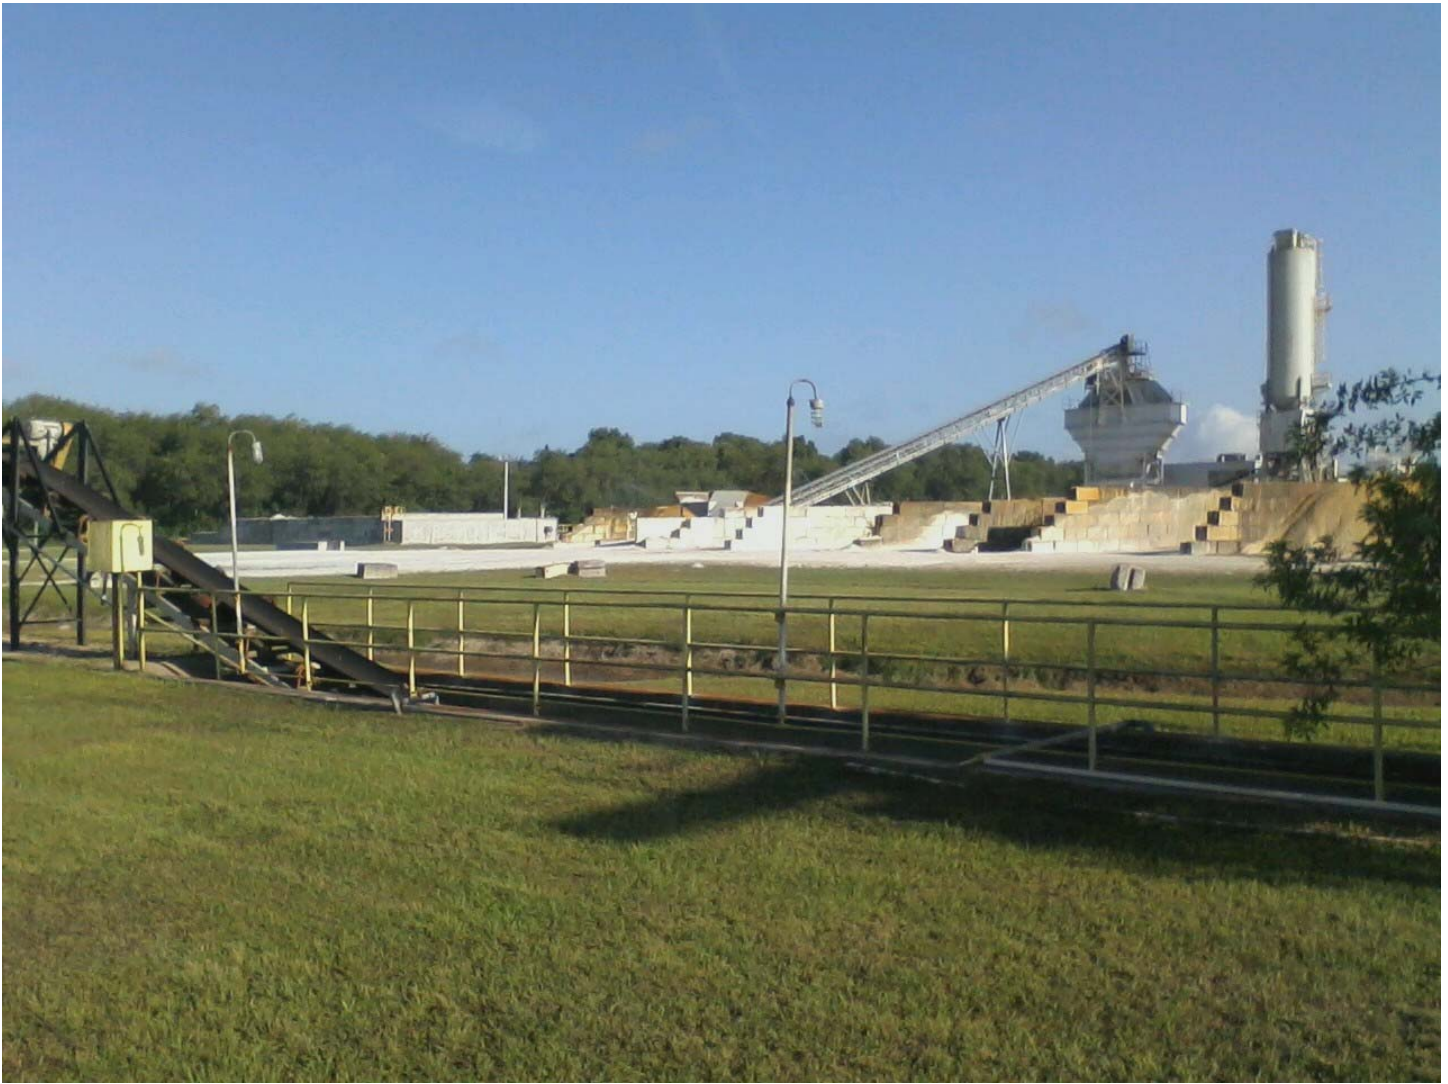
Photo ID No: 1050073_Photo_05_02_2012-002

View of conveyor belt and open channel, which is filled with dark and filmy water. Camera is facing Approx. Northwest.
