DIGITAL PHOTOGRAPHIC LOG

Facility Name: Cemex Four Corners (Davenport) Ready Mix and Block Plant

Facility ID No: 1050350 County: Polk Inspection Type/Date: INS3 / 01-24-2012 Page 1 of 4

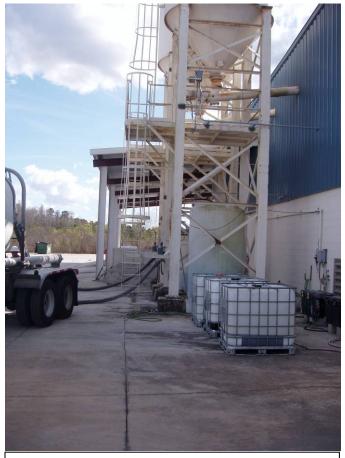
Photo ID No: 1050350_Photo_01_24_2012-1

The North silo (front silo in photo) is EU006, also listed as silo #2, and was filled with white cement. The South silo (back silo in photo) is EU005, also listed as silo #1, and was filled with grey cement. Camera facing approx. S.

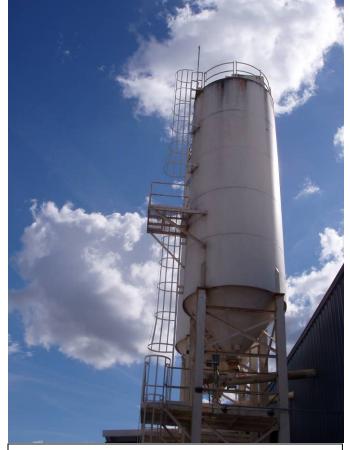
Photo ID No: 1050350_Photo_01_24_2012-3

View of North silo (EU006) with South silo (EU005)

behind. Camera facing approx. S.

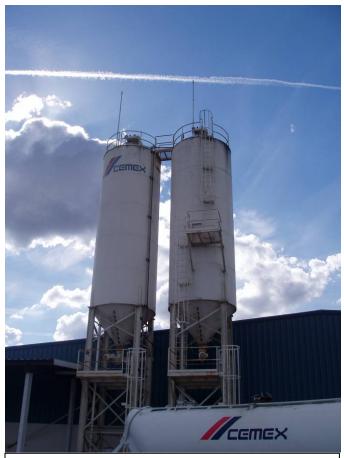
Photo ID No: 1050350_Photo_01_24_2012-15

View of both the North silo (EU006) and the South silo

(EU005), camera facing approx. W.

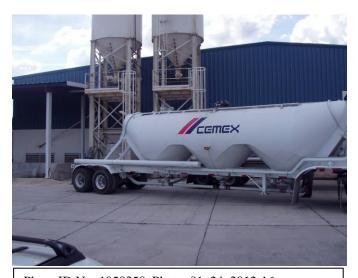
Photo ID No: 1050350_Photo_01_24_2012-16

View of truck loading grey cement into South silo (EU005), camera facing approx. W. The white cement truck is behind the grey cement truck in the photograph.

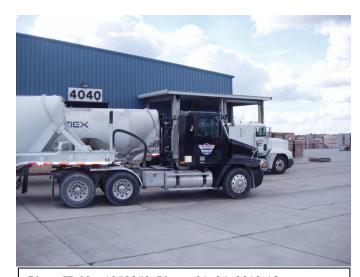
Photo ID No: 1050350_Photo_01_24_2012-18

Grey cement truck is in foreground of photo and white cement truck is visible behind grey cement truck; camera

facing approx. NW.

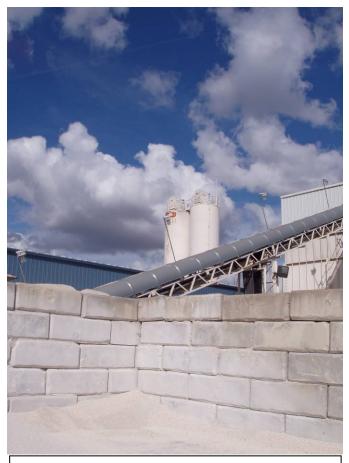
Photo ID No: 1050350_Photo_01_24_2012-7

Approximate view from where VE tests were conducted for EU005 and EU006; camera facing approx. NE.

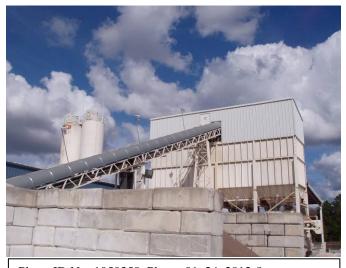
Photo ID No: 1050350_Photo_01_24_2012-8

View of silos from approximate perspective of where VE tests were conducted for EU005 and EU006; camera

facing approx. ENE.

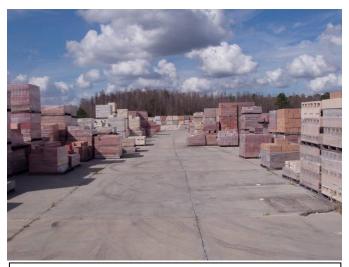
Photo ID No: 1050350_Photo_01_24_2012-6

Some of the manufactured products stored at the facility,

North side of the facility; camera facing approx. N.

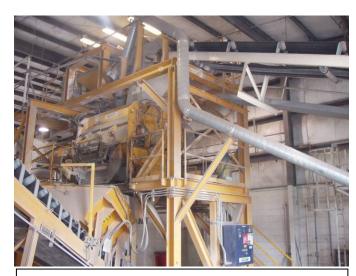
Photo ID No: 1050350_Photo_01_24_2012-12

Weighing and batching operations located inside the building at the facility; camera facing approx. NE. Silos are outside the building, just behind this equipment.

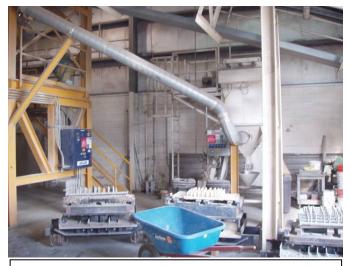
Photo ID No: 1050350_Photo_01_24_2012-11

Some weighing and batching equipment located inside the building at the facility; camera facing approx. ENE.

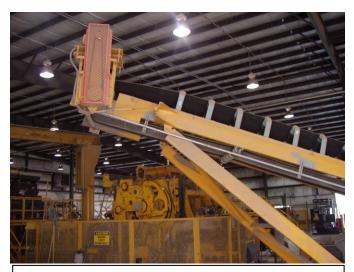
Photo ID No: 1050350_Photo_01_24_2012-14

Top of the conveyor belt that is part of the weighing and batching equipment inside the building at the facility;

camera facing approx. NW.

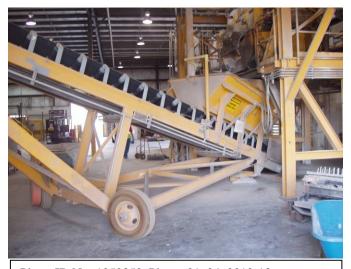
Photo ID No: 1050350_Photo_01_24_2012-13

Conveyor belt that is part of the weighing and batching equipment inside the building at the facility; camera

facing approx. N.

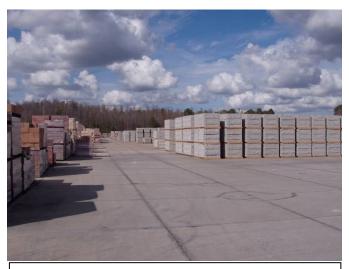
Photo ID No: 1050350_Photo_01_24_2012-4

Some of the manufactured products at the facility; camera

facing approx. N.
