DIGITAL PHOTOGRAPHIC LOG

1. Facility Name: Hernando County Animal
2. County / AIRS ID No: 0530365
3. Inspection Type: INS 2
4. Inspection Date: 09/28/2012
5. Date Photographic Log was completed: 10/16/2012
6. Type of Camera Used: Canon Power Shot SD400 Digital ELPH
7. Digital Recording Media: ScanDisk 256 MB SD Card
8. All Digital Photos Were Copied To: Hard Disk of Computer 143986 and to Digital Photographic Log
9. Original Copy Is Stored In/On: Hard disk of computer 143986
10. Were the photos altered?: NO ___ YES XXX explain yes: photo sizes were reduced to fit in this log.
11. Photographer: Wendy D. Akins
12. Signature of Photographer: _____

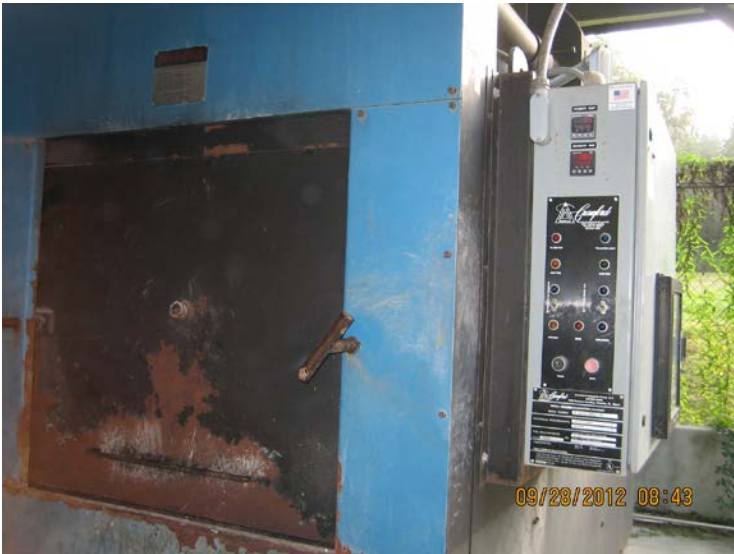
Photo ID No: IMG_435 - photo shows front view of cremation unit. The unit is a Crawford C700P cremation unit.

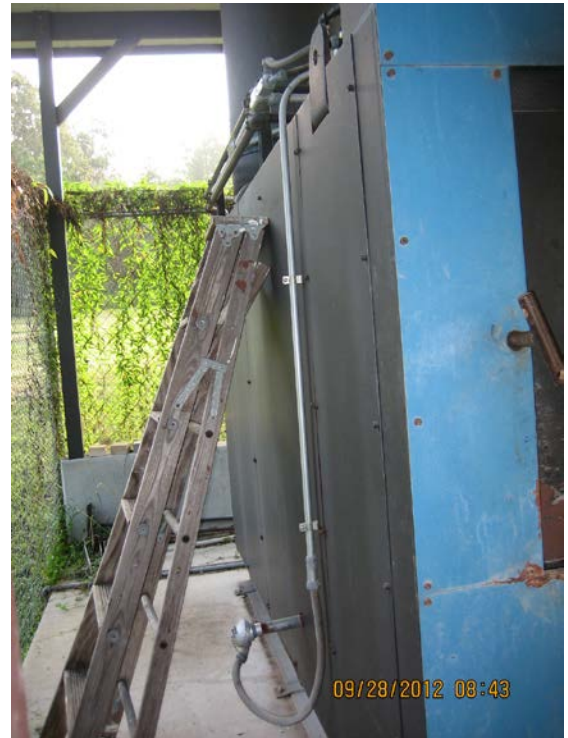
Photo ID No: IMG_436 – Primary Chamber thermocouple located on left side of cremation unit.

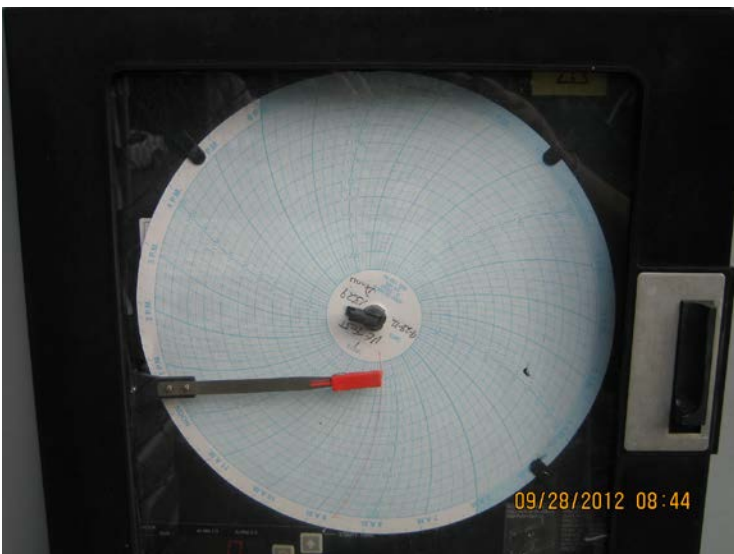
Photo ID No: IMG_437 – View of chart record in place. Cremation unit warming up. This unit is capable of burning 350lbs. per hour.

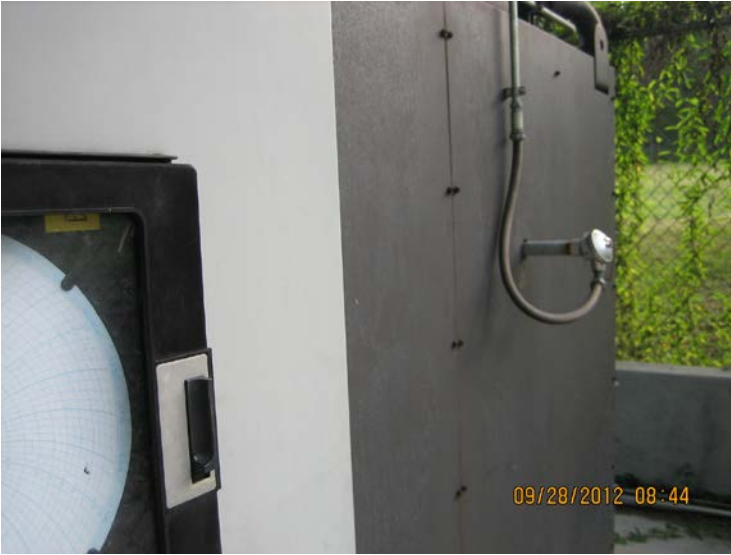
Photo ID No: IMG_438 – Photo shows secondary chamber thermocouple placement on the right side of the cremation unit.

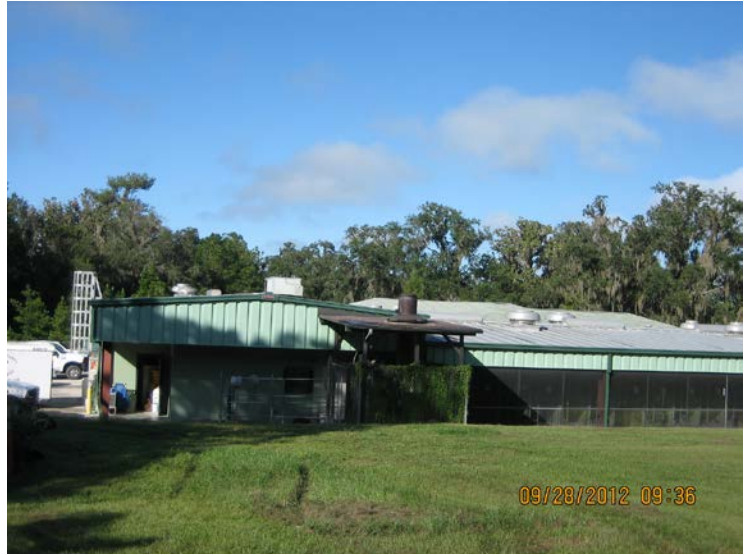
Photo ID No: IMG_442 – This photo shows view from the VE observation point. The cremation unit was in operation when this photo was taken.

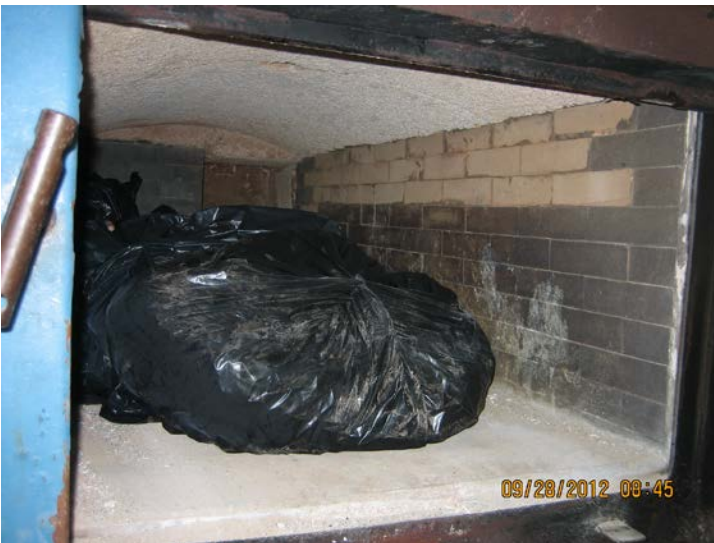
Photo ID No: IMG_439 – This facility does use bag containers during cremation. This photo was taken as the unit was being loaded for the Visible Emissions Testing.

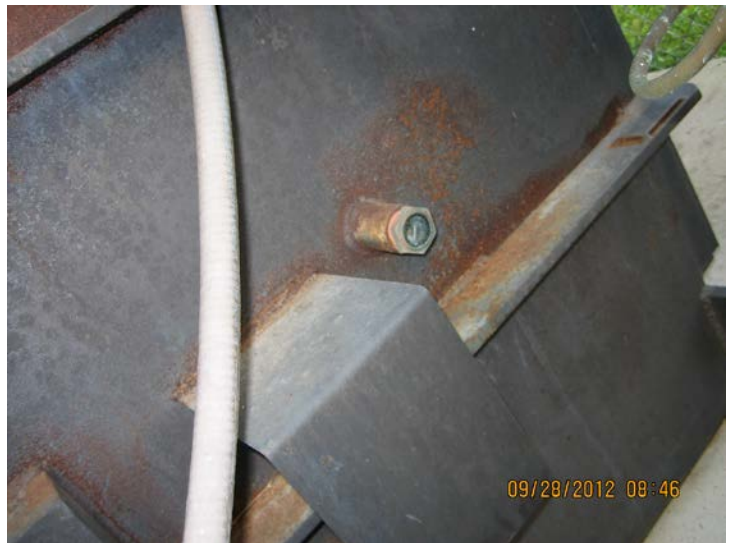
Photo ID No: IMG_441 – This photo shows the flame view port on the back of the cremation unit.
