- 1. Facility Name: Crush-It, Inc.
- 2. County / AIRS ID No: Polk County / Facility ID 7775229
- 3. Inspection Type: INS2 with VE Test Audit
- 4. Inspection Date: 09/27/2012
- 5. Date Photographic Log was completed: 10/22/2012
- 6. Camera Used: Canon Power Shot 5.0 mega pixels A530 (Air Section digital camera).
- 7. Recording Media: Canon 16 MB MultiMediaCard.
- 8. All Digital Photos Were Copied To: Hard Disk of Computer DEP 143271 and on this Digital Photographic Log.
- 9. Original Copy Is Stored In/On: Hard Disk of Computer DEP 143271.
- 10. Were the photos altered?: NO_X_YES____ explain yes:
- 11. Photographer: Amaury Betancourt
- 12. Signature of Photographer:_

Facility Name: Crush-It, Inc.; Facility ID No: 7775229; County: Polk County, FL Inspection Type/Date: INS2 with VE Test audit on 09/27/2012

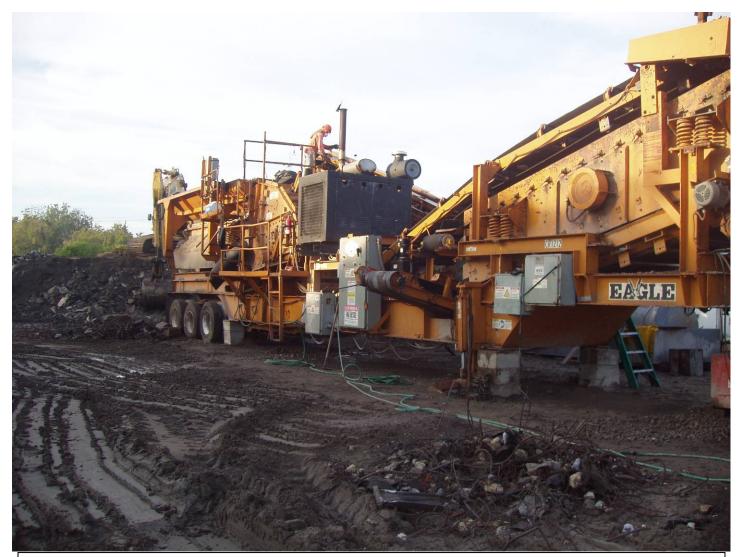
Photo ID No: 7775229_Photo_1_of_11_on_09_27_2012; **Date:** 09/27/2012; **Time:** Approx. 08:30 AM. Eagle crusher. In foreground is the conveyor belt above the screener and leading to the screener entrance, and in the background, behind the man in the photo, is the crusher and crusher hopper. The camera is facing approx. SW.

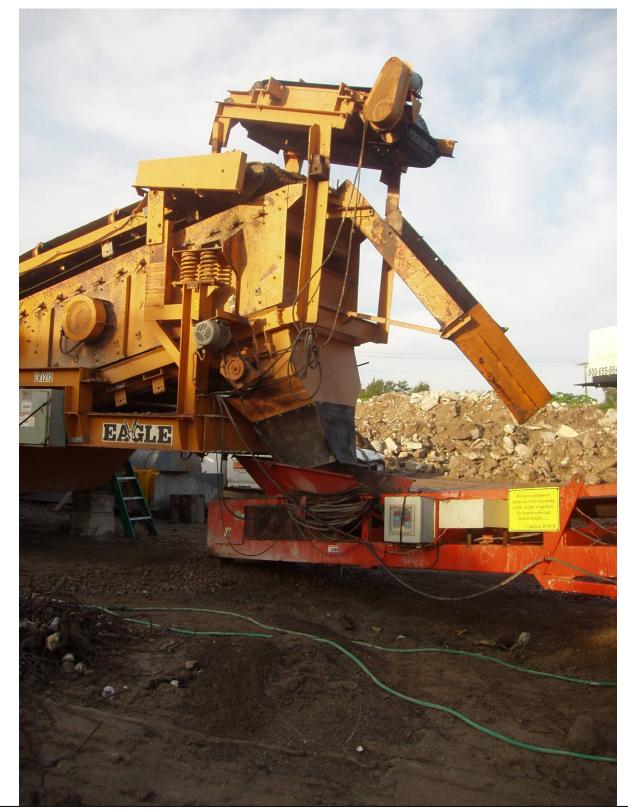
Photo ID No: 7775229_Photo_2_of_11_on_09_27_2012; **Date:** 09/27/2012; **Time:** Approx. 08:30 AM. Eagle crusher, view of screener. At center of photograph is drop from screener to conveyor belt. Also visible near the top of the photograph is the magnetic belt for removing magnetic metal material, which goes down the chute and onto a metals pile. The camera is facing approx. SW.

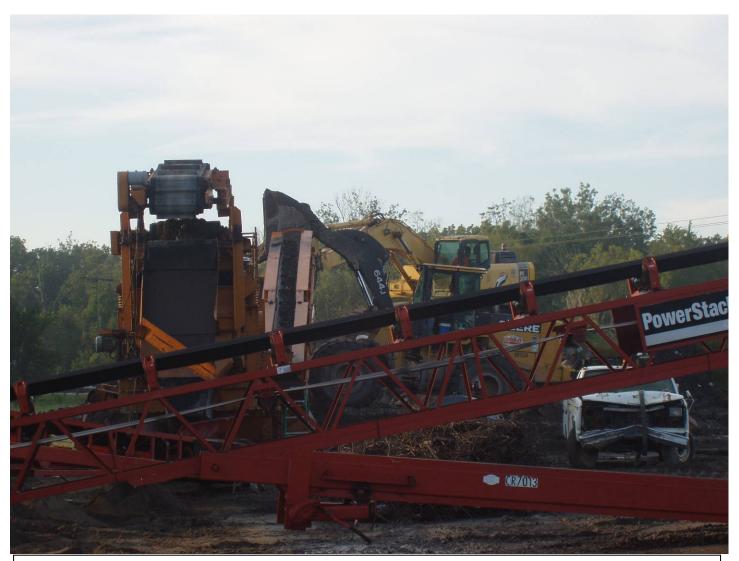
Photo ID No: 7775229_Photo_3_of_11_on_09_27_2012; **Date:** 09/27/2012; **Time:** Approx. 08:30 AM. Crushing operation. The camera is facing approx. S. In the background is the excavator, which loosens up the material to be crushed so that the front-end loader, also visible in the background, can load the crusher hopper. From the screener exit (visible with magnetic belt on top), the product drops to one conveyor belt (barely visible in photograph), then drops onto the conveyor belt (foreground) that leads to the product pile (not visible).

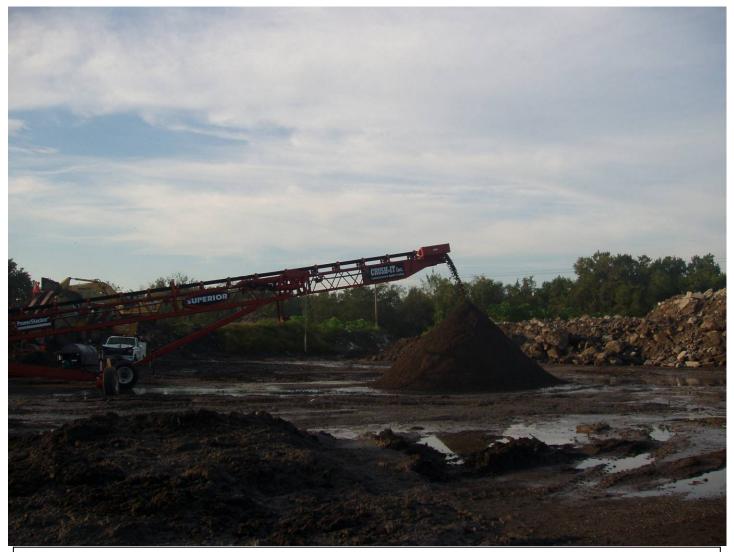
Photo ID No: 7775229_Photo_4_of_11_on_09_27_2012; Date: 09/27/2012; Time: Approx. 08:30 AM. View of conveyor belt to product pile. The camera is facing approx. SW.

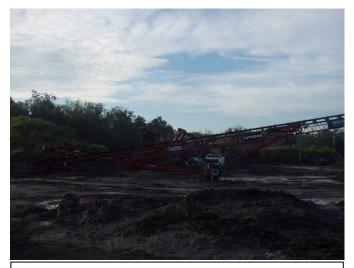
Photo ID No: 7775229_Photo_5_of_11_on_09_27_2012; **Date:** 09/27/2012; **Time:** Approx. 08:30 AM. View of conveyor belt to product pile (pile not visible). The camera is facing approx. S.

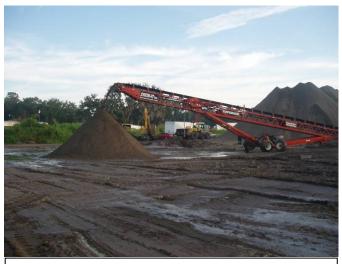
Photo ID No: 7775229_Photo_7_of_11_on_09_27_2012; Date: 09/27/2012; Time: Approx. 08:30 AM. View of product pile. The camera is facing approx. NE.

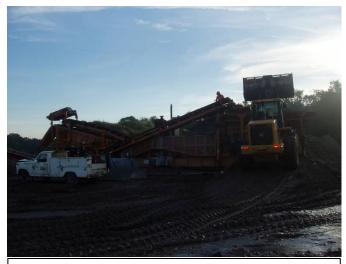
Photo ID No: 7775229_Photo_6_of_11_on_09_27_2012; **Date:** 09/27/2012; **Time:** Approx. 08:30 AM. View of front end loader loading crusher hopper. The camera is facing approx. ENE.

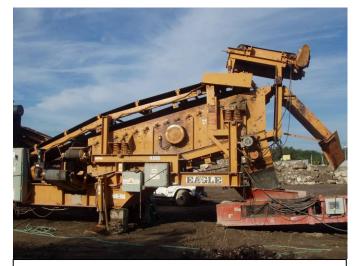
Photo ID No: 7775229_Photo_8_of_11_on_09_27_2012; Date: 09/27/2012; Time: Approx. 08:30 AM. Close-up of screener. The camera is facing approx. WSW.

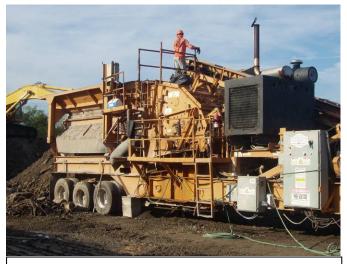
Photo ID No: 7775229_Photo_9_of_11_on_09_27_2012; **Date:** 09/27/2012; **Time:** Approx. 08:30 AM. Close-up of crusher and crusher engine. Man is standing above crusher compartment. Closer to the foreground of the photograph is the crusher engine, which looks like a black box with a small stack. The camera is facing approx. SW.

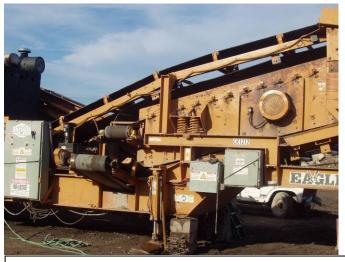
Photo ID No: 7775229_Photo_11_of_11_on_09_27_2012; **Date:** 09/27/2012; **Time:** Approx. 08:30 AM. Close-up of right side (East side) of screener (front side assumed to be exit of screener). The camera is facing approx. SW.

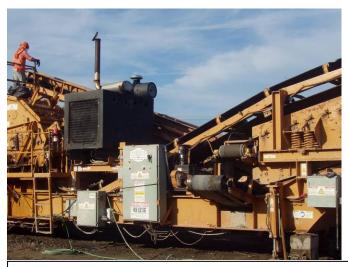
Photo ID No: 7775229_Photo_10_of_11_on_09_27_2012; **Date:** 09/27/2012; **Time:** Approx. 08:30 AM. View of right side (East side) of crusher system (front side assumed to be exit of screener) with crusher engine visible. The camera is facing approx. SW.
