DIGITAL PHOTOGRAPHIC LOG

1. Facility Name: Hanson Hardscape Products, Inc.
2. County / AIRS ID No: Polk / 1050372
3. Inspection Type: INS3: Site inspection and audit of visible emissions (VE) tests.
4. Inspection Date: 01/24/2012
5. Photo log completed: 02/03/2012
6. Type of Camera Used: Olympus Camedia Digital Camera, 5.0 Megapixel, C-50 ZOOM, S/N 115248297
7. Digital Recording Media: FUJIFILM xD-Picture Card, 128 MB, S/N DPC-128, R31695 5RZ7, 0244 MAD
8. All Digital Photos Were Copied To: Hard drive of desktop computer DEP 143271. Some photos are on this Digital Photographic Log, but many photos are redundant so have been left out of photo log.
9. Original Copy Is Stored In/On: Hard drive of desktop computer DEP 143271.
10. Were the photos altered?: NO X YES _____ explain yes:
11. Photographer: Amaury Betancourt
12. Signature of Photographer: _____

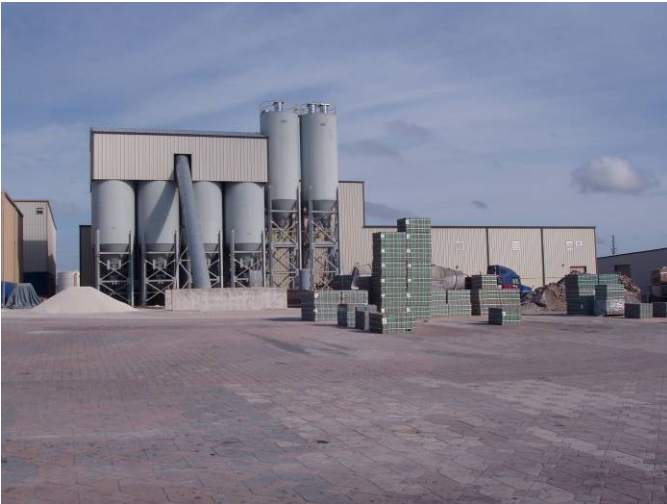
Photo ID No: 1050372_Photo_01_24_2012-1;
Time: Approx. 10:15 AM
View of Plant 4, camera facing approx. NNE. This photograph shows the approximate perspective from where the VE tests were conducted for Plant 4 silos (EU011, EU012, and EU013). A conveyor belt leads to eight storage bins (four are visible in the photograph, and four more are just North of the front four) with a structure enclosing the tops of the storage bins. There are two silos. The West silo is the grey cement silo (EU011) and split silo is for white cement (West portion, EU012) and cement supplement, or slag (East portion, EU013).

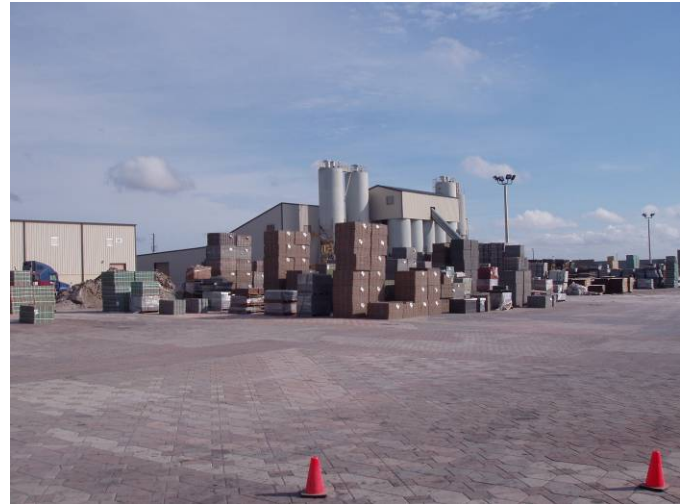
Photo ID No: 1050372_Photo_01_24_2012-2;
Time: Approx. 10:15 AM
View of Plant 2 and Plant 3 (inside same production building). These plants are not operational. The camera is facing approx. NE. The two silos for Plant 2 are west of the two silos for Plant 3 (shown in photograph).

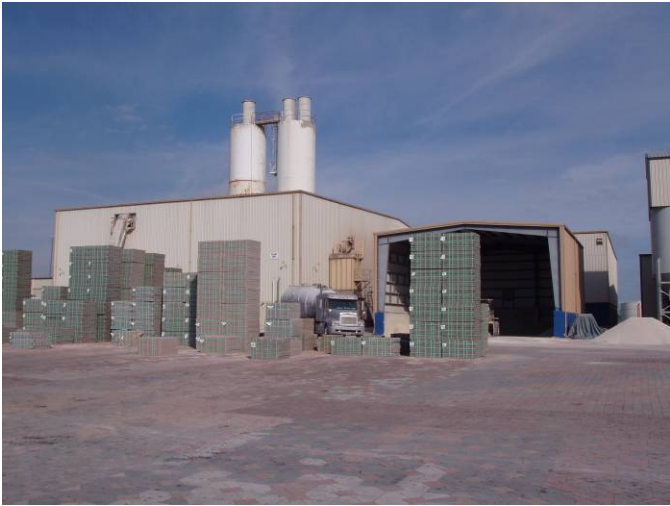
Photo ID No: 1050372_Photo_01_24_2012-3
 Time: Approx. 10:30 AM.
 View of Plant 1, camera facing approx. NNW. This photograph shows the approximate perspective from where the VE tests were conducted for the Plant 1 silos (EU001, EU002, and EU003) and the Plant 1 central dust collector (EU004). The two silos are, from left to right, grey cement silo (EU001) and a split silo for white cement (West portion, EU002) and for cement supplement, or slag (East portion, EU003). The Plant 1 central dust collector (EU004) is the light-yellow-colored structure in between Plant 1 and the sand hanger (building with open face). The central dust collector is directly behind the truck, which was filling the cement supplement silo.

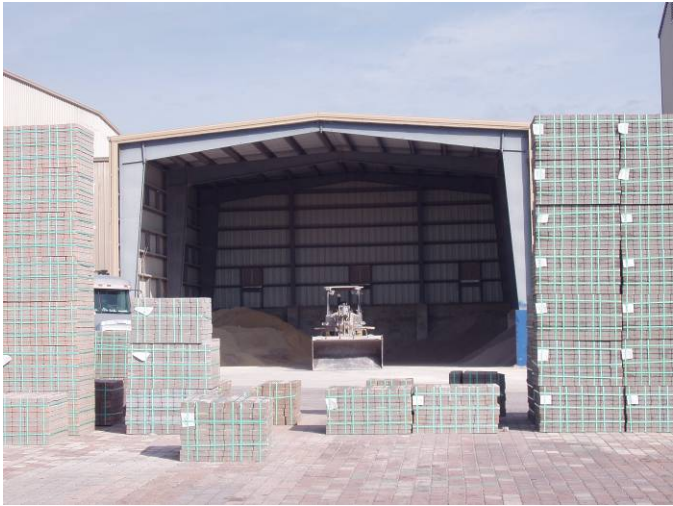
Photo ID No: 1050372_Photo_01_24_2012-5
 Time: Approx. 10:30 AM.
 Close-up photograph of the enclosed sand hanger for storage of materials not unloaded directly to the production lines, camera facing approx. N.

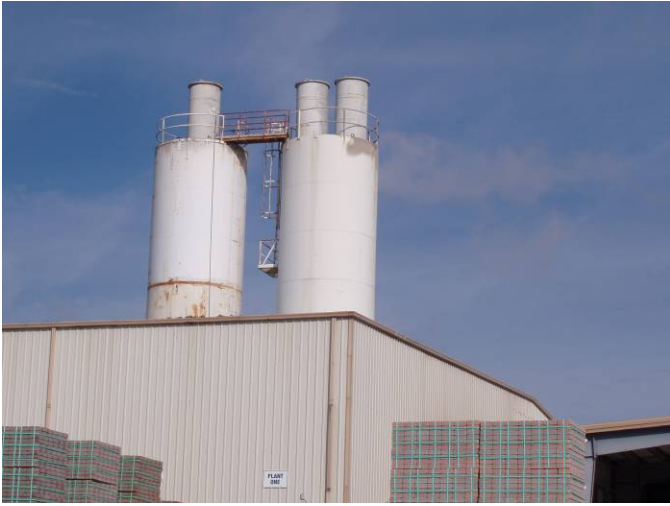
Photo ID No: 1050372_Photo_01_24_2012-4
 Time: Approx. 10:30 AM.
 Close-up photo of the two silos for Plant 1 (EU001, EU002, and EU003), camera facing approx. NNW.

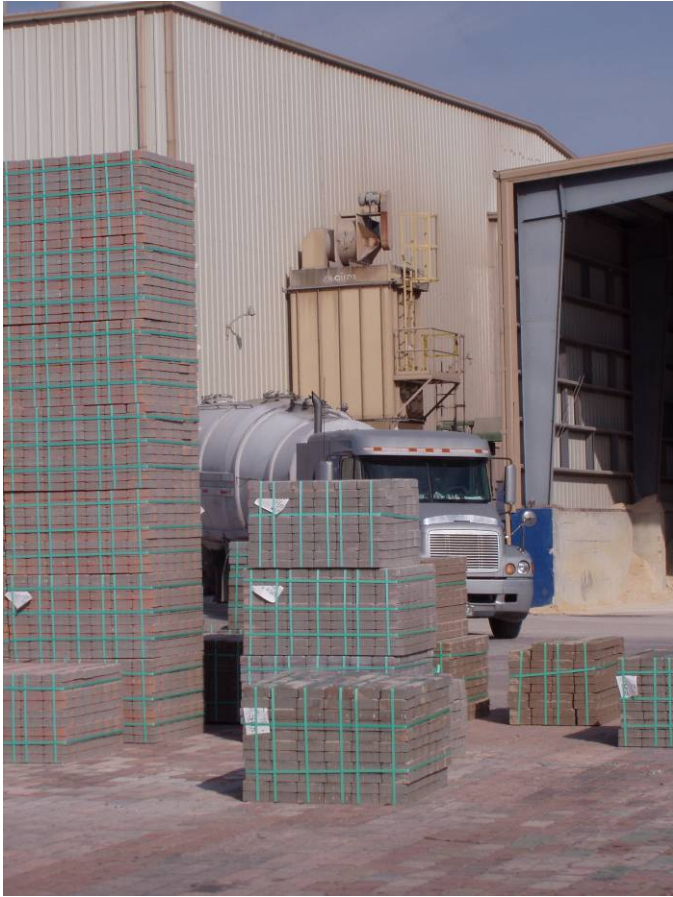
Photo ID No: 1050372_Photo_01_24_2012-6
 Time: Approx. 10:30 AM.
 Photo of the Plant 1 central dust collector (EU004), which is directly behind the truck. Camera facing approx. NW. The central dust collector picks up dust from two mixers (for batching) in Plant 1 and collects dust in a bin.

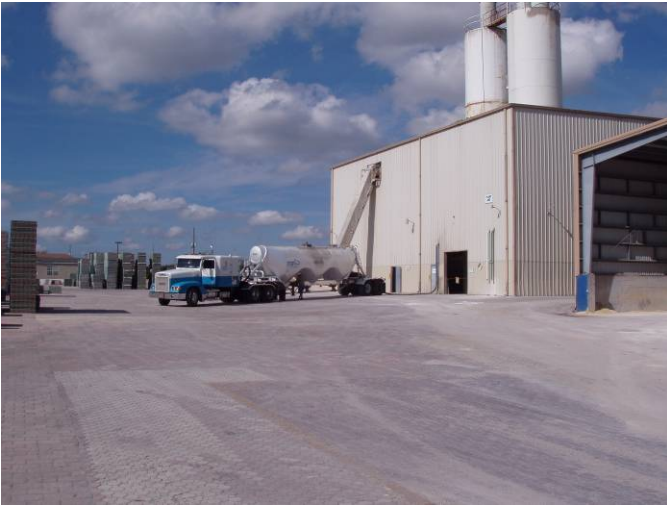
Photo ID No: 1050372_Photo_01_24_2012-9
Time: Approx. 11:45 AM
Grey cement truck finishing the filling of the Plant 1 grey cement silo (EU001) after the second VE test had been conducted at Hanson Hardscape Products Facility on 01/24/2012. Camera facing approx. WNW.

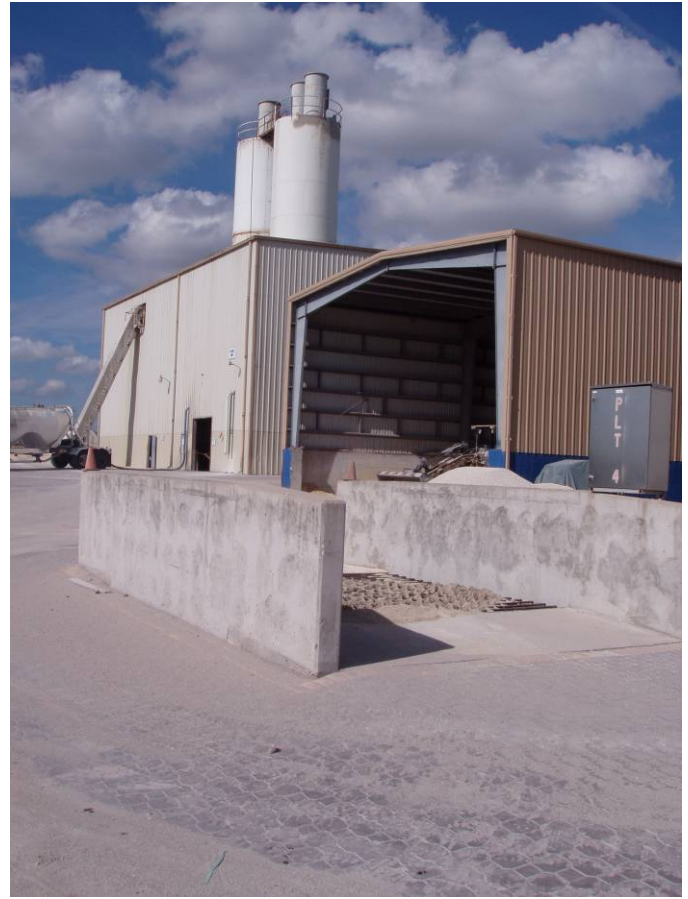
Photo ID No: 1050372_Photo_01_24_2012-12
Time: Approx. 11:45 AM
Underground drop-off pit with grates for aggregates, outside of Plant 4, to be delivered to storage bins by conveyor belt. Camera facing approx. NE. In the background, Plant 1 and the sand hanger are visible.

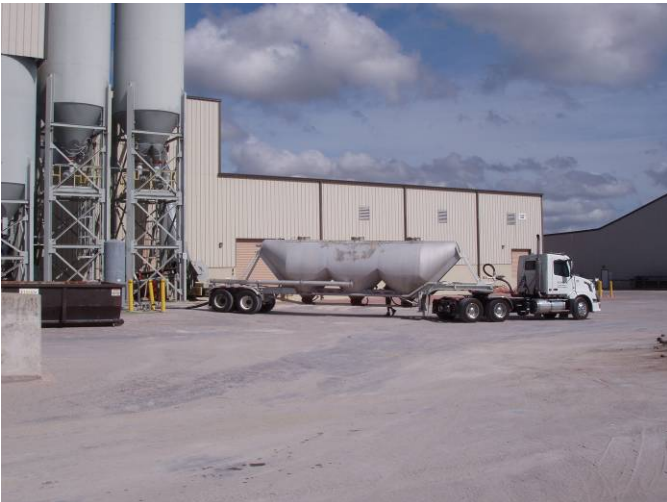
Photo ID No: 1050372_Photo_01_24_2012-10
Time: Approx. 11:45 AM
White cement truck outside of Plant 4. About half of the white cement in this truck was used to fill the Plant 1 white cement silo (EU002) during the second VE test at the facility on 01/24/2012, and the remaining contents of white cement in the truck were used to fill the Plant 4 white cement silo (EU012) during the third VE test at the facility on 01/24/2012. Camera facing approx. NW.

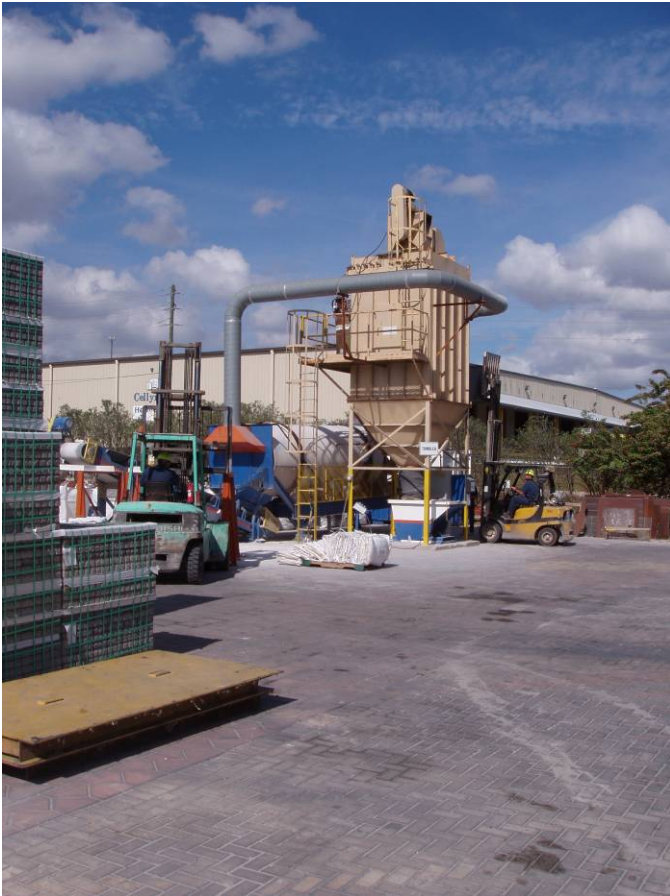
Photo ID No: 1050372_Photo_01_24_2012-13
 Time: Approx. 12:20 PM
 Paver tumbler machine with central dust collector (EU014) just West of Plant 1. The camera is facing approx. NE. This photograph shows the approximate perspective from where the VE test was conducted for the paver tumbler machine with central dust collector (EU014). In this photograph, the operator on the yellow-colored fork-lift delivers loads of pavers into the tumbler, which is the horizontal cylinder that is white in color. The South face of the tumbler is blue with an orange ventilation system that receives dust from the tumbler. The dust flows through the grey ducts up to the central dust collector (unit that is light-yellow or beige in color). The dust then collects at the base of the central dust collector in a storage bin that is white and blue in color with an orange stripe in the center. The operator on the mint-green-colored fork-lift removes filled bags of pavers from the paver loading area.

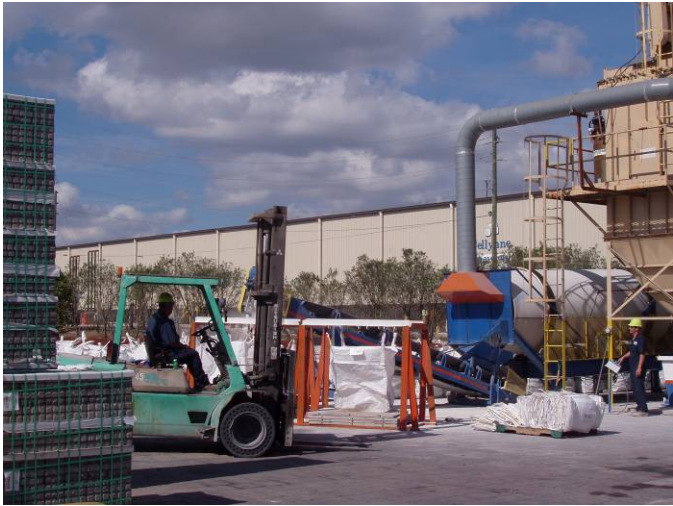
Photo ID No: 1050372_Photo_01_24_2012-16
 Time: Approx. 12:20 PM
 An operator waits to transport a filled paver bag and another operator controls the paver tumbler machine. While the fork-lift is used to deliver a filled bag to a storage area, the conveyor belt shifts to fill the second bag with pavers and an operator places an empty bag on the rack to be filled.

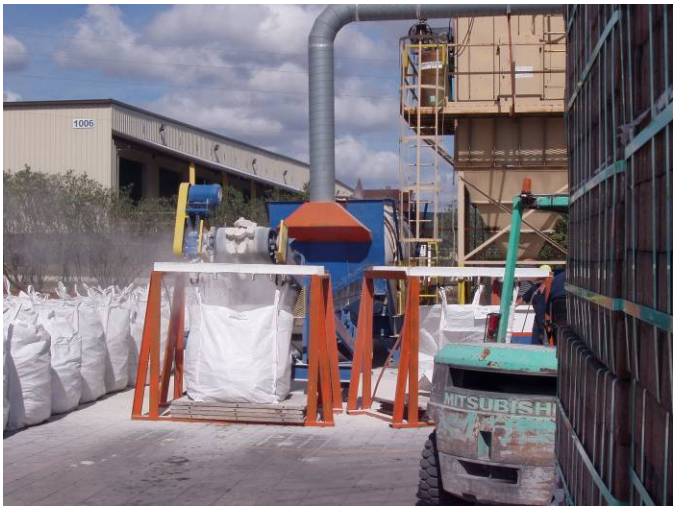
Photo ID No: 1050372_Photo_01_24_2012-17
 Time: Approx. 12:20 PM
 Fugitive dust from the drop-off point on the paver tumbler where pavers are dropped into a paver bag. During operations, the fugitive dust opacity was under the 20 % opacity limit over a 6-minute average period, as observed by Bill Arlington of Arlington Environmental Services, Inc. This day was particularly windy, which may have affected and possibly increased the fugitive dust emissions. Camera facing approx. N.

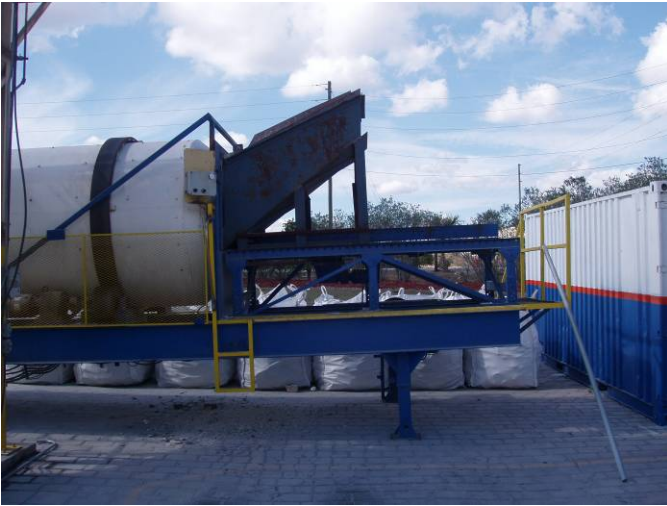
Photo ID No: 1050372_Photo_01_24_2012-24
Time: Approx. 12:20 PM
Back view of paver tumbler, where pavers are loaded into tumbler. Camera facing approx. W.

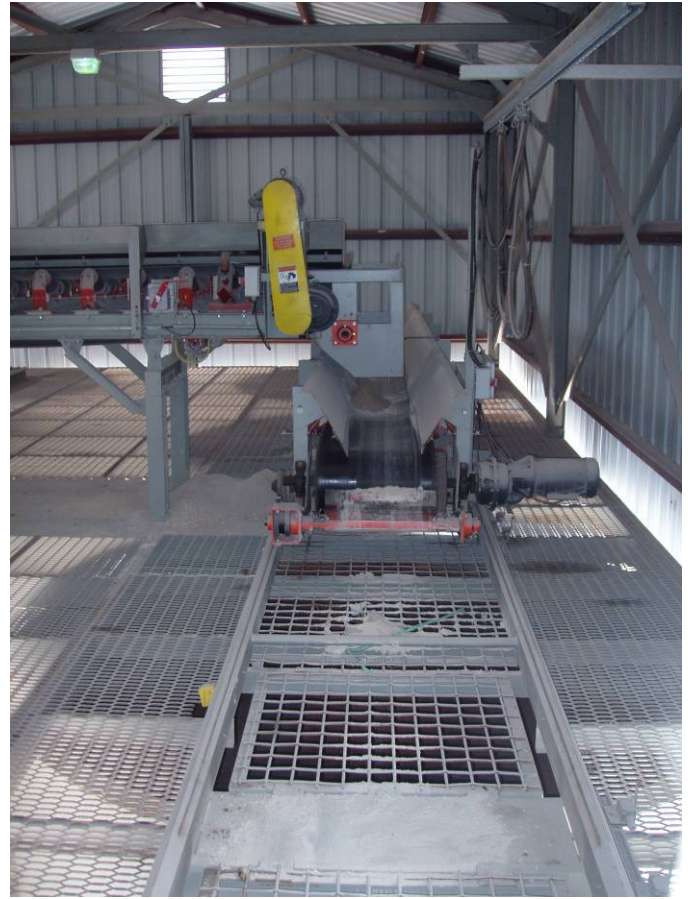
Photo ID No: 1050372_Photo_01_24_2012-36
Time: Approx. 12:40 PM
Inside the structure on top of the storage bins in Plant 4, where aggregate materials are loaded. The grates are directly on top of each storage bin. Camera is facing approx. W.

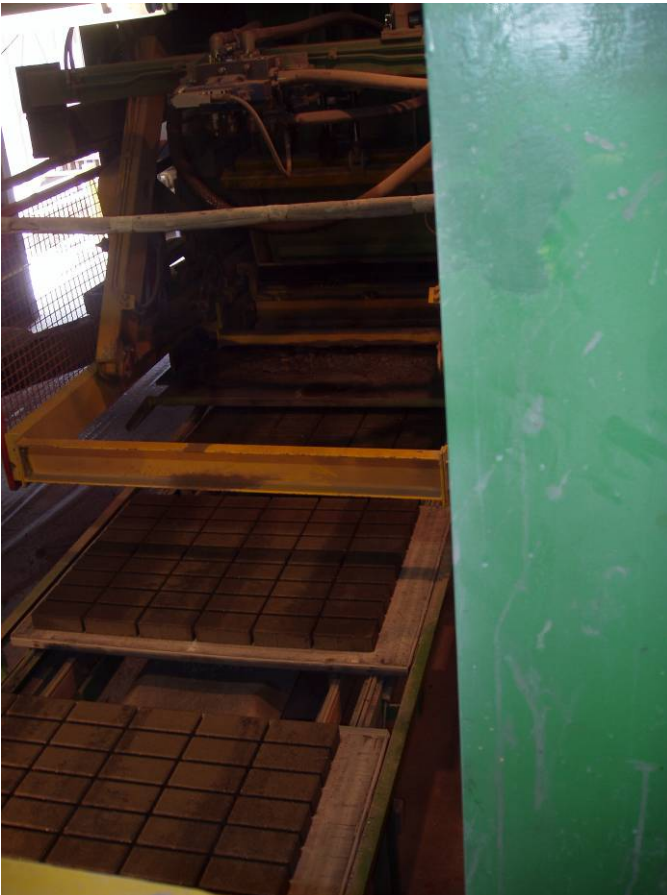
Photo ID No: 1050372_Photo_01_24_2012-31
Time: Approx. 12:30 PM
Inside of Plant 1, view of paver molding and manufacturing. Camera is facing approx. SE.
