Air Pollution Source Inspection Report Form

Florida Department of Environmental Protection, Southwest District

Photographic Inspection Log

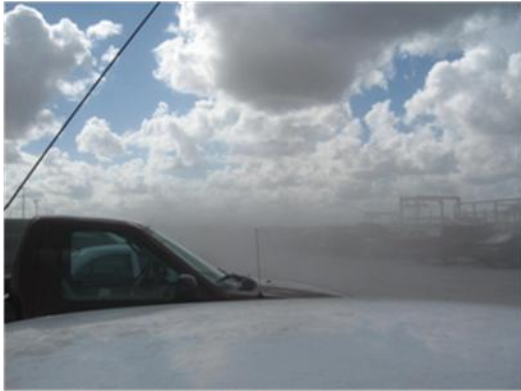
I (Chris Haines) arrived at the facility after viewing quite a bit of dust blowing onto route US 17 South. Upon arrival I took a few pictures in the parking lot and then proceeded to the front office to speak with Mr. Mark Felton. I alerted him to the issue, and he was already aware, the facility was loading a water truck already. I advised him to alert Ms. Danielle Henry and see to it that the water truck is used as needed. I gave Mr. Felton Ms. Henry's email address and left the facility at approximately 10:45.

Picture ID No. 001
Southward Photo of parking lot during wind.

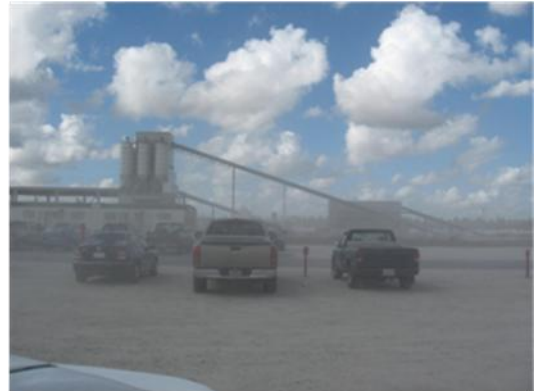
Picture ID No. 002
Westward photo of parking lot during wind.

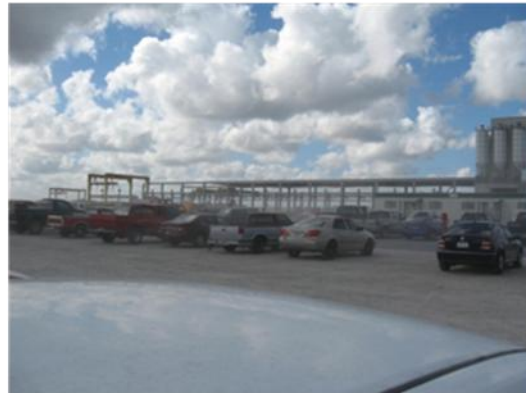
Picture ID No. 003
South-west photo of parking lot after wind.
