## DIGITAL PHOTOGRAPHIC LOG

1. **Facility Name:** Outdoor Living Centers of America.
2. **County / AIRS ID No:** Polk County, FL / Facility ID 7775719.
3. **Inspection Type:** INS2 on 09/14/2012, then FUI and VE Test Audit on 09/18/2012.
4. **Inspection Date:** 09/14/2012 (INS2) and 09/18/2012 (FUI and VE Test Audit). Photograph taken on 09/18/2012.
5. **Date Photographic Log was completed:** 10/16/2012.
6. **Camera Used:** Canon Power Shot 5.0 mega pixels A530 (Air Section digital camera).
7. **Recording Media:** Canon 16 MB MultiMediaCard.
8. **All Digital Photos Were Copied To:** Hard Disk of Computer DEP 143271 and on this Digital Photographic Log.
9. **Original Copy Is Stored In/On:** Hard Disk of Computer DEP 143271.
10. **Were the photos altered?:** NO  YES  **explain yes:** N/A
11. **Photographer:** Amaury Betancourt
12. **Signature of Photographer:** \_\_\_\_\_

**Facility Name:** Outdoor Living Centers of America; **Facility ID No:** 7775719; **County:** Polk County, FL  
**Inspection Type/Date:** INS2 on 09/14/2012, FUI & VE Test Audit on 09/18/2012

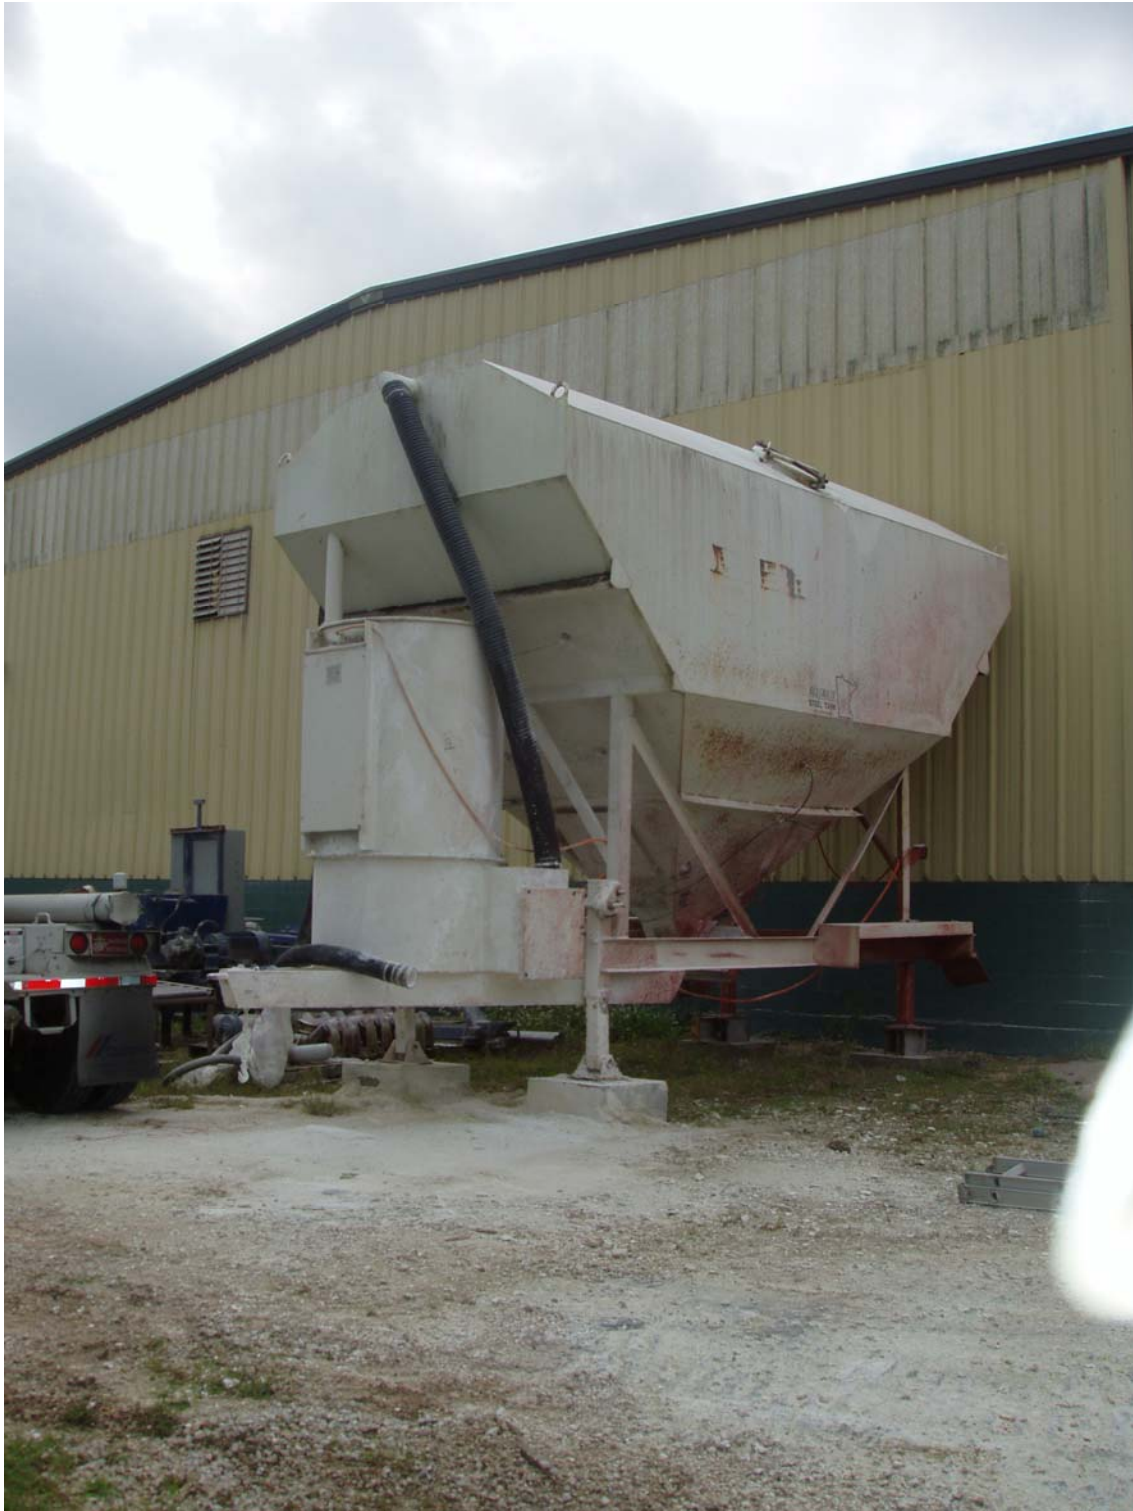
**Photo ID No:** 7775719\_Photo\_1\_of\_1\_09\_18\_2012.jpg; **Date:** 09/18/2012; **Time:** Approx. 10:00 AM; Emission Unit (EU) EU001, Belgrade Steel Tank silo with Belgrade Steel Tank baghouse. The silo with baghouse is located on the North side (back side) of the facility building. This silo has an unusual appearance and is described on the manufacturer's website as a low-profile silo. The baghouse is the cylindrical tank on the front of the baghouse. The camera is facing approx. SE. The baghouse takes in emissions from the top of the silo to the bottom of the baghouse. The silo is loaded (truck visible to East of silo) via tubing on the East side of the baghouse. Material is taken from the silo into the building via an enclosed feed system, and material is batched inside the facility building.####
