**Facility Detailed List Report**

**RE: Leachfield Sampling Results for  
Wright's Dry Cleaners  
2510 Ave. G NW  
Winter Haven, FL**

Wright's Cleaners  
2510 Ave. .G NW, Winter Haven, FL

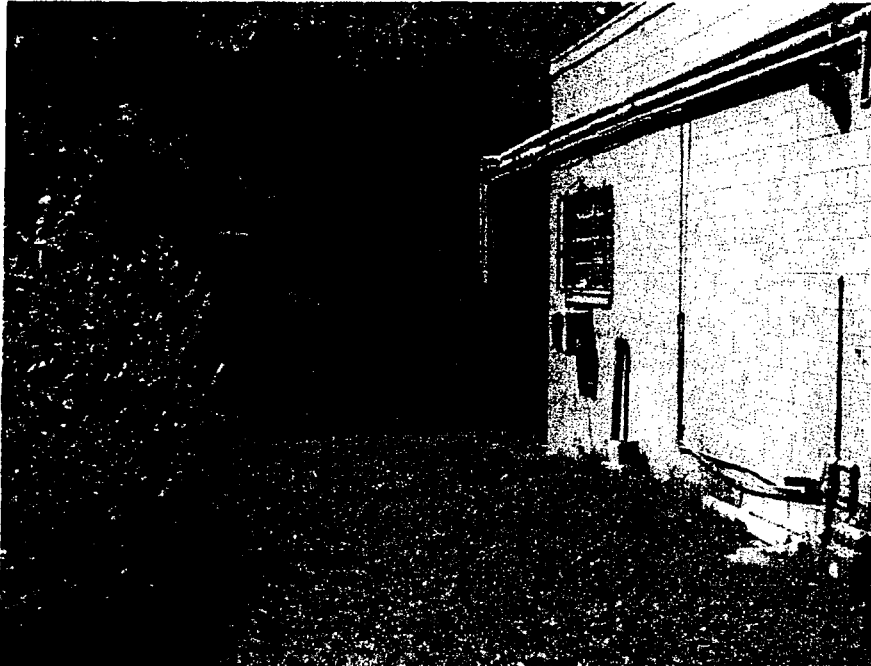
VES identified an existing monitoring well on the south side of the septic area next to the garage wall (Figure 1). The well was constructed of 1" OD PVC with a total depth of 10'. The depth-to-water (DTW) was 3.5'. FDEP agreed that this well was adequately located and could be used for the groundwater sampling.

View looking south from the septic tank down the leachfield. The monitoring well is located of the right of the garage door.

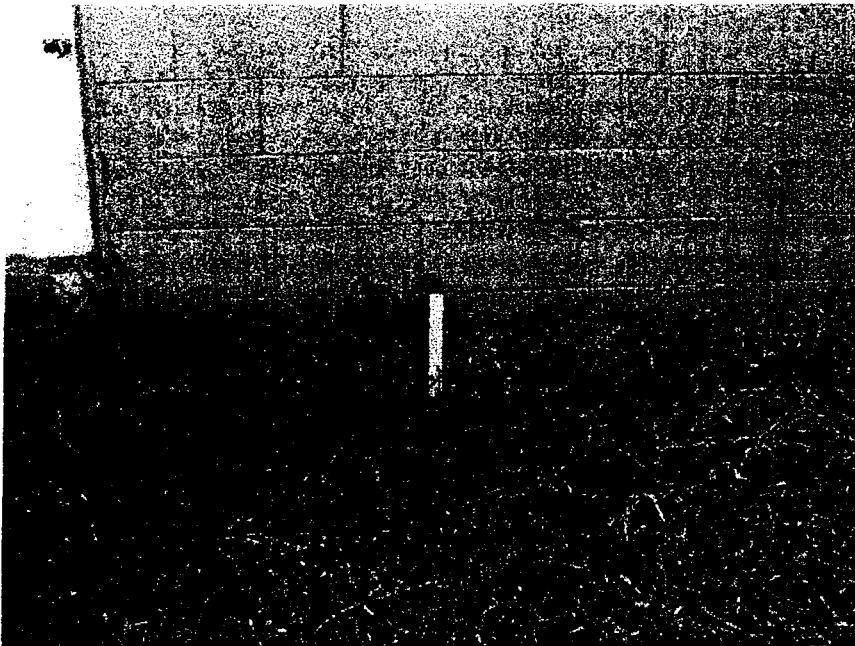
The laboratory analytical report is included in Attachment B. The results of the laboratory analyses indicated that PCE was not present above the laboratory method detection limit (MDL) of 0.23 ug/L. The compound cis-1,2 Dichloroethene (DCE) was detected at 19 ug/L; well below the GCTL of 70 ug/L.

Close-up of the monitoring well, designated as Leachfield-1.
