**Container Division**

Under the terms of a consent decree between Container Corporation of America (CCA) and the State of Florida Department of Environmental Regulation (DER), PEI Associates, Inc. (PEI) conducted an inspection of emissions sources at Container Corporation's Fernandina Beach Mill. Sources to be covered during the inspection included the No. 5 Recovery Boiler and electrostatic precipitator (ESP), No. 4 Recovery Boiler and ESP, No. 4 Power Boiler and mechanical collector (Bahco) and No. 5 Power Boiler and mechanical collector (Bahco).

1. Inspect and determine the physical condition of the ESP serving the No. 4 and No. 5 Recovery Boilers.
2. Inspect and determine the physical condition of mechanical collectors on the No. 4 and 5 Power Boilers.
3. Review the preventive maintenance and emergency maintenance procedures and determine the adequacy of these programs to maintain compliance with applicable opacity and emission limitations.

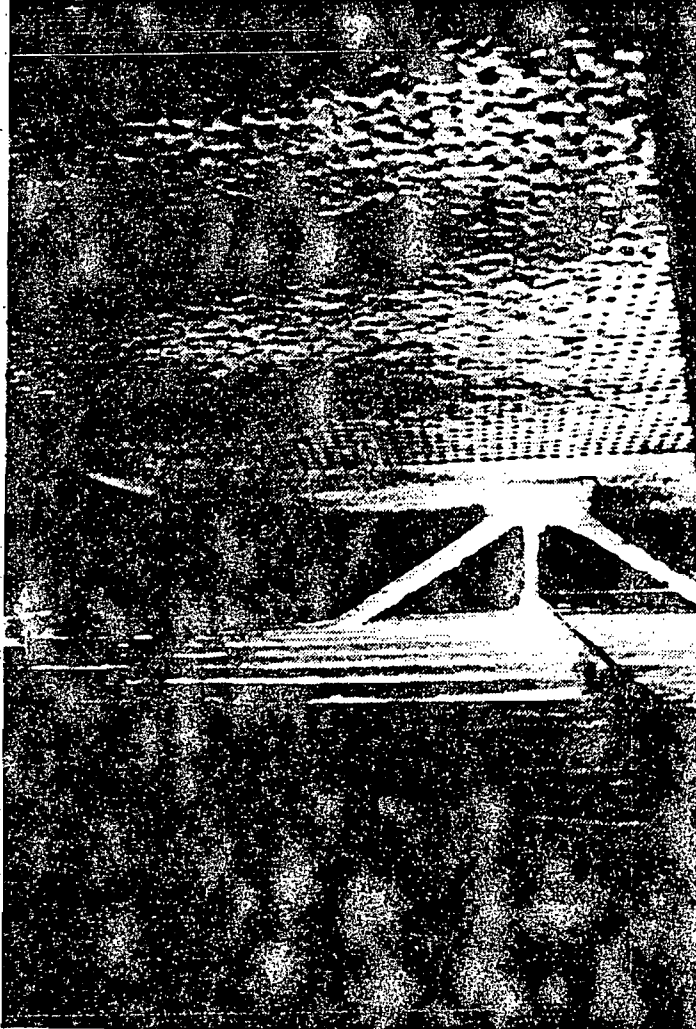
A visual inspection of the distribution plate from the top looking into the inlet plenum indicated substantial pluggage of the perforated distribution plate (Figure 19). The fouling was sufficient to seriously affect the gas distribution within the chamber and affect collection efficiency. It is suspected that the pluggage is directing gas flow to the north chamber as implied by the V-I curves and corona power levels. An inspection of the north chamber inlet, however, could not be conducted to verify this suspicion. It is also possible that the north chamber distribution plate was also fouled.

Figure 19. South chamber turning vanes and gas distribution plate showing pluggage (looking down into inlet plenum, vane lower portion of photograph).

Chronic fouling of the inlet vanes and distribution plate usually occurs because the plates are structurally rigid and rappers cannot impart sufficient vibration to dislodge the salt cake. In many cases, this is initiated and aggravated by sticky salt cake caused by low temperature (i.e., direct contact evaporation) or sulfur trioxide ( $\text{SO}_3$ ) adsorption (i.e., low salt cake pH). Neither of these key elements in the formation of sticky salt cake were apparent in this application.

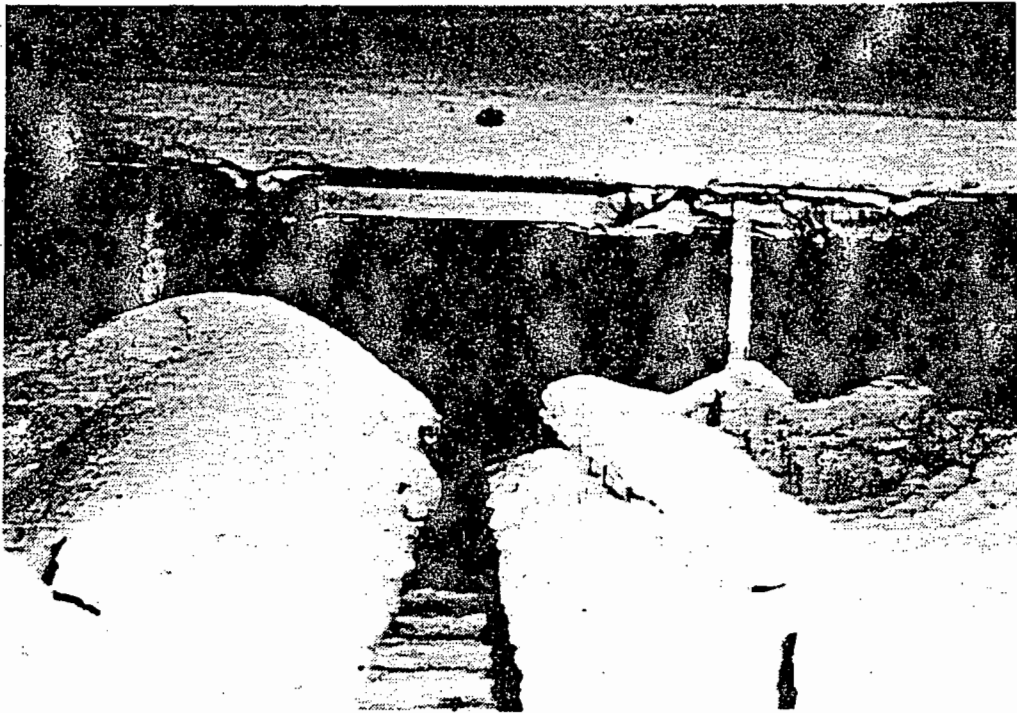
Figure 23. Upper wire frame inlet field No. 5. ESP showing salt cake deposits.

preventive maintenance is not defined. If these intervals can be confined to periods of normal outages, the deposits would not require forced outages or operation with only a single chamber. With changes in inlet gas distribution, improved rapping, and modification to the gas turning vanes, the buildup may be eliminated.

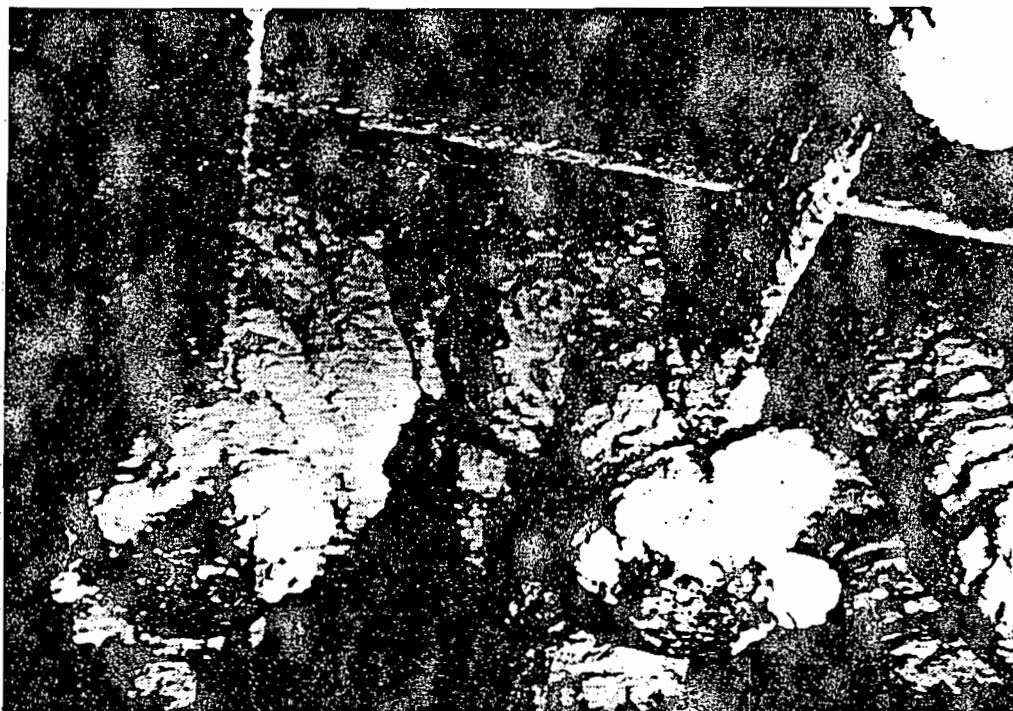
Figure 24. Buildup of salt cake on bottle weights  
C field south chamber.

found in low temperature direct contact applications. Also these deposits are not uniform as would be expected from condensation on low temperature areas (i.e., near walls). Discussion with plant personnel indicated that when drag repairs are made, the ESP bottom may be washed to aid in maintenance. Water could have splashed up on the wire frame initiating the growth of the deposits in a random manner.

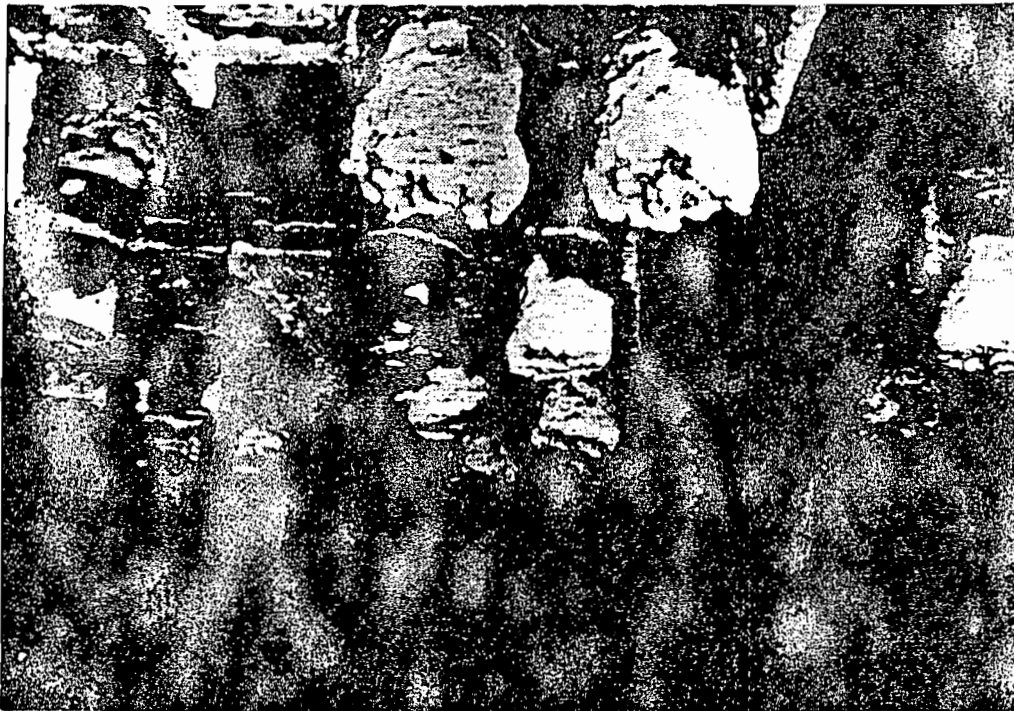
Figure 25. Frame alignment between C and D electrical fields south chamber.

Plant personnel repositioned the frame by tightening the frame support nut on the barrel insulator, which raised the frame (Figure 26). Alignment was achieved without lateral adjustment of the jack screws positioning the insulator.

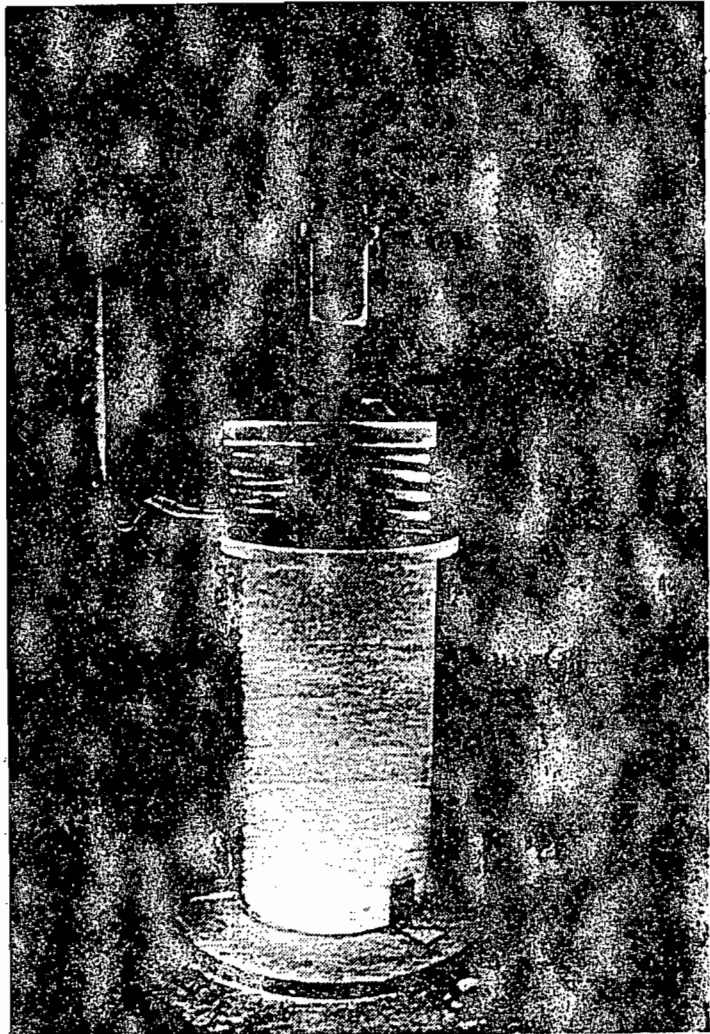
Figure 26. Support insulator showing alignment jacks and frame vertical adjustment.

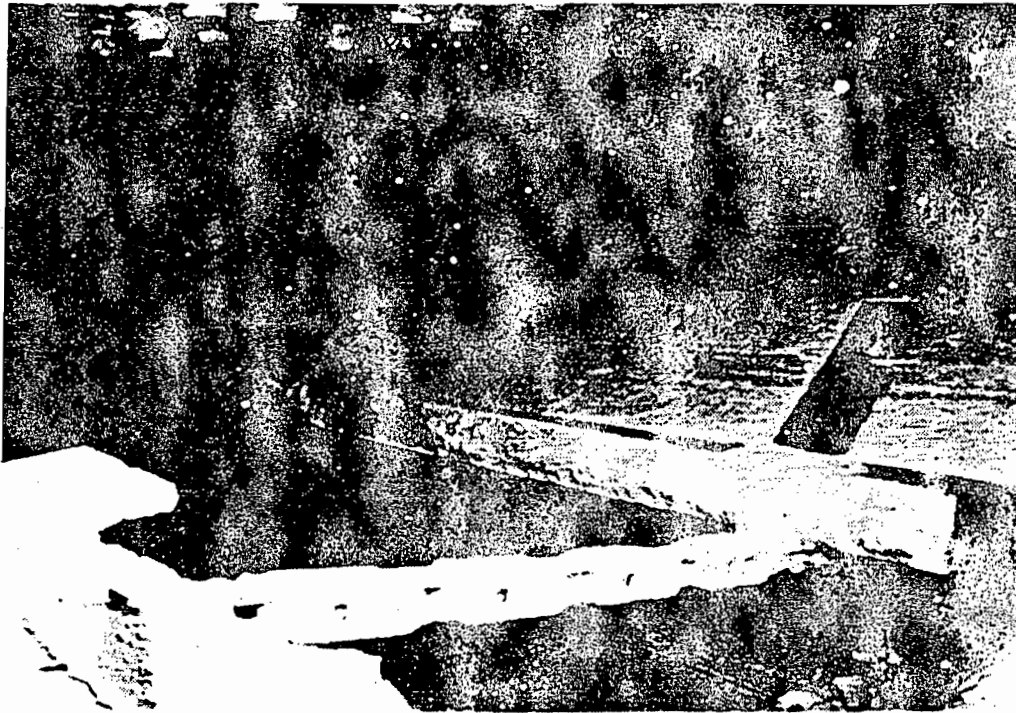
Figure 30. Antisneakage baffle between inlet field and inlet plenum No. 4 ESP.

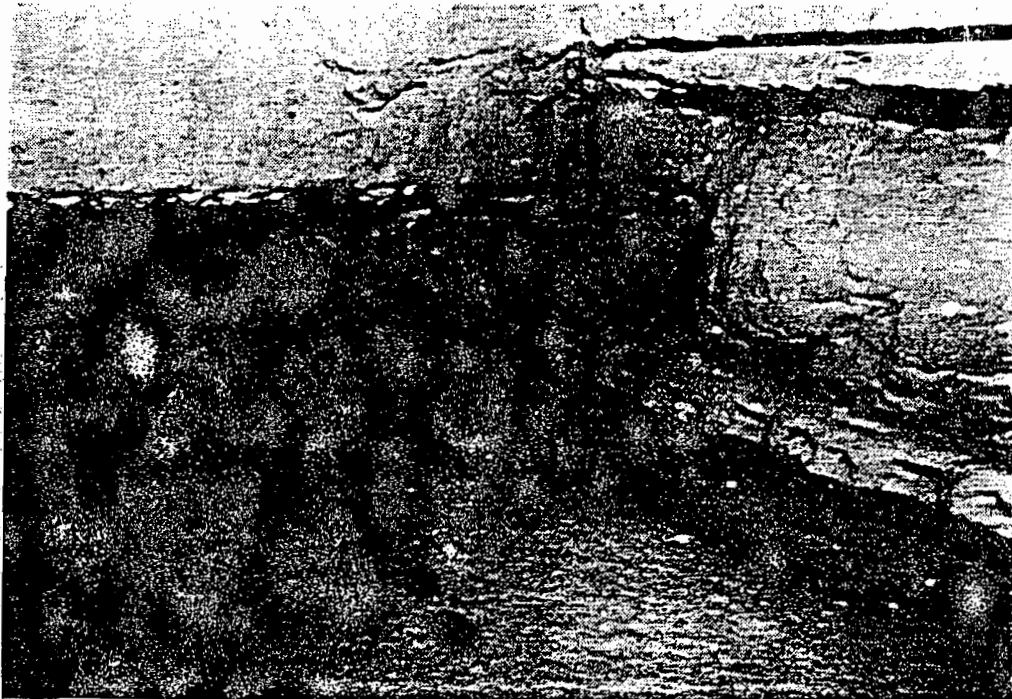
Figure 31. Lower antisneakage baffle allowing passage  
of lower drag scraper blade between  
fields B and C No. 4 ESP.

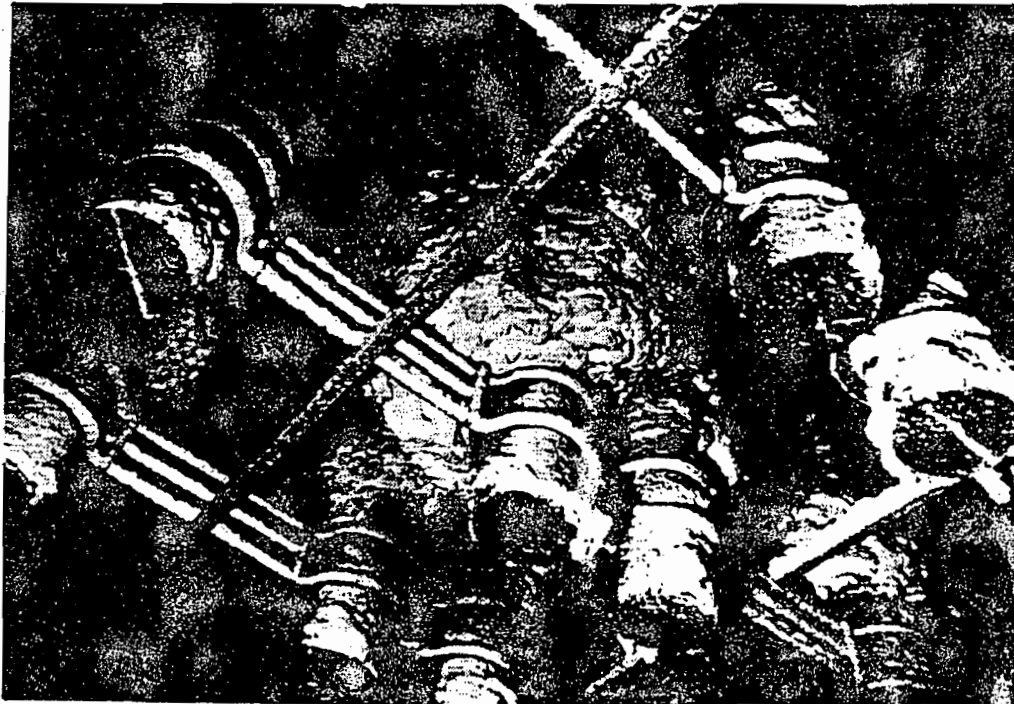
Figure 35. Buildup on bottle weights and wire south chamber No. 4 recovery boiler, inlet field.

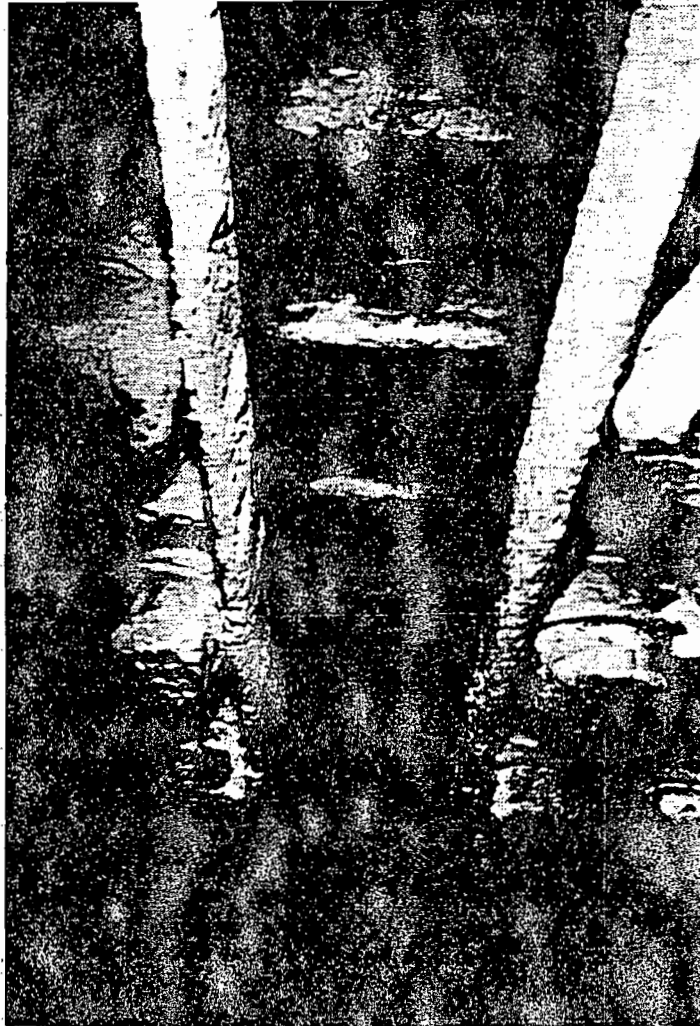
Figure 37. Plate repair No. 4 ESP,  
between electrical fields A and B.

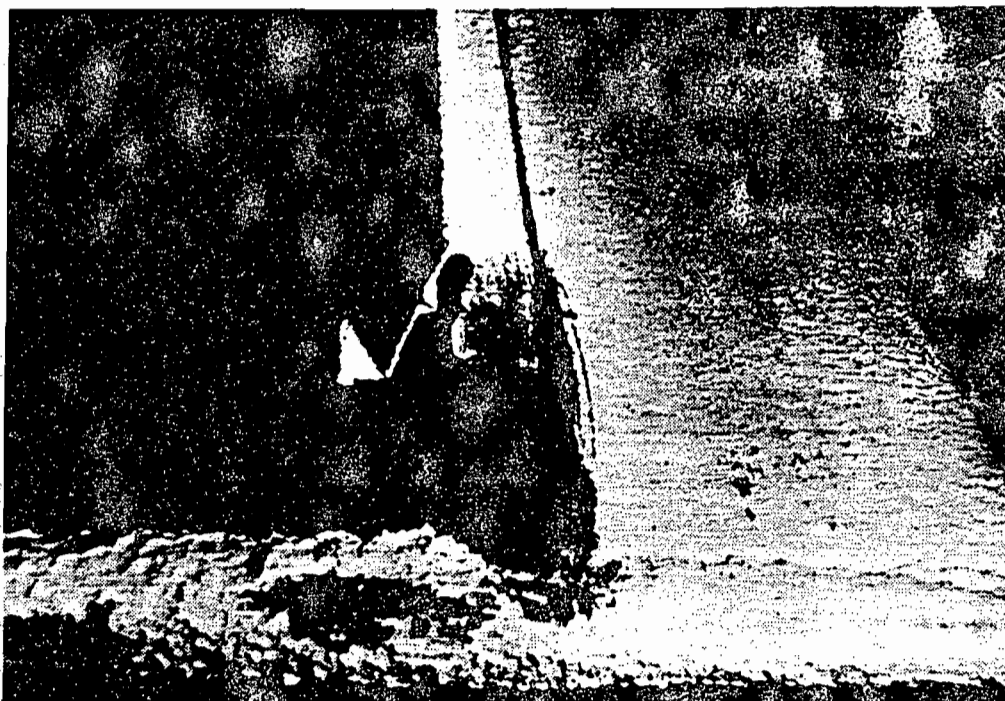
Figure 38. Close-up plate repair No. 4 ESP showing plate split.

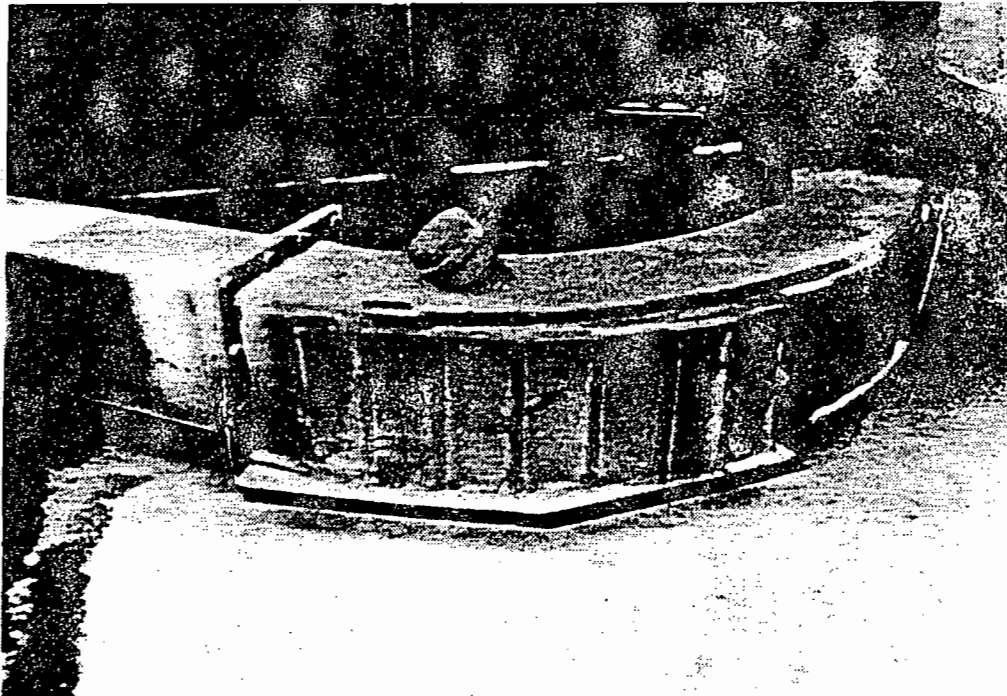
Figure 43. Secondary air ductwork reinforcement used to prevent abrasive failure.

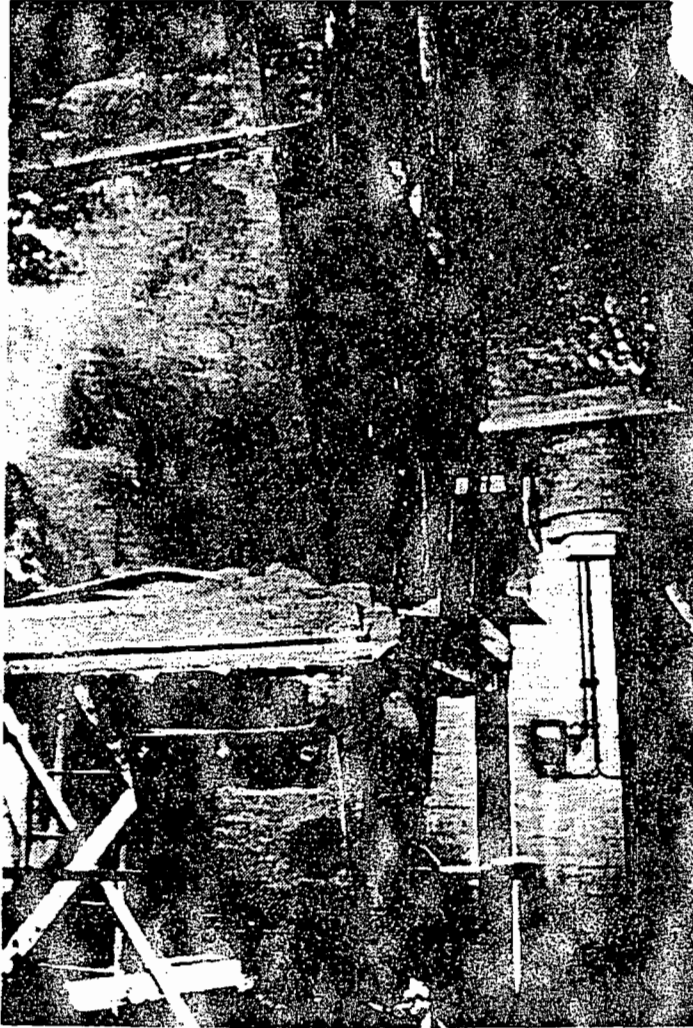
Figure 44. Photograph of drop-out chamber hopper showing hammer blows.

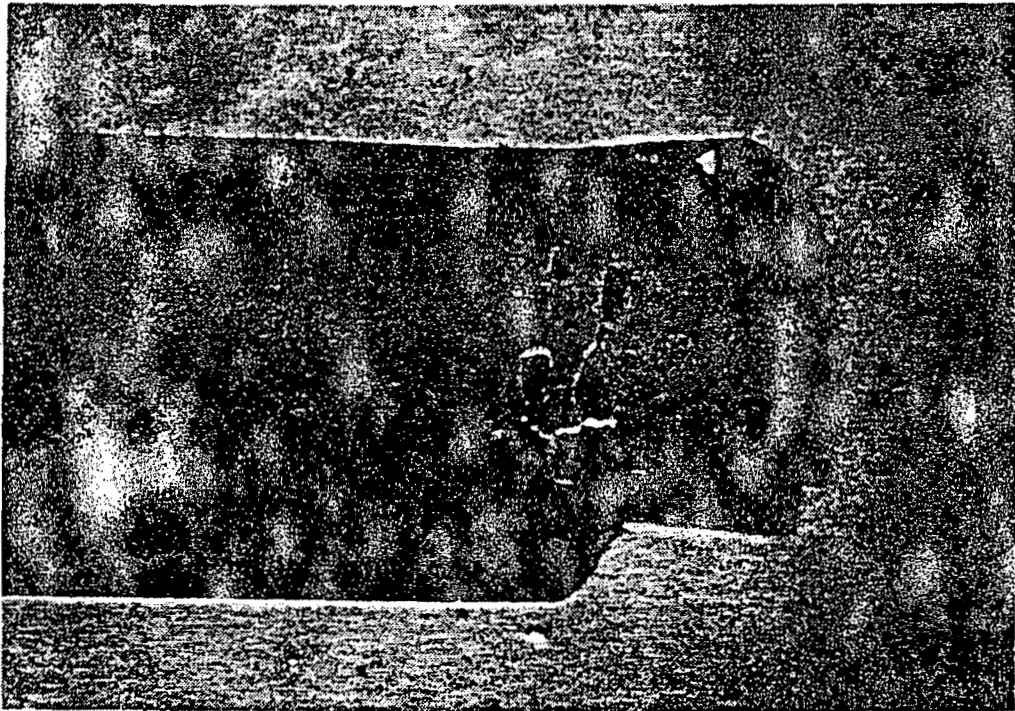
Figure 45. Removed cyclone tube showing tube wear.
