DIGITAL PHOTOGRAPHIC LOG

1. **Facility Name:** Great Southern Wood Preserving, Inc.
2. **County / AIRS ID No:** Sumter County / 1190048
3. **Inspection Type:** INS2
4. **Inspection Date:** 03/01/2012
5. **Date Photographic Log was completed:** 03/16/2012
6. **Camera Used:** Olympus Camedia Digital Camera, 5.0 Megapixel, C-50 ZOOM, S/N 115248297.
7. **Recording Media:** FUJIFILM xD-Picture Card, 128 MB, S/N DPC-128, R31695 5RZ7, 0244 MAD.
8. **All Digital Photos Were Copied To:** Hard Disk of Computer DEP 143271; Some photos were copied to this Digital Photographic Log.
9. **Original Copy Is Stored In/On:** Hard disk of computer DEP 143271.
10. **Were the photos altered?:** NO YES _____ explain yes:
11. **Photographer:** Amaury Betancourt
12. **Signature of Photographer:** _____

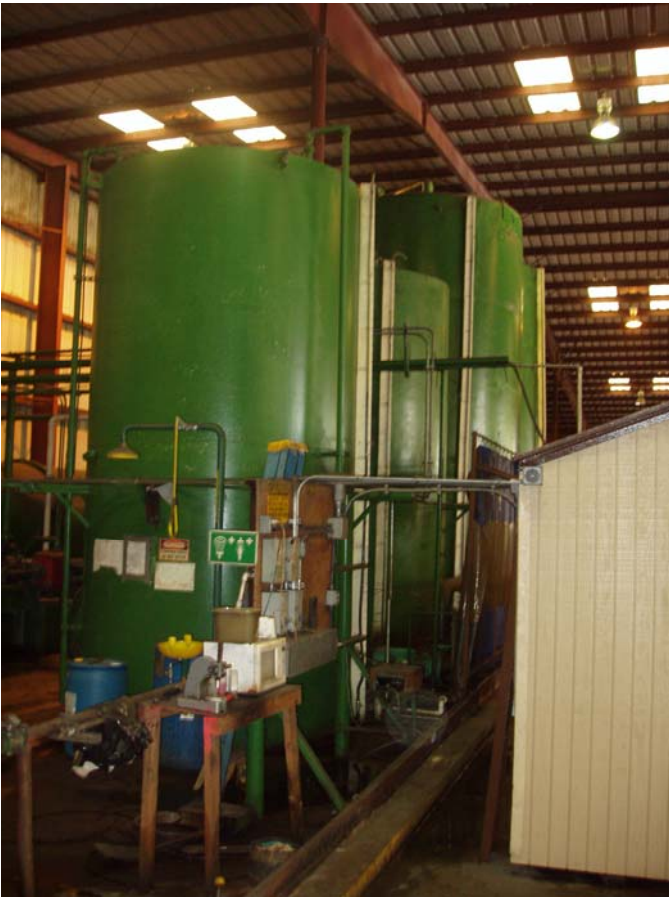
Photo ID No: 1190048_Photo_03_01_2012-001
Time: Approx. 10:00 AM
Tanks for preparing chromated copper arsenate (CCA)
for wood preserving. The camera is facing approx. NW.

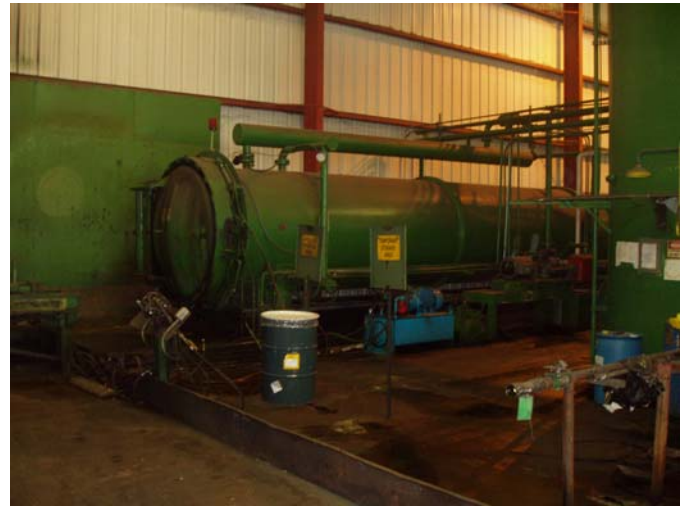
Photo ID No: 1190048_Photo_03_01_2012-002
Time: Approx. 10:00 AM
Horizontal cylinder (cylinder 3) used for pressure treating
wood products with CCA. The camera is facing approx.
NW.

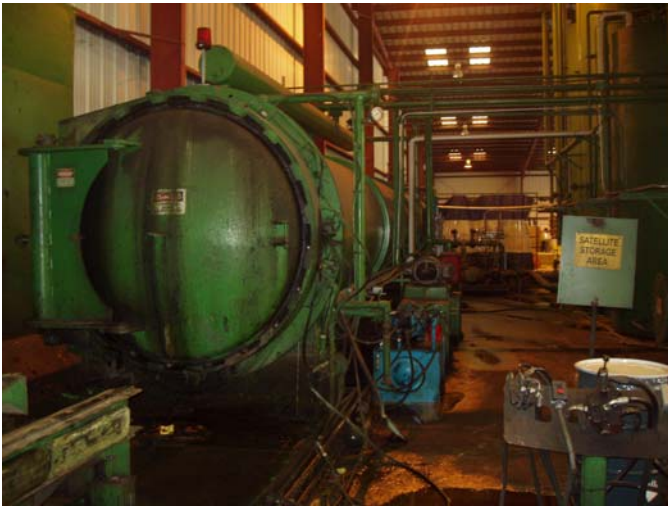
Photo ID No: 1190048_Photo_03_01_2012-003
Time: Approx. 10:00 AM
Front view of the horizontal cylinder for preserving wood products with CCA. The camera is facing approx. N.

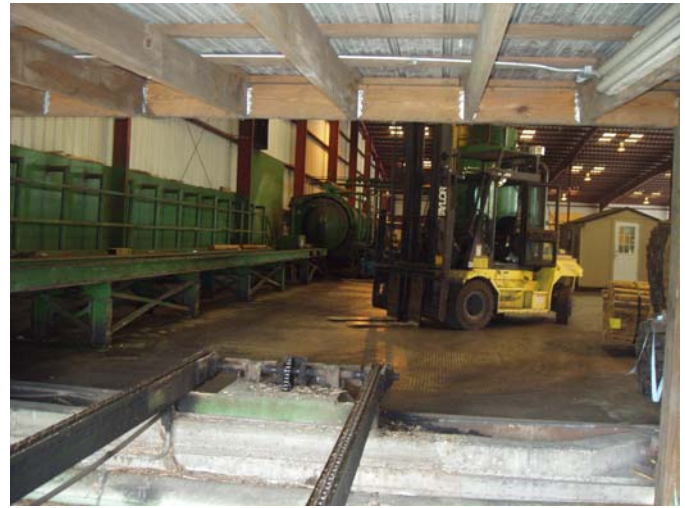
Photo ID No: 1190048_Photo_03_01_2012-007
Time: Approx. 10:00 AM
Forklift and other equipment for loading wood products onto horizontal cylinder for CCA treatment. The forklift is on a pad with borders to help prevent any possible leaks from spreading to the rest of the building or environment. The camera is facing approx. N.

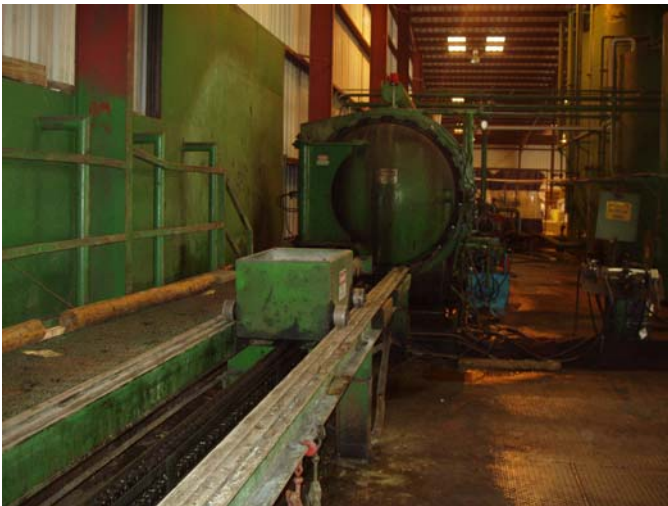
Photo ID No: 1190048_Photo_03_01_2012-006
Time: Approx. 10:00 AM
View of small rail system used to load wood products into horizontal cylinder for CCA treatment. The camera is facing approx. N.

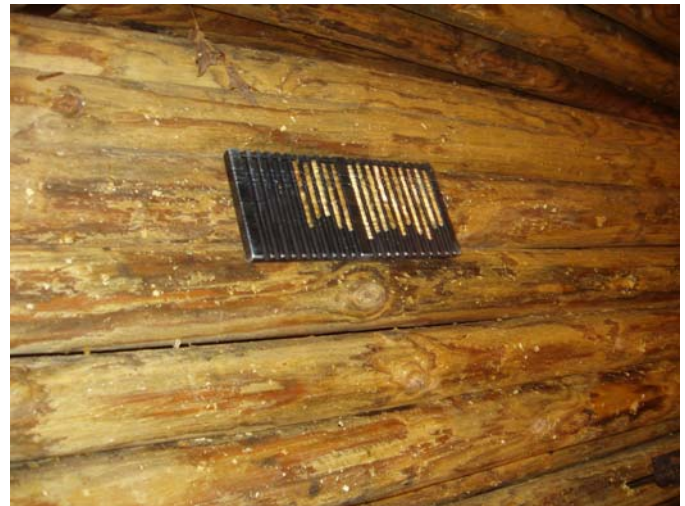
Photo ID No: 1190048_Photo_03_01_2012-009
Time: Approx. 10:15 AM
Drill samples of pressure treated wood pack. The drill samples are taken to determine the depth of penetration of preservative chemical, which in this case is CCA. For individual wood products with a diameter, or thickness, of less than or equal to 4" (inches), the penetration depth of preservative must be at least 1.75", and for a thickness of greater than or equal to 6", the penetration depth must be at least 2.50".

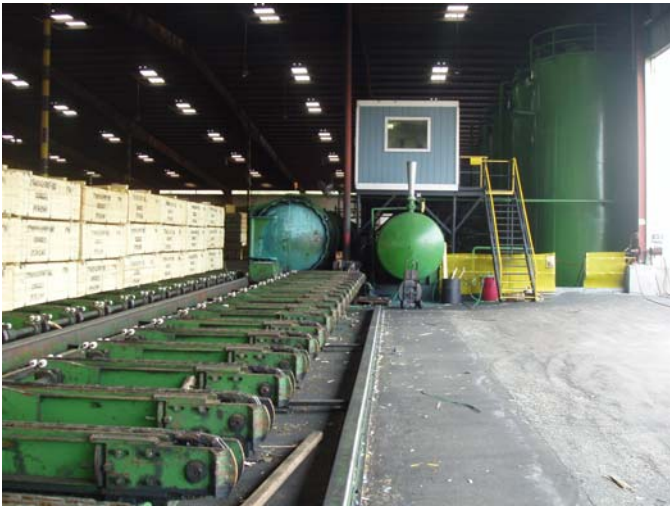
Photo ID No: 1190048_Photo_03_01_2012-010
Time: Approx. 10:30 AM
Horizontal cylinders (cylinders 1 and 2) for pressure treating wood products with chemicals such as micronized copper azole (MCA), boron, and alkaline copper quat (ACQ). CCA is not used in these cylinders. Wood products are loaded and unloaded using the loading track visible in the photo. The camera is facing approx. E.

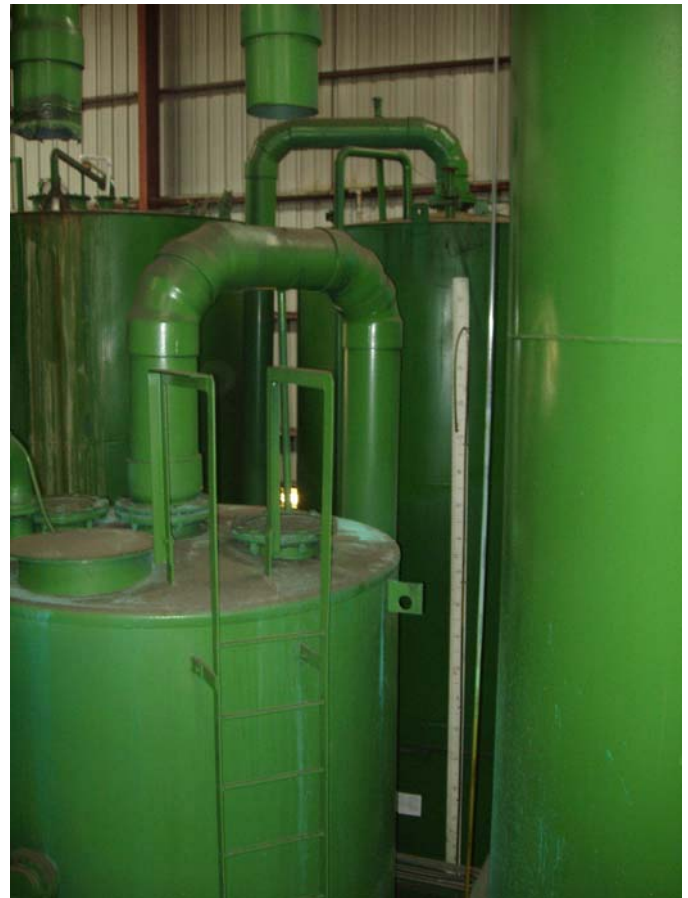
Photo ID No: 1190048_Photo_03_01_2012-013
Time: Approx. 10:30 AM
Tanks used for storing and preparing chemicals. The camera is facing approx SE.

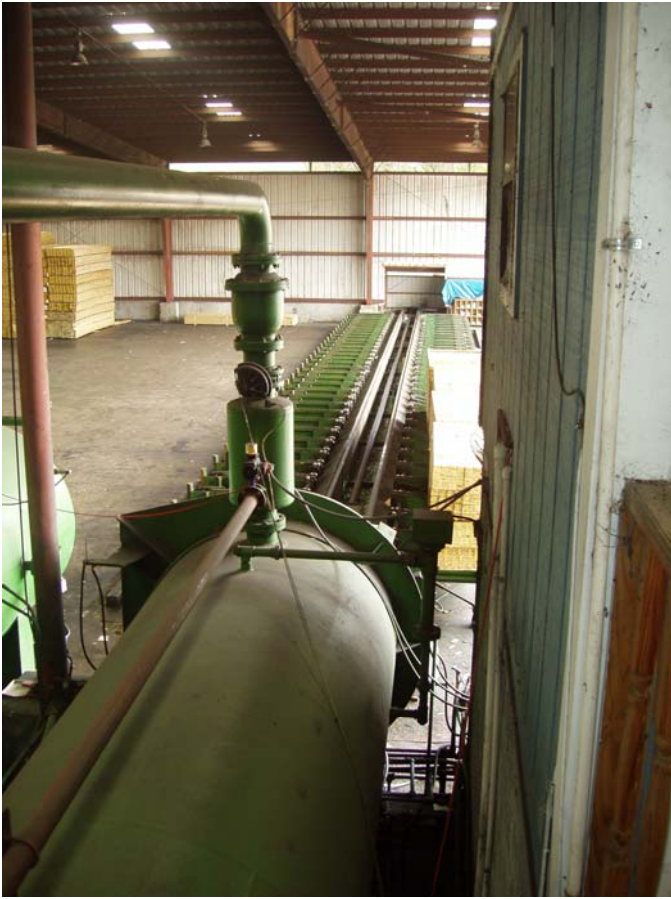
Photo ID No: 1190048_Photo_03_01_2012-017
Time: Approx. 10:30 AM
View from control room for cylinders 1 and 2. The camera is facing approx. E.
