Inspection list for Crematories

Hernando Co. Animal Services

0530365

Crematory Unit Information:	
Emission Unit No.	001 Model C700P S.N. P/310/0022/00
Specifications:	220-Volts 3 phase - Combustion Fan } Propane 120 Volts - Control circuit } 11 inches WC
Thermocouple Location:	Diagram/Description: See ATTACHED Diagram
Afterburner Location:	Diagram/Description: Right Side See ATTACHED Diagram

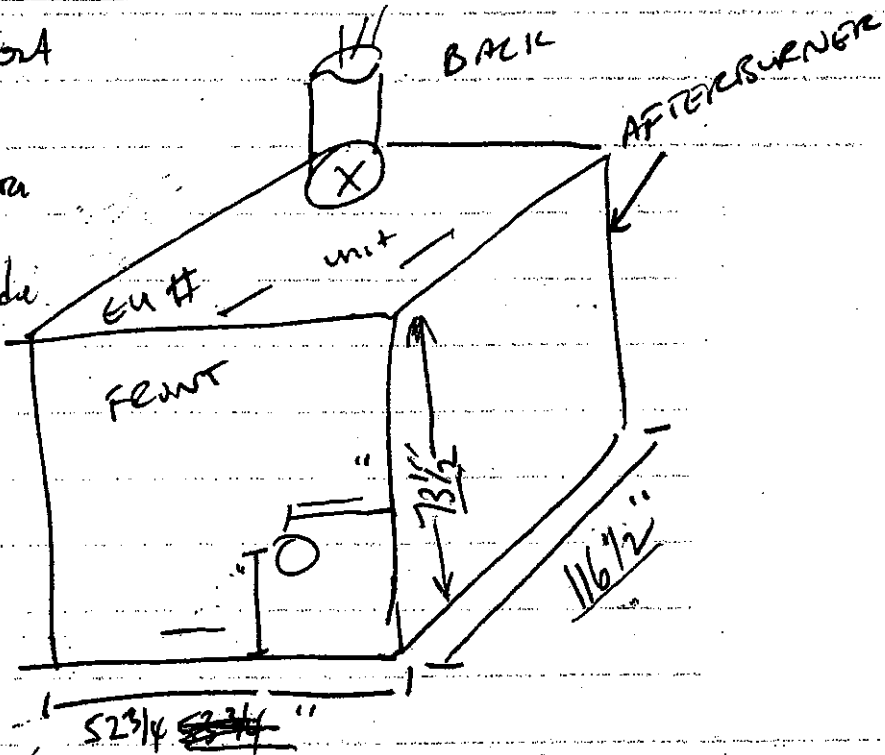
Thermocouple on ^{Left} ~~Right~~ side

40 1/2 From Floor

19 1/2 From Floor

Thermocouple on Right side

32 1/2 From Near Floor

52 1/2 From Floor

2 1/2 " from charge door to front

8 3/8 " from wall/secondary chamber to front
