**CRYSTAL RIVER  
SALT DRIFT STUDY  
1993-1994 ANNUAL REPORT**

**Florida Power Corporation  
3201 34th Street South  
St. Petersburg, Florida 33711**

**KBN Engineering and Applied Sciences, Inc.  
6241 NW 23rd Street  
Gainesville, Florida 32653-1500**

**May 1995  
13309C**

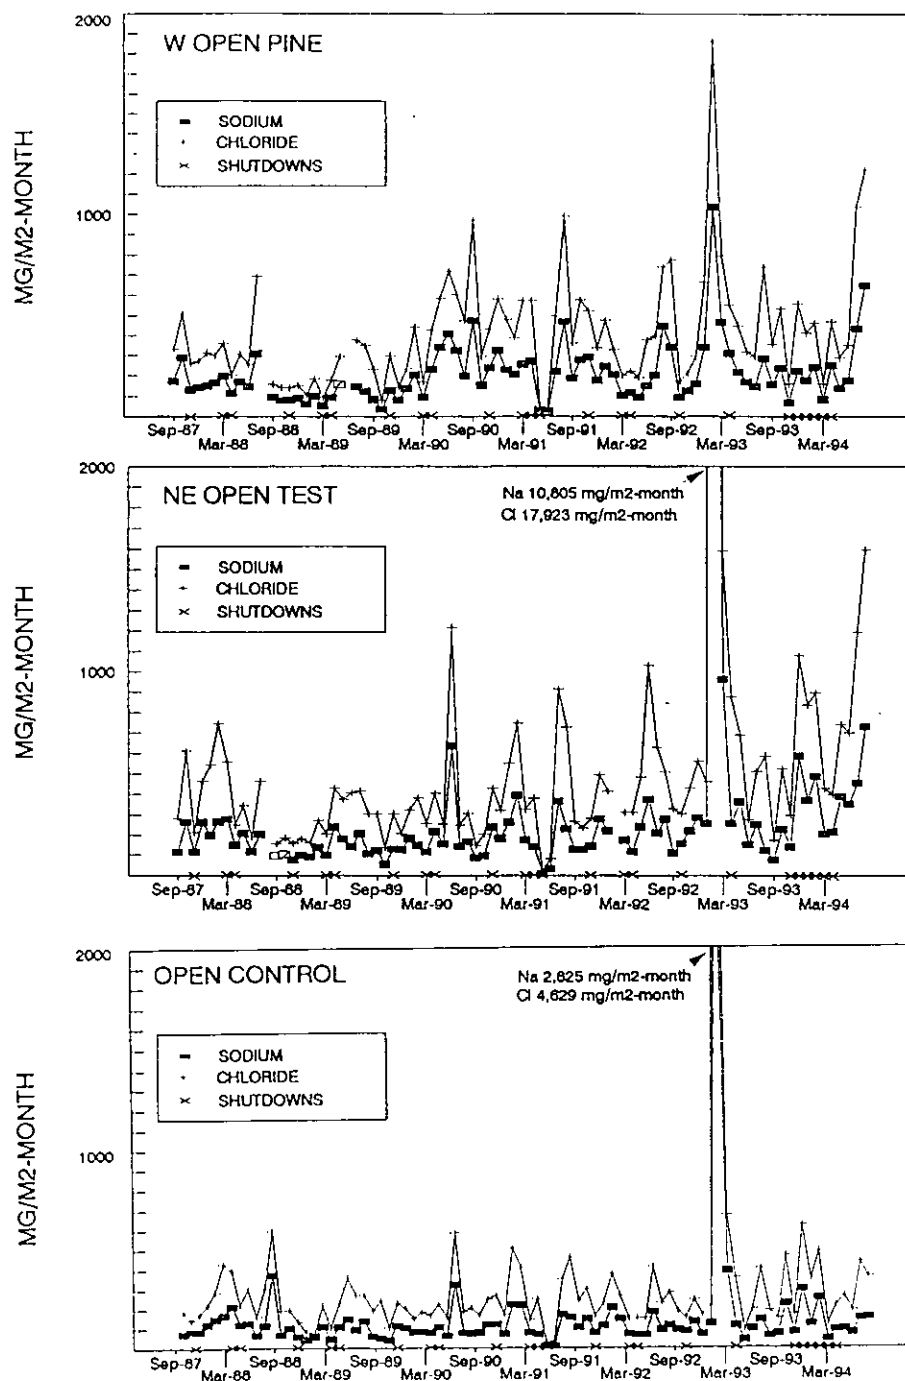
Figure 4-3  
Mean Monthly Deposition at the Three Sites with the Longest  
Monitoring Record from 1987 through 1994

Note: Cooling tower shutdowns are indicated with an X. Highest level of  
deposition occurred in March 1993 from the unnamed tropical storm.

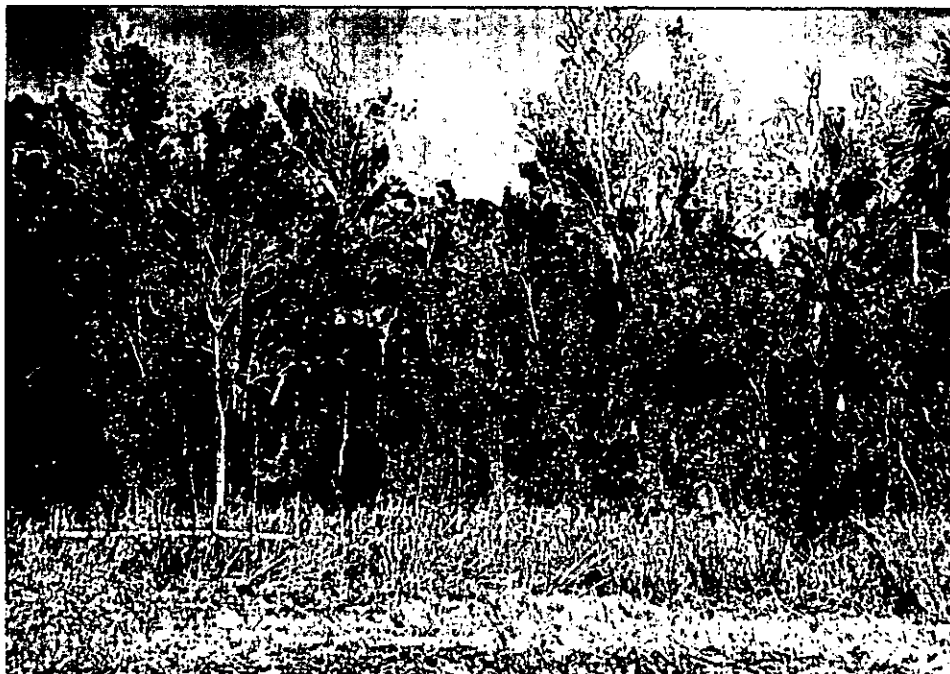
B-7

**Sawgrass Marsh Transitional Hardwood and Pine Communities North of the Power Plant, Showing Continued Presence of Stressed Red Maple or Sweetgum.**
