**Container Division**

Under the terms of a consent decree between Container Corporation of America (CCA) and the State of Florida Department of Environmental Regulation (DER), PEI Associates, Inc. (PEI) conducted an inspection of emissions sources at Container Corporation's Fernandina Beach Mill. Sources to be covered during the inspection included the No. 5 Recovery Boiler and electrostatic precipitator (ESP), No. 4 Recovery Boiler and ESP, No. 4 Power Boiler and mechanical collector (Bahco) and No. 5 Power Boiler and mechanical collector (Bahco).

1. Inspect and determine the physical condition of the ESP serving the No. 4 and No. 5 Recovery Boilers.
2. Inspect and determine the physical condition of mechanical collectors on the No. 4 and 5 Power Boilers.
3. Review the preventive maintenance and emergency maintenance procedures and determine the adequacy of these programs to maintain compliance with applicable opacity and emission limitations.

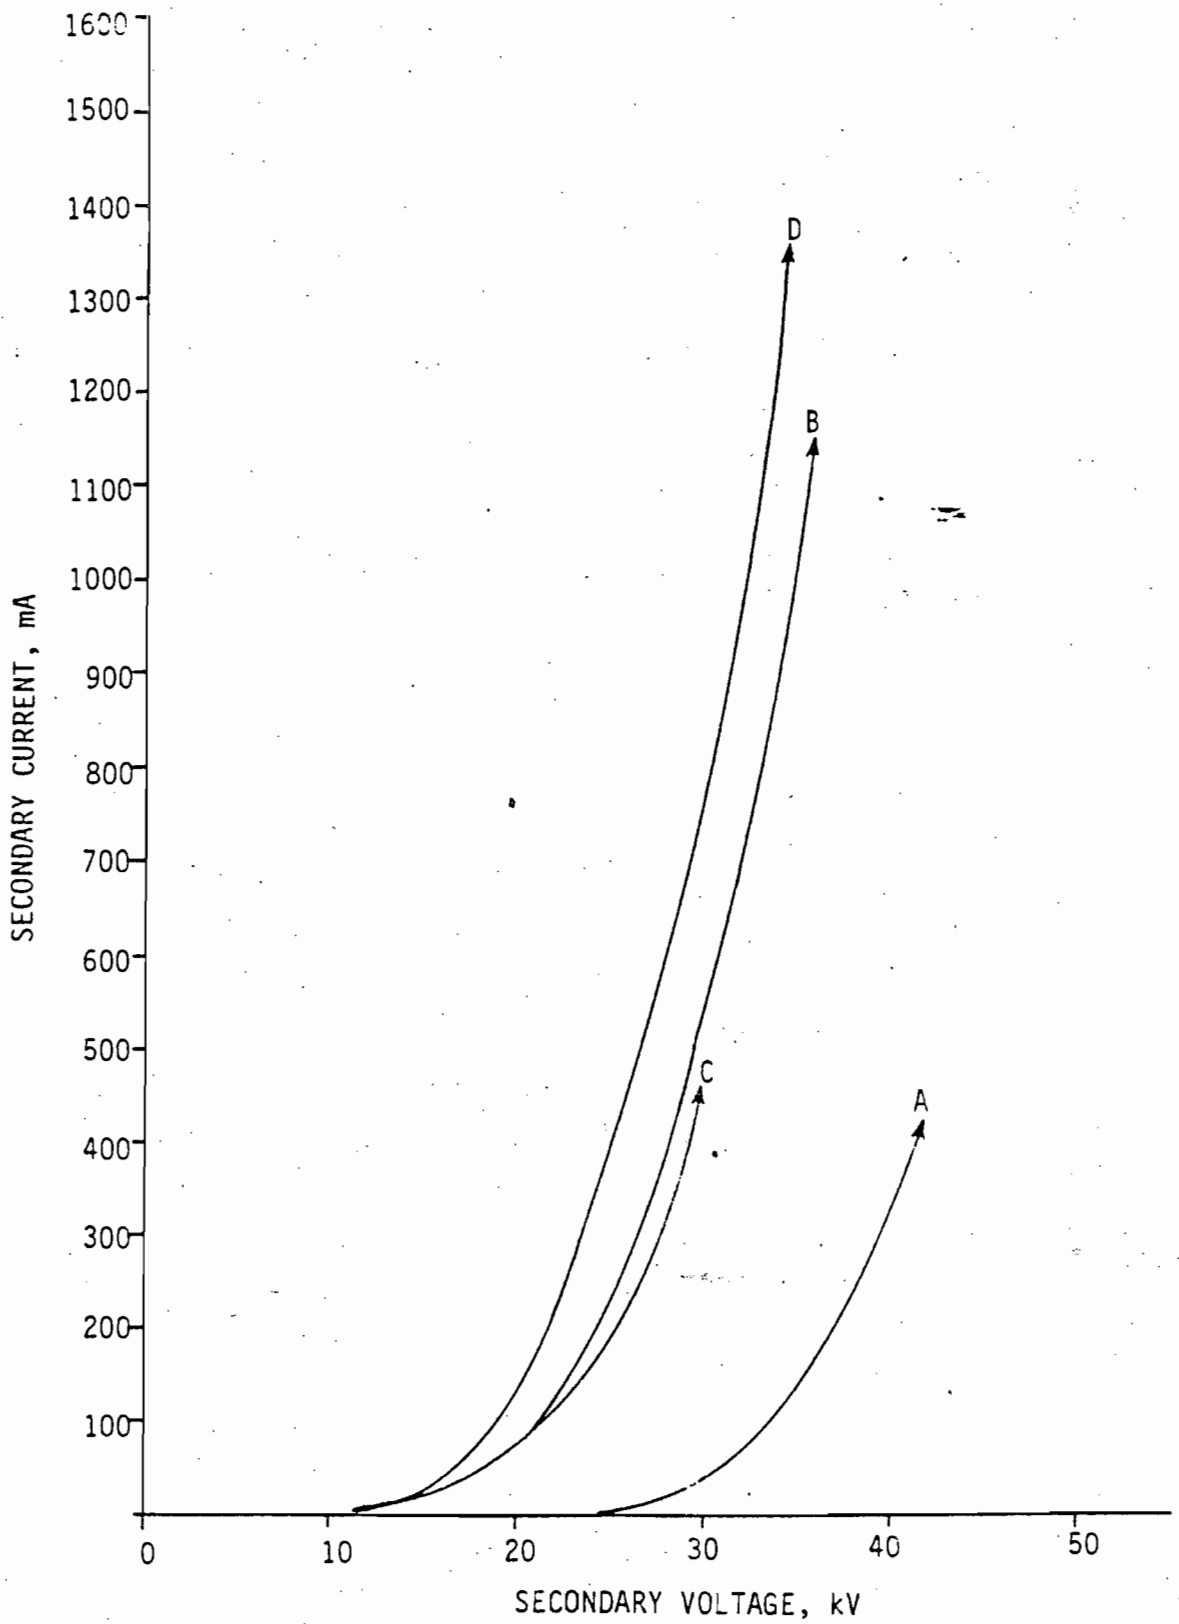
Figure 15. North chamber, No. 5 ESP gas load V-I curves.

Comparison of the general pattern between north and south chambers implies that the north chamber may be receiving a substantially higher gas flow and mass loading than the south chamber. No indication of insulator tracking was observed in either chamber.

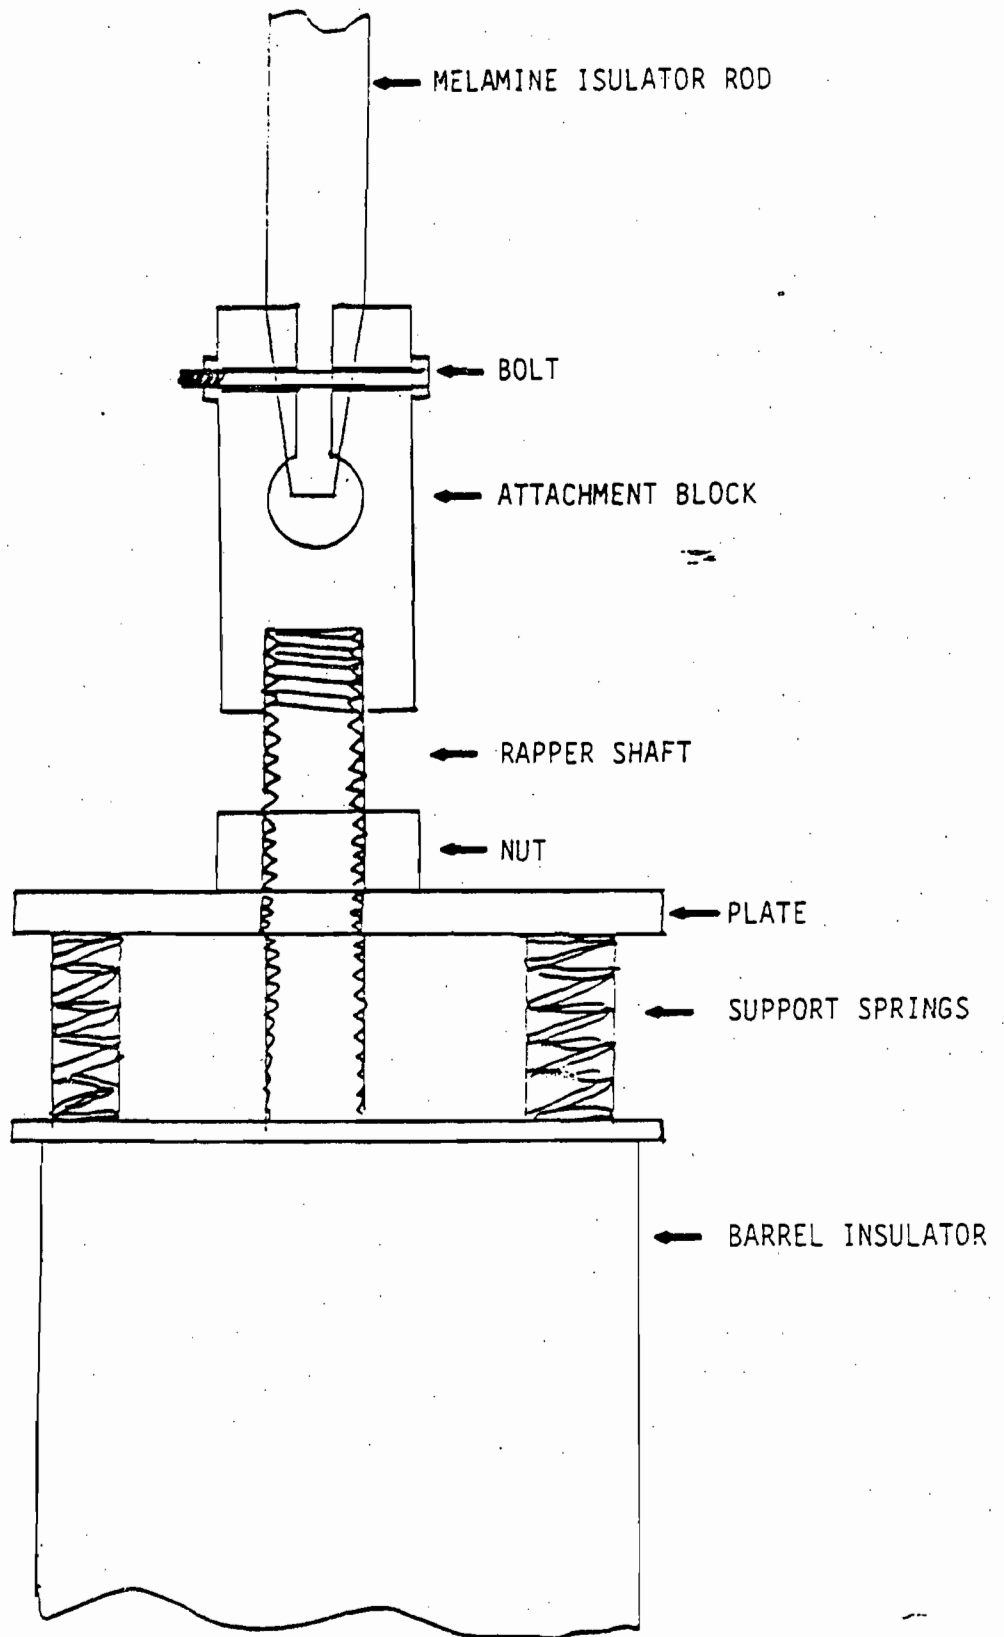
Figure 17. Wire frame rapper rod attachment block.

Turning vane rappers were not available for use because the solenoids had been removed. One rapper shaft was broken and the plates were not rapped. Wire frame rappers are isolated from the wire frame by synthetic polymer rods. The rapper shaft is connected to the insulator by a block clamp. The insulator is housed in a tapered seat in the block and clamped using a split block and bolt (Figure 17). Over periods of continued operation, the tapered shaft loosens and rapping energy is not effectively transferred to the wire frame. This problem is aggravated if the rapper shaft is not vertical and side stress is placed on the connection. Shifts in the wire frame alignment can move the support insulator laterally causing the shaft to be stressed when penetrating the penthouse roof. A visual inspection indicated only two shafts in the south chamber operating at a detectable angle.

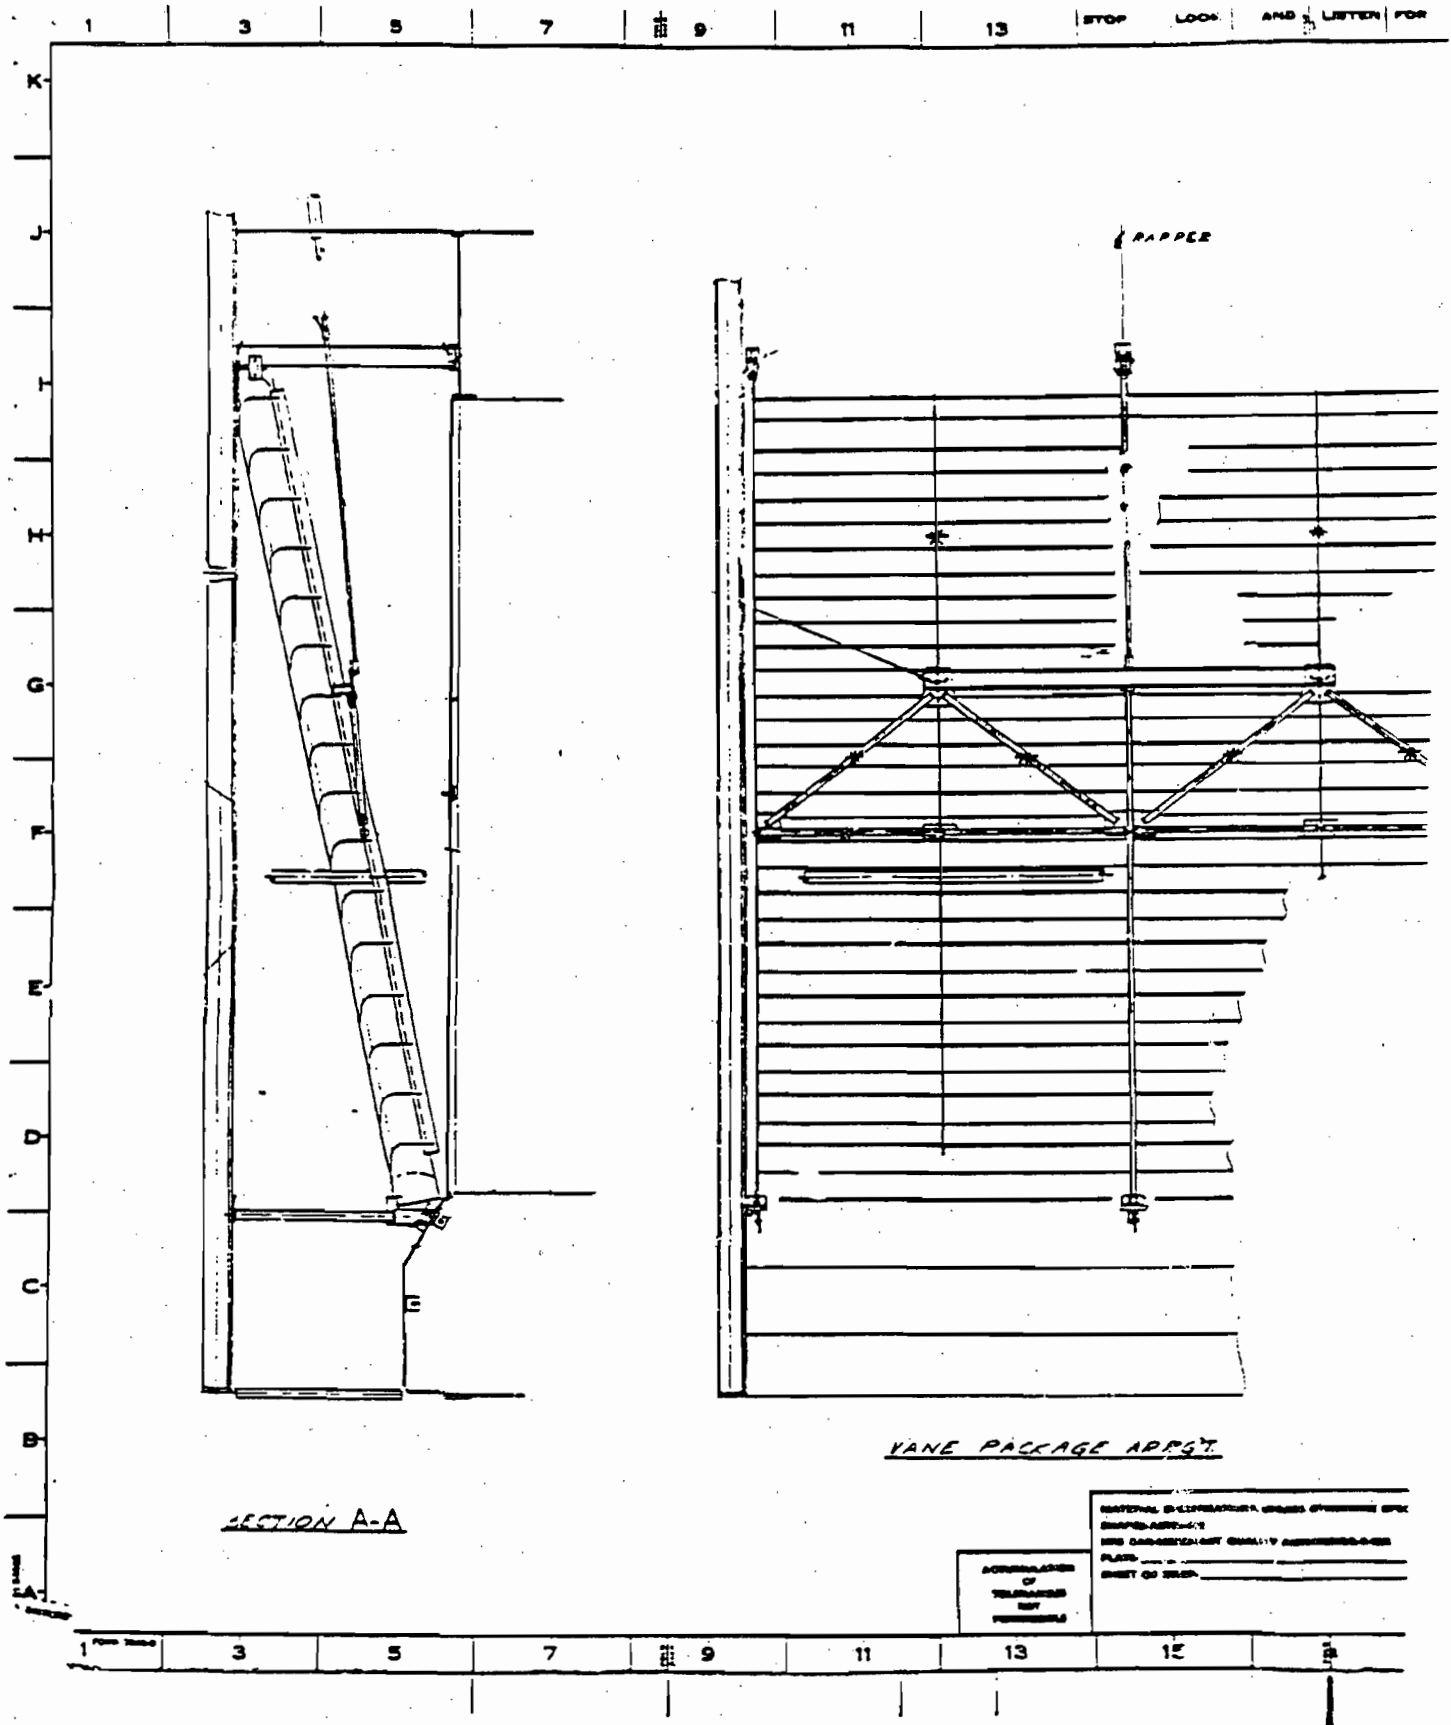
Figure 18. Turning vane configuration.

The gas inlet to the ESP is from the bottom up into the ESP box (bottom entry). The inlet plenum is rectangular and the gas is turned by an inclined set of turning vanes containing 16 individual vanes. Each vane is a "L" shape with the long side toward the ESP inlet (Figure 18).

During the inspection, it was observed that a buildup of salt cake was present on the horizontal face of the turning vanes, which was partially obstructing the flow of gas on the south chamber inlet (the north chamber could not be observed because of ESP operation). Discussion with plant personnel indicated that chronic fouling had occurred and that all efforts to maintain clean turning vanes were ineffective. In an effort to improve gas distribution (i.e., reduce pluggage), a portion of the horizontal vane had been removed.

It should be noted that both the gas distribution plate and turning vanes are rapped by the same two rappers. As noted in the previous sections, the turning vane rappers were not functioning.

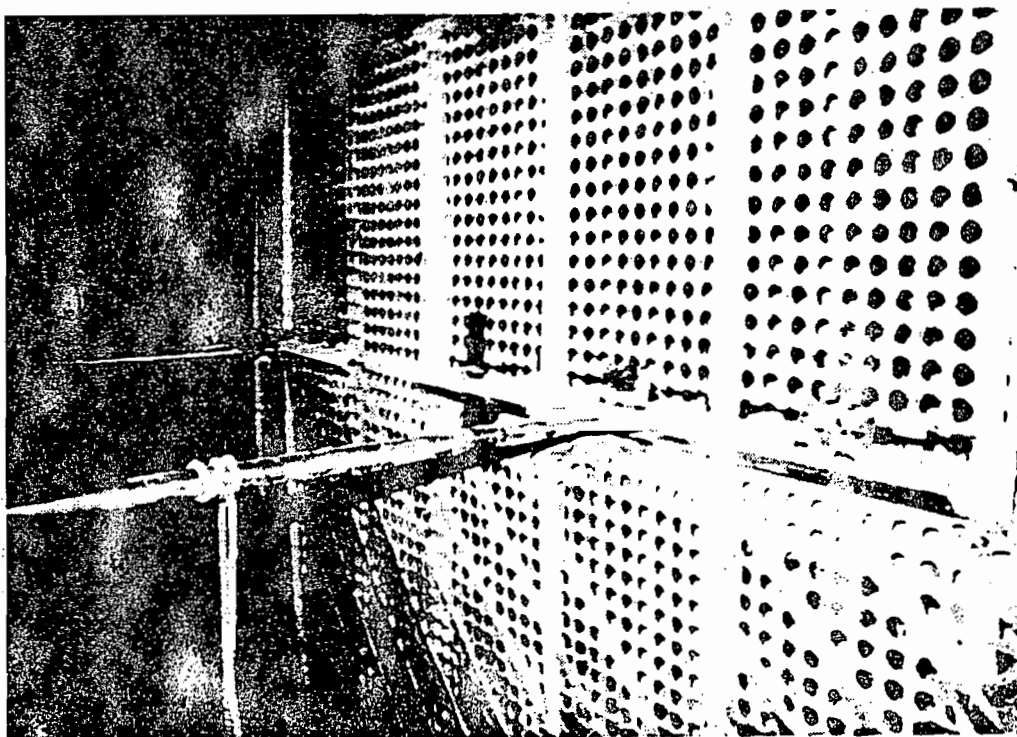
A visual inspection of the distribution plate from the top looking into the inlet plenum indicated substantial pluggage of the perforated distribution plate (Figure 19). The fouling was sufficient to seriously affect the gas distribution within the chamber and affect collection efficiency. It is suspected that the pluggage is directing gas flow to the north chamber as implied by the V-I curves and corona power levels. An inspection of the north chamber inlet, however, could not be conducted to verify this suspicion. It is also possible that the north chamber distribution plate was also fouled.

Figure 22. Inlet distribution plate showing horizontal rafter.

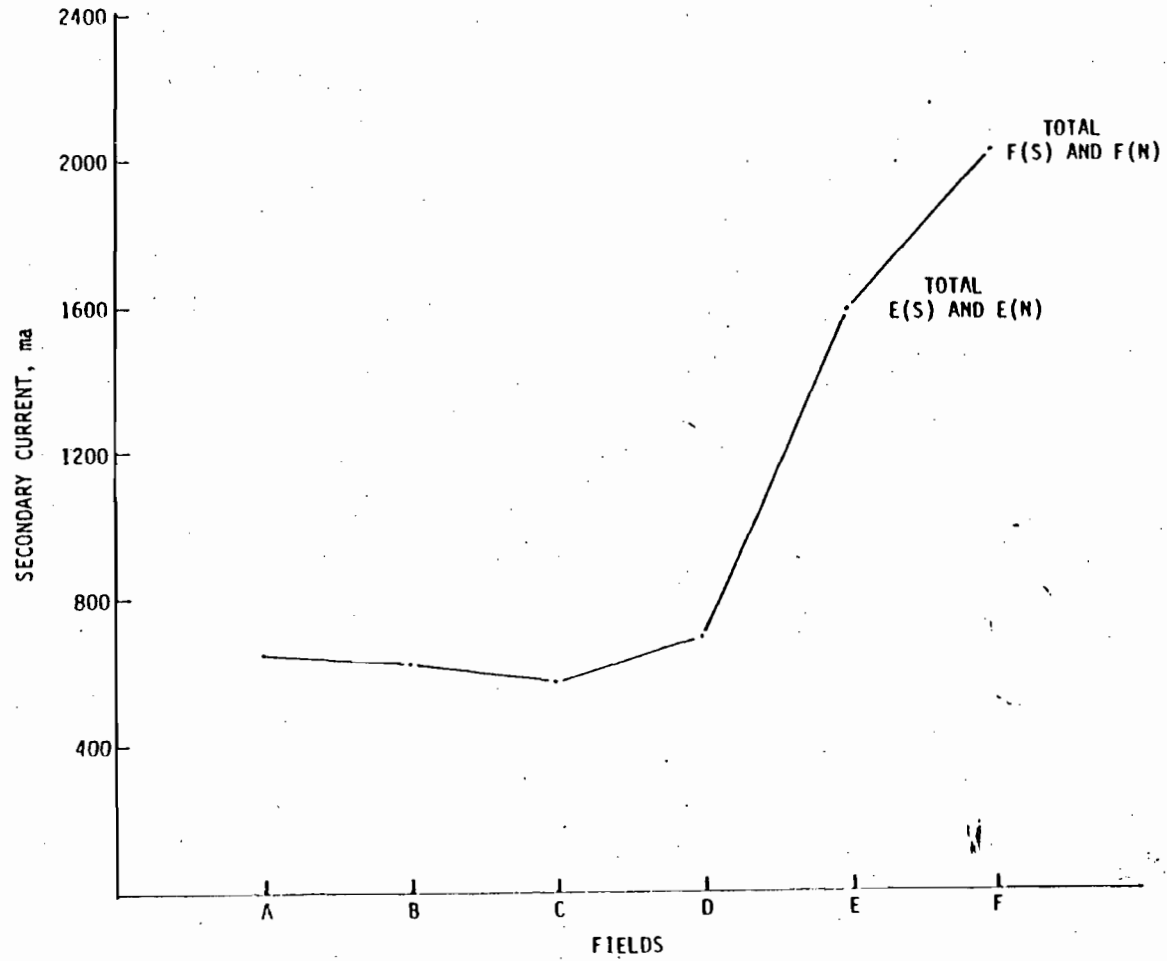
Figure 28. Secondary current No. 4 ESP.

The secondary current pattern in the unit increased from inlet to outlet as dust was removed from the gas stream (Figure 28). A plot of chamber current (Figure 29) from inlet to outlet, however, indicated that the north chamber had a suppression in the last field (F). All other fields appeared reasonably balanced (north to south).

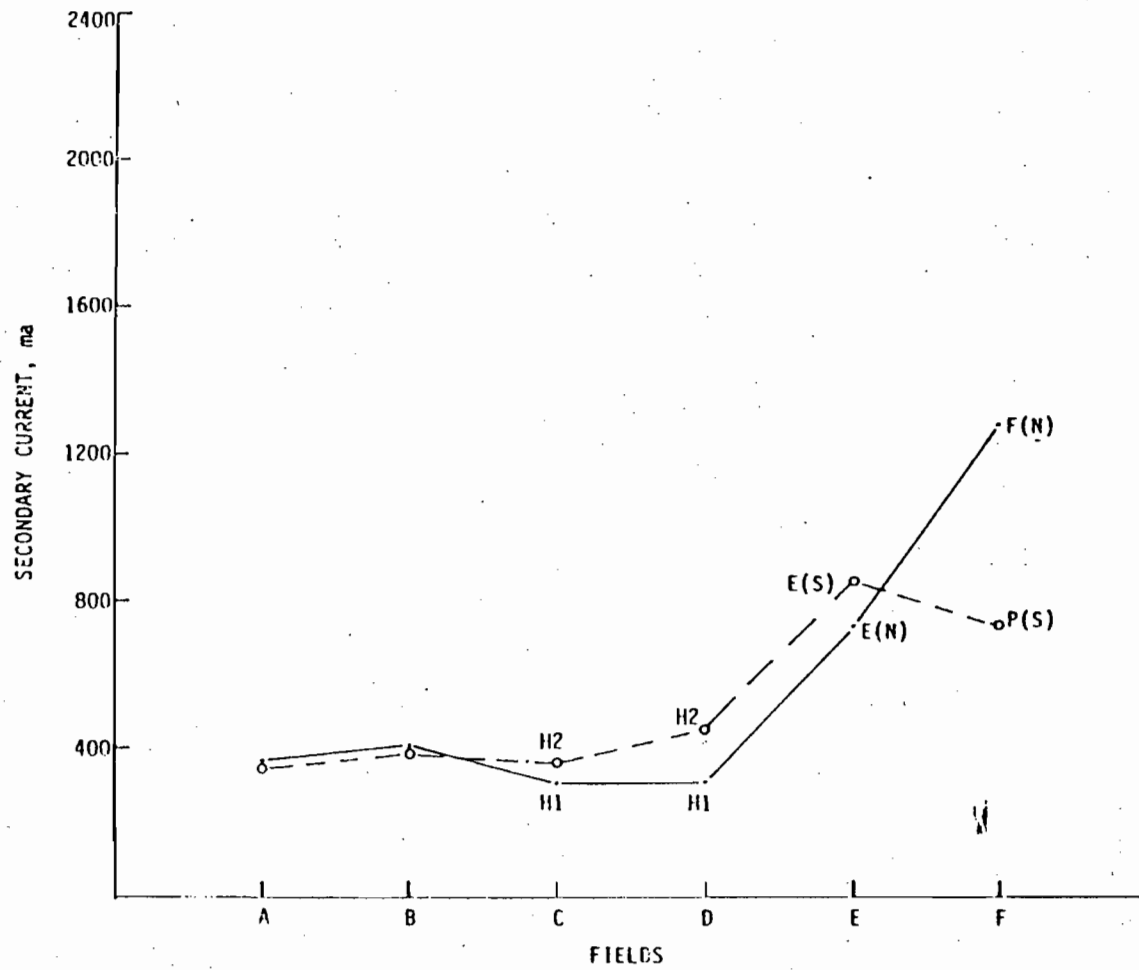
Figure 29. Secondary current by chamber No. 4 ESP.

The sum of the current drawn by each bus section Fields A, B, C and D was significantly higher than that indicated by the meters when measuring total current from the T-R set. This was also observed in E(N), E(S), F(N), and F(S). Because of this deviation, chamber balance may not be indicative

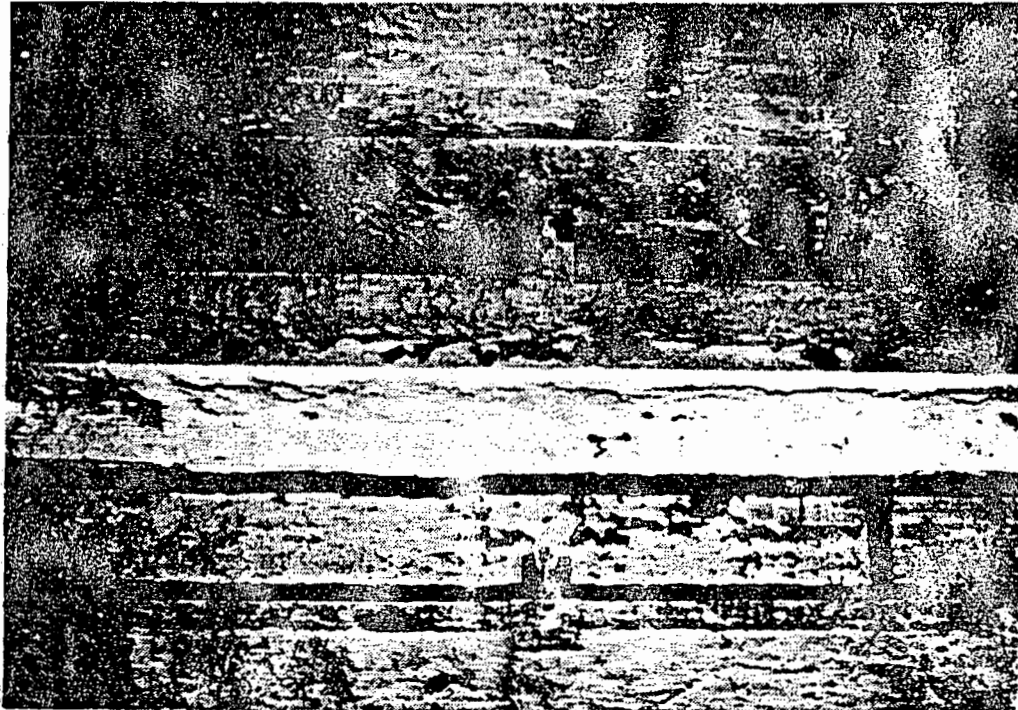
The baffles between the remaining fields are constructed of two movable baffle plates with a rigid structural member between them. One baffle is provided for passage of the upper drag chain scraper blades, and the other is provided for passage of the lower blade in the opposite direction (Figures 31 and 32). Each moveable baffle is suspended by a chain that allows it to swing freely in either direction. These baffles are shorter in length than those used in the inlet field. Also, the plates fit closer providing a more positive seal. When scraper blades on all three drags are in line across the chamber, a large opening is presented between the fields. If the blades are spaced at regular distances, two successive baffles may be opened between the fields, which provides a gas sneakage path. During the inspection, the blades appeared to be staggered across the chamber. Staggered placement of blades across the chamber presents the minimum open baffle area at any period of time (Figure 33). The number of blades per chain (distance between blades) should be checked to prevent simultaneous opening of successive baffles on each drag.

Figure 32. Upper antisneakage baffle.

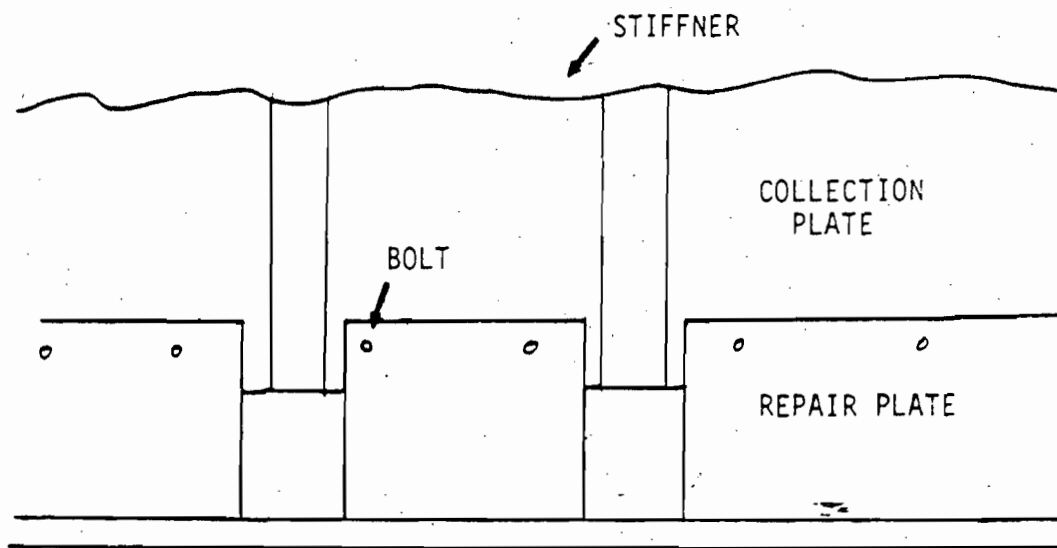
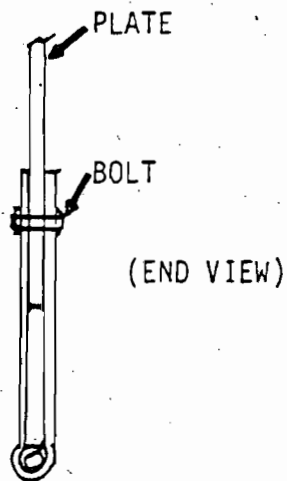
Figure 36. Plate repair method No. 4 ESP.

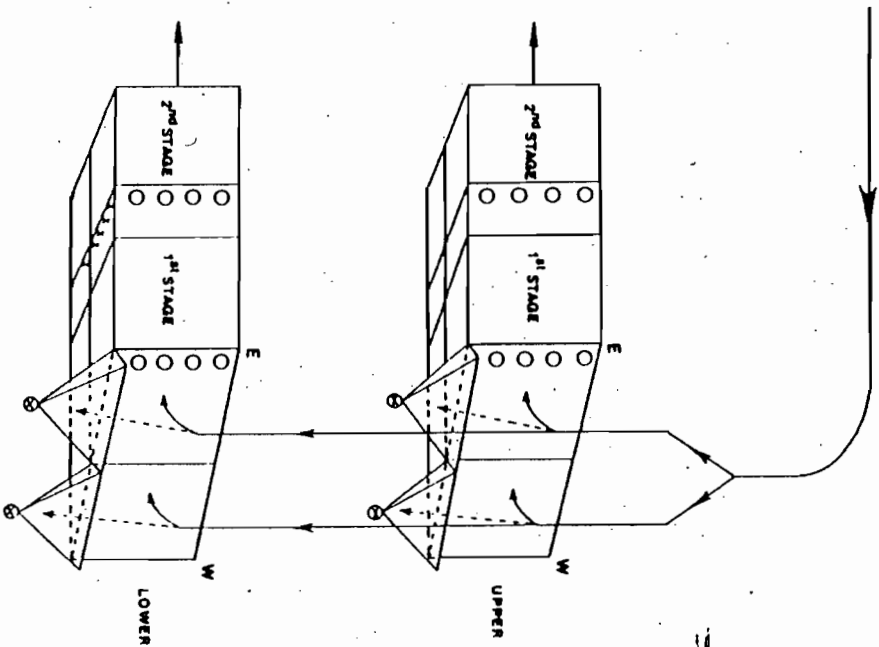
Figure 41. Inlet plenum arrangement of No. 5 Bahco primary collectors.

The abnormal deposits of dust in the lower two primary collectors seem to be the result of maldistribution of incoming flue gas. Figure 41 illustrates the inlet plenum layout for all four primary collectors. Flue gas from the boiler air heater is routed parallel and above the collectors, makes a 90° turn to vertical, and splits between east and west plenums. Four 90° branch ducts from these two plenums feed the upper and lower collectors. Dropout chambers ahead of each inlet collect large particulate matter as the flue gas makes the final turn into the collector. Because each set of upper and lower collectors are fed by the same vertical plenum, heavier grain loading can be expected in the lower collectors due to the added inertia imparted to the particulate matter by gravity.

Abnormal dust deposits on the floor between the first and second stages of the lower level eastern collector and the eastern end of the lower level western collectors are indicated in Figure 41 by a series of "X's." This pattern also suggests a higher gas flow in the eastern vertical plenum or a left-to-right gas maldistribution. This left-to-right maldistribution may be caused by partial pluggage of the boiler air heater, stratification, or partial obstruction of the main plenum.

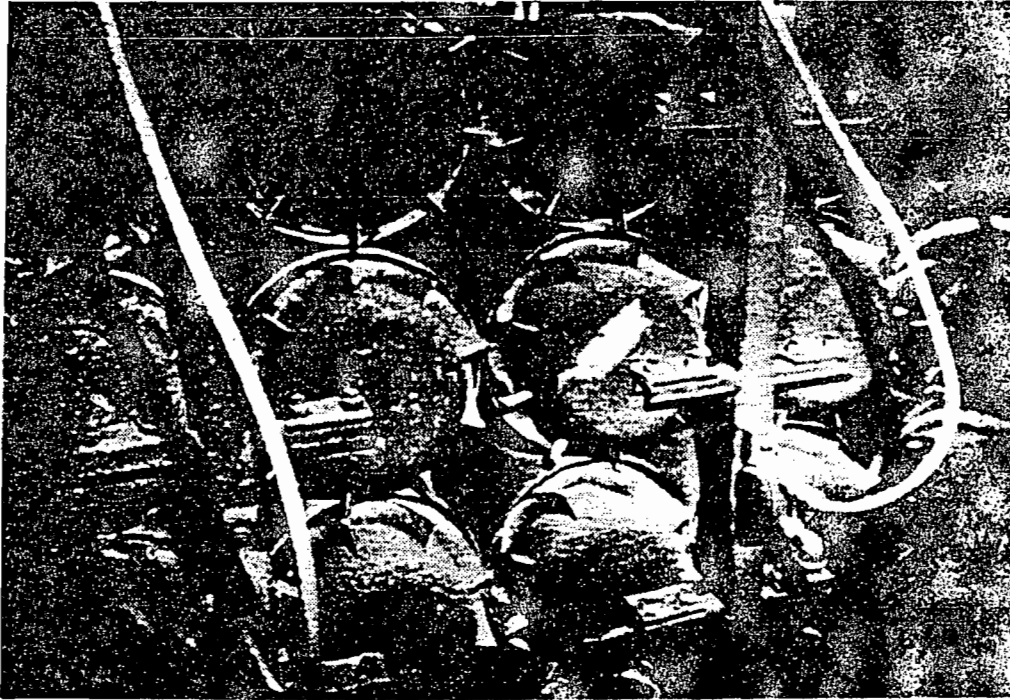
Figure 42. Pneumatic vibrators on inlet of cyclone tubes.

It was discovered upon entry that pneumatic vibrators were attached to the tube vane guide arms in some sections of each collector (Figure 42). These vibrators are designed to loosen dust accumulation on the guide vanes. During the inspection, several of these vibrators were still in service. It should be noted that when activated, little or no dust was dislodged from the adjoining guide vanes.
