# Indiantown Cogeneration, L.P.

RE: Indiantown Generating Plant  
Permit Nos.: PSD-FL-168 & PA 90-31

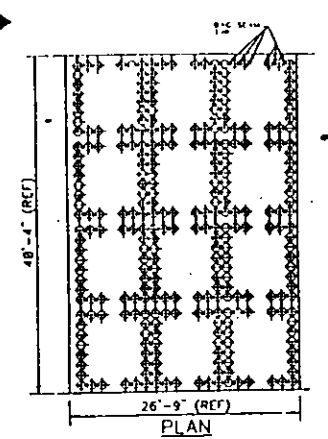
TYPICAL COMPARTMENT SHOWING BAG SEAM ORIENTATION

**NO INSTALLATION OF GLASS CLOTH FILTER BAGS**

IF BAGS NEAR AREA OF FILTER BAG (O) AND INSERT. ROTATE CAP 90° AND PULL CAP SNUGLY AGAINST ROLLED RIM TO CAP (b) AND RAISE BULK OF BAG (o)

TO TIGHTEN THIMBLE AS SHOWN IN STEP (2) UNTIL THIMBLE RIM IS COMPLETELY TIGHT. EVERY TIME BAG IS MOVED UPWARD UNTIL IT IS 1" FROM GRID SHEET, CLIP MUST BE PARALLEL TO GRID SHEET. USE WRENCH ONLY (NO SCREWDRIVER REQUIRED).

TO INSTALL CLAMP SCREW HOLDER DIRECTLY OVER BAG SEAM. CLAMP SCREW HOLDER IS INSTALLED

TO CONNECT TO BAG HANGING SYSTEM. JUST TENSION ON BAG TO APPROX. 65 PSI. CLIP, USE TENSION TOOL REF. DWG. 000-11-49-02 (THIS DWG)

IF THE BAG IS TIGHT AT THE THIMBLE (LE). X. 1-WEEK AFTER BEING PLACED INTO SERVICE

- a) The bag clamps were all loosened and removed in a individual compartment.
- b) The new stainless steel clamps were put on the collar of the bag and then positioned on the thimble of the lower plenum.

- g) Once this is complete the lower retaining clip is replaced on the tensioning assembly and the air is bled from the tensioning device.
- h) After the work on a section was complete the area was inspected.

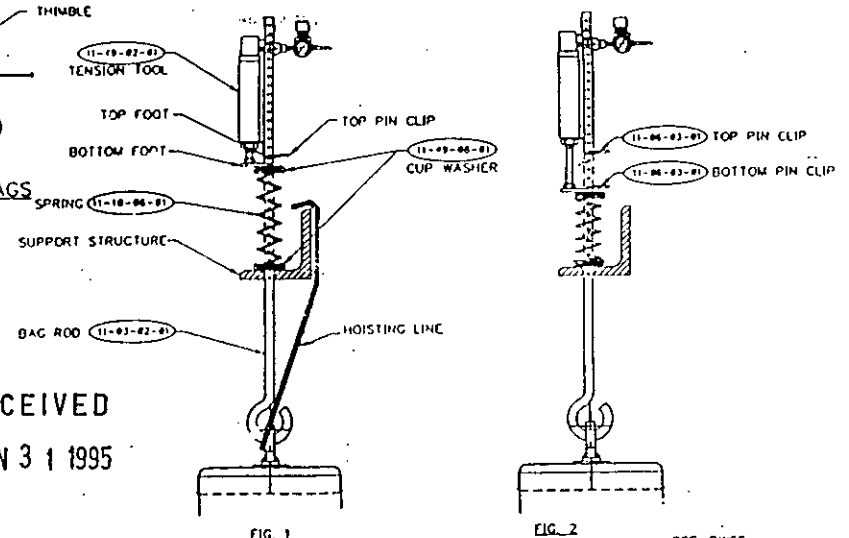
FIG. 1  
BAG TENSION INSTRUCTIONS

1. - HOLD ROD & BAG IN POSITION WITH HOISTING LINE. (FIG. 1)
2. - INSTALL WASHERS & SPRING AS SHOWN. (FIG. 1)
3. - POSITION BOTTOM FOOT ON SPRING WASHER. (FIG. 1)
4. - PLACE TOP CLIP IN ROD & POSITION TOP FOOT UNDER CLIP. (FIG. 1)
5. - SET GAUGE TO 65 PSI FOR DESIRED BAG TENSION & ACTIVATE CYL. AIR. (FIG. 2)
6. - INSERT BOTTOM CLIP JUST ABOVE BOTTOM FOOT OF TENSION TOOL. (FIG. 2)
7. - RELEASE CYL. AIR PRESSURE AND REMOVE TENSION TOOL.
8. - REMOVE HOISTING LINE. LEAVE TOP & BOTTOM PIN CLIP INSERTED IN ROD.
